# WILDFIRE DAMAGE ASSESSMENT REPORT

SEPTEMBER 24, 2020

**San Lorenzo Valley Water District**

Prepared by:  
Sandis Civil Engineers Surveyors Planners

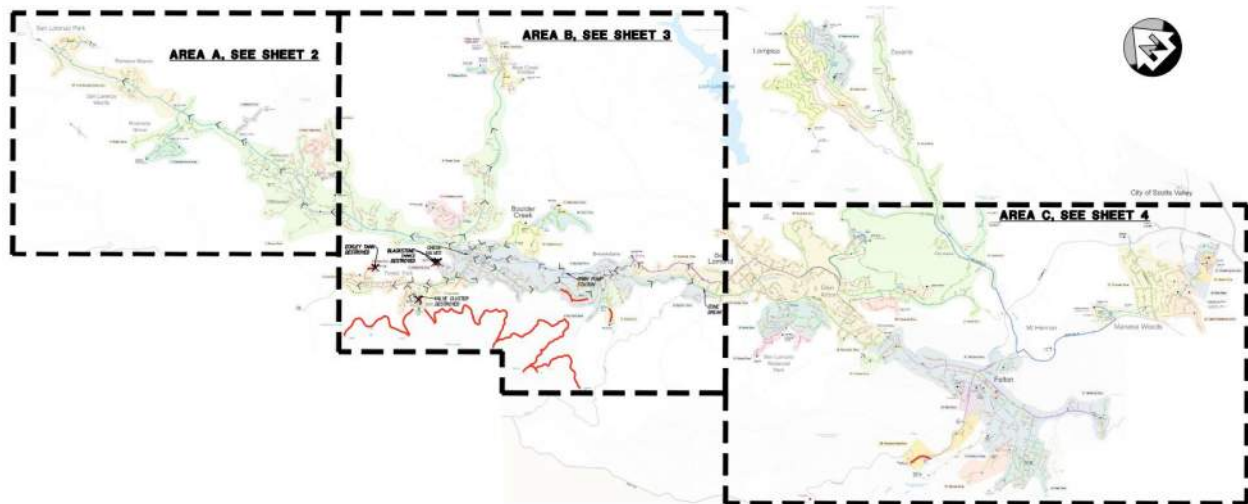
Figure 1: System Fire Damage Overview

An overview of the District's facilities damaged by the wildfire is presented in Figure 1 below (damaged facilities are highlighted in red). The damaged facilities have also been broken into three areas (Area A, Area B, and Area C) for display purposes; see Figures 2-4 below for the Wildfire Zonal Detail exhibits.

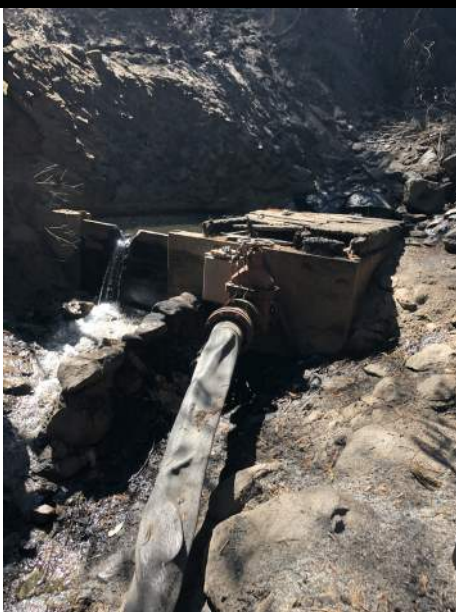
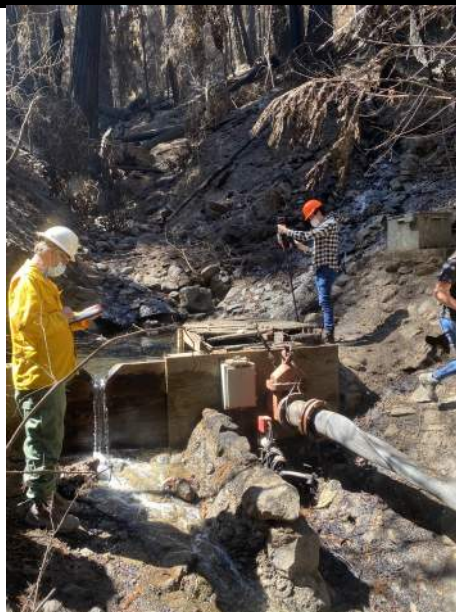
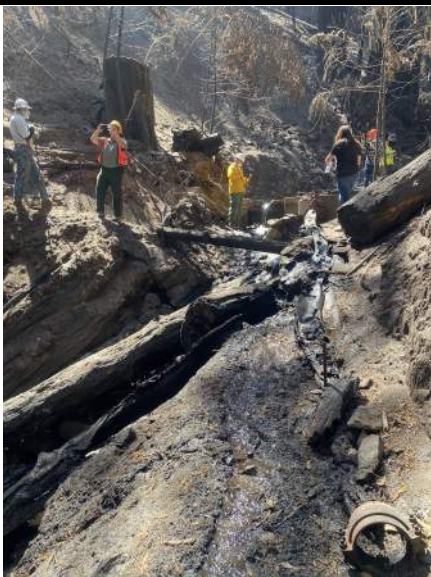
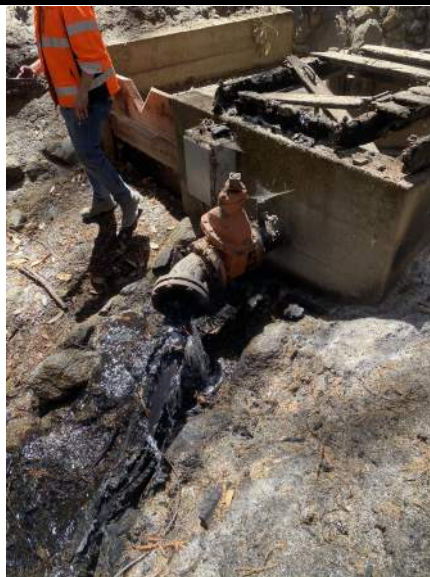
The CZU Lightning Complex Fires have extensively damaged the District's intake and treatment system. The intake pipes, which traverse miles of steep grades and are inaccessible by traditional trenching equipment, were installed above grade. Due to exposure and rugged terrain, High-density polyethylene (HDPE) pipes were selected for the water system for its strength and ease of construction. Most of the intake piping was in the path of the fires and therefore melted, rendering the intake system inoperable. Many of the ductile iron fittings (including valves, unions, etc.) fared better than the HDPE pipe, but the internal rubber gaskets melted from the heat causing the fittings to be unusable. All non-metallic components of the pipeline were destroyed. The stream diversion structures are largely constructed of concrete and steel which was unaffected by the fire, but the wood planks used in the weirs were effectively destroyed, fittings were damaged, and the HDPE pipe outlets were burned or melted.

Caption: Typical Creek Diversion Structure

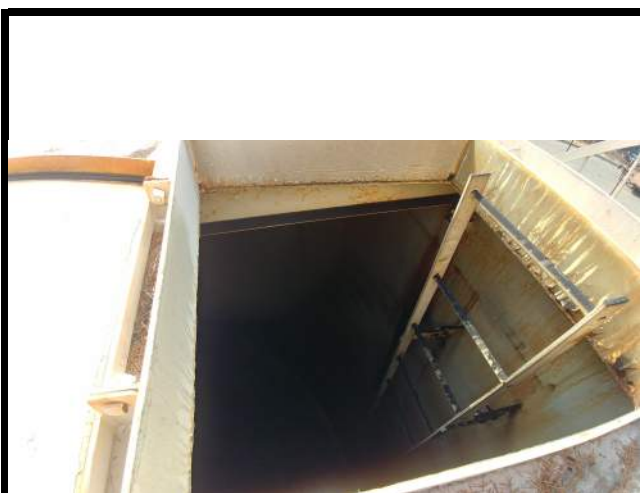
Caption: Typical Little Lyon/Lyon Tank Interior

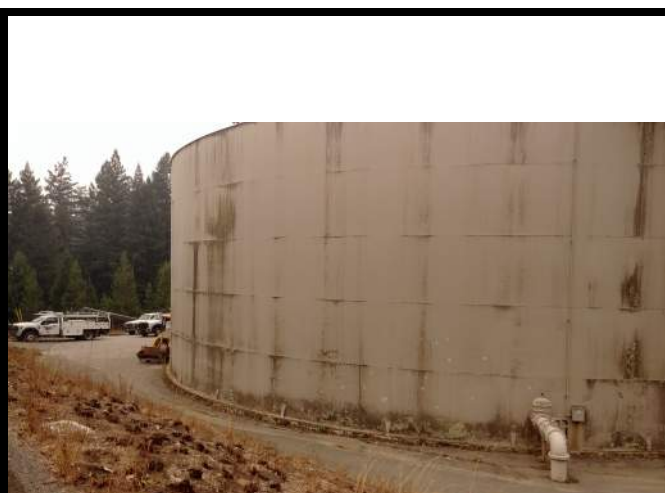
Caption: Lyon Tank

Despite the exterior of the storage tanks appearing to be intact, the tanks should undergo additional evaluation by the District and professional consultants to verify that they are safe to operate as intended. Water should be tested to verify its safety, or it should be discarded. Potential contaminants for this water include chemicals from the off gassing of the heated metal, burning of paint or other coatings, or other sources of contamination. The exterior of the Lyon Water Treatment Plant also appears to be undamaged but should be evaluated before resuming full operation. Additionally, the District's trailer-mounted generator was destroyed, and the trailer-mounted air compressor unit was damaged by heat and smoke. The generator and compressor unit should also be either repaired or replaced before use.

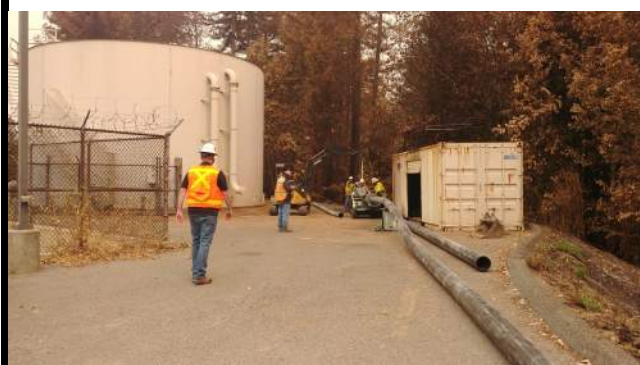
Caption: Little Lyon Tank

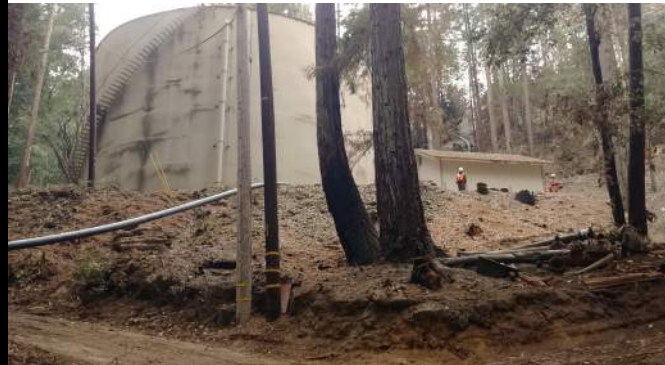
Caption: Typical Tank Exterior

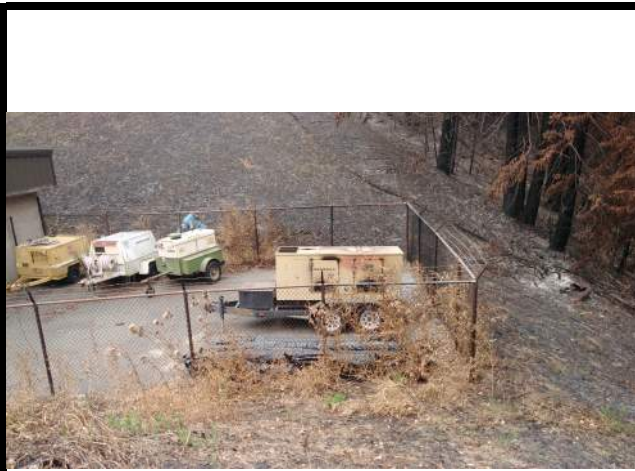
Caption: Damaged Trailer Equipment

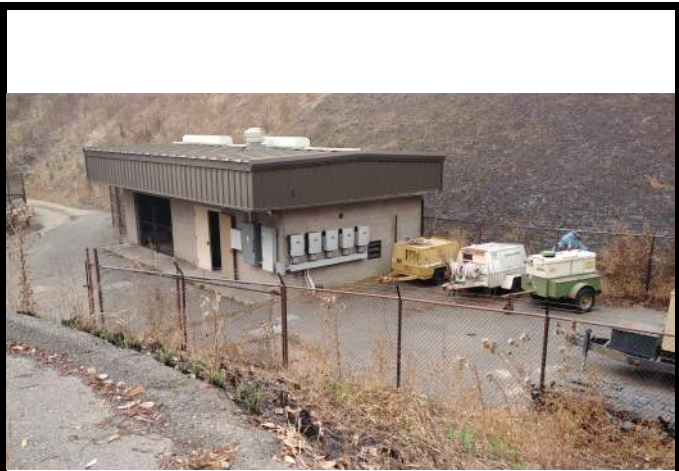
Caption: Damaged Equipment Water at Water Treatment Plant

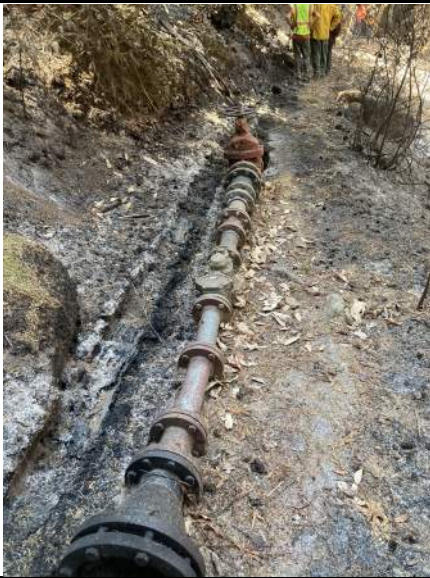
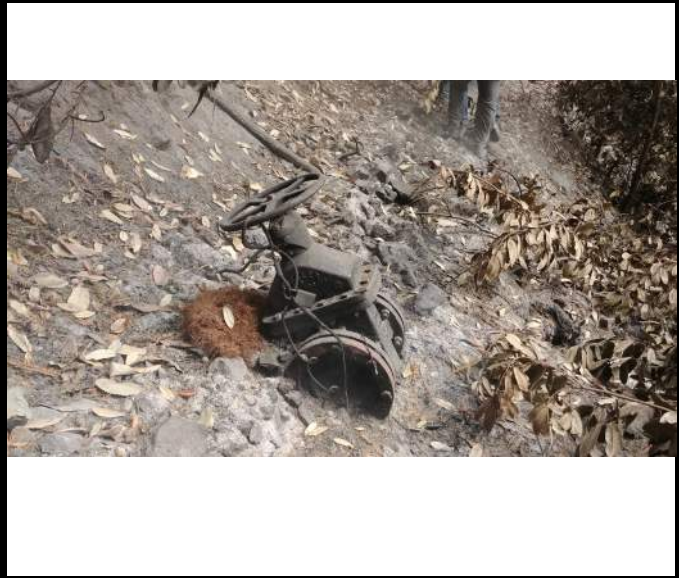
Caption: Typical Above Ground Pipe Fittings

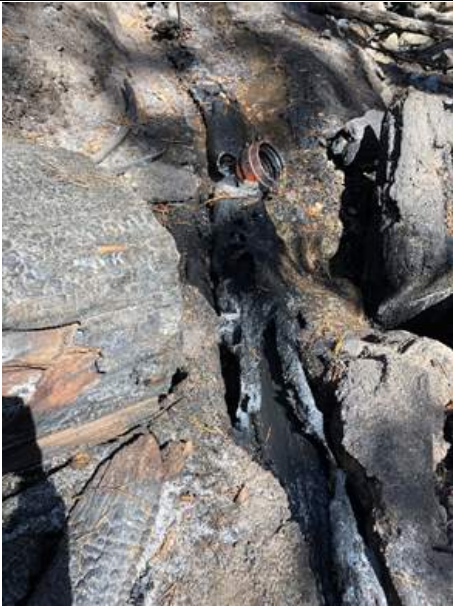
Caption: Melted HDPE Pipe

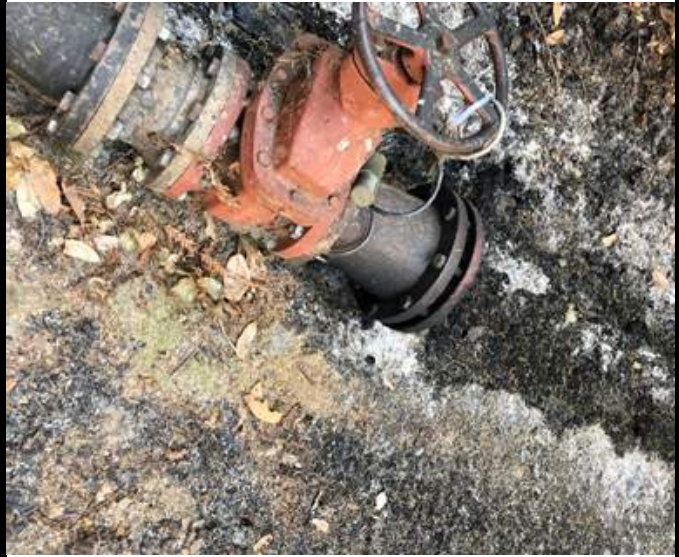
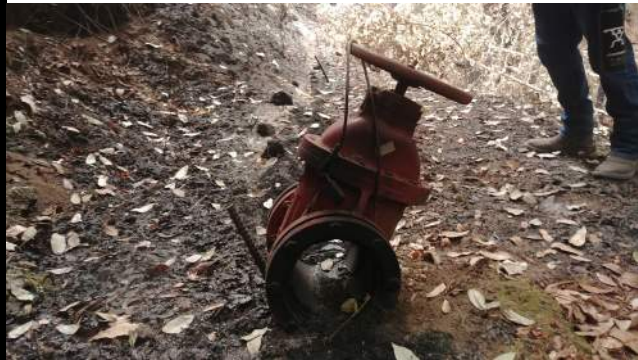
Caption: Existing Pipe Destroyed Around Pipe Fittings

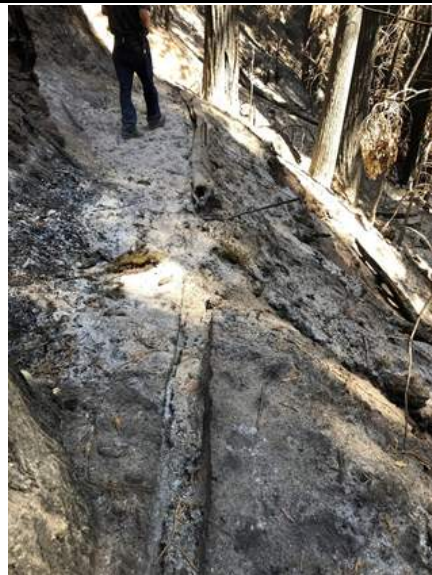
Caption: Destroyed Pipe Installed on Steep Incline

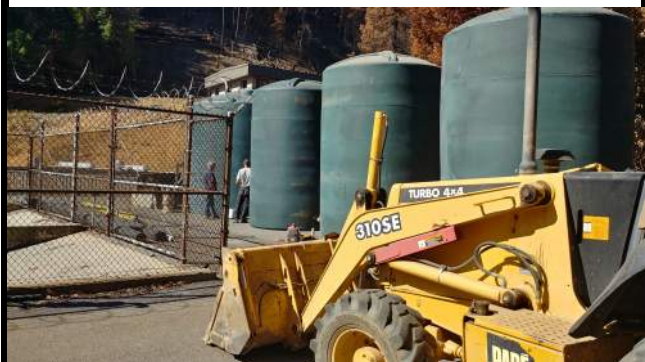
Caption: Temporary Storage Tanks

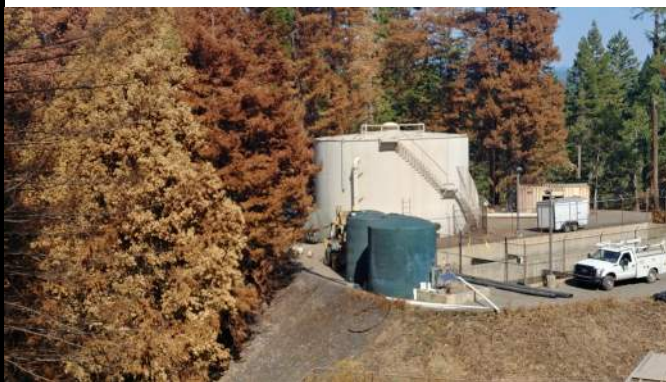
Caption: Temporary Storage Tank Location

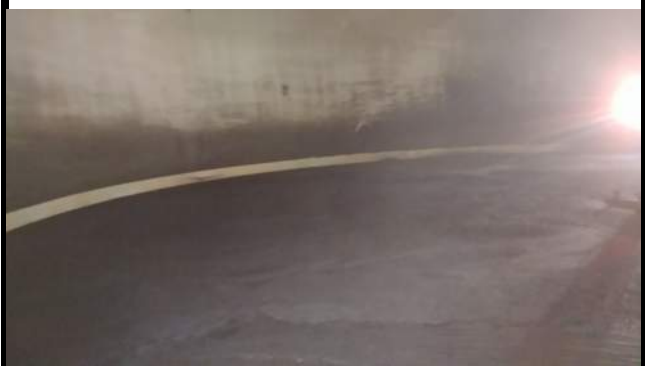
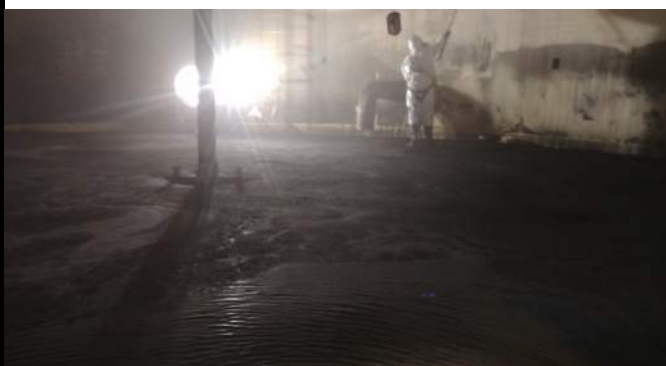
District infrastructure within the burn zone, and at the water treatment plant and tank complex, has suffered contamination by ash, soot, and other fire byproducts. Release of volatile oxidizing compounds (VOCs) by the plastics, coatings, and other materials used in the SLVWD system is suspected. SANDIS has taken samples from both Lyon tanks for analysis. The District has taken samples from the water treatment plant and from sampling points located throughout the system, also submitted for analysis. Water quality sampling and testing is ongoing as emergency repairs are made to the system. Contamination extents and levels, with associated test data will be presented under separate cover, together with recommendations to address the specific contaminants identified.

Caption: Contaminated Little Lyon Tank Interior
