GEOTECHNICAL DESIGN REPORT

**SAN LORENZO VALLEY WATER DISTRICT
FOREMAN INTAKE GRADING AND EROSION CONTROL PROJECT**

CE&G DOCUMENT NO.: 210450.001

24 JUNE 2022

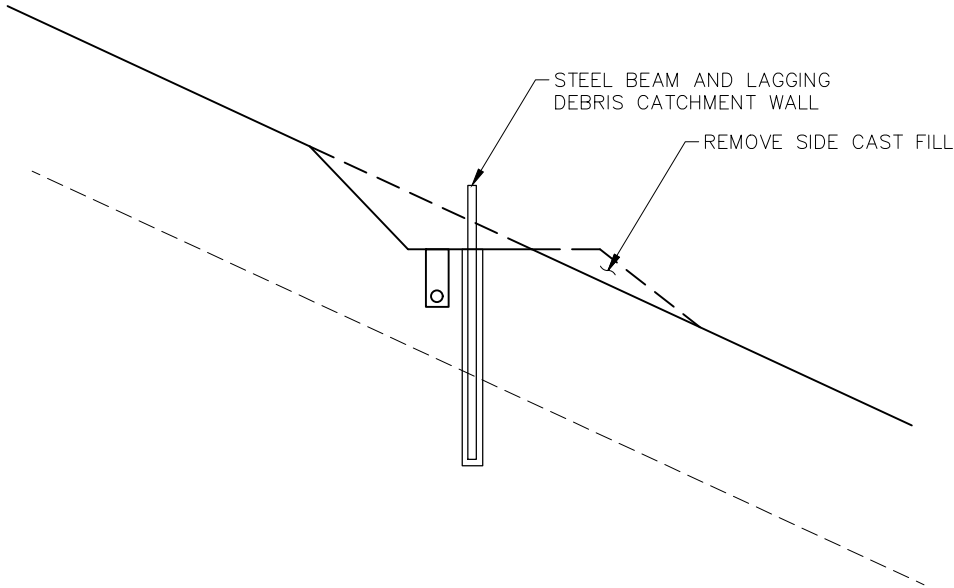
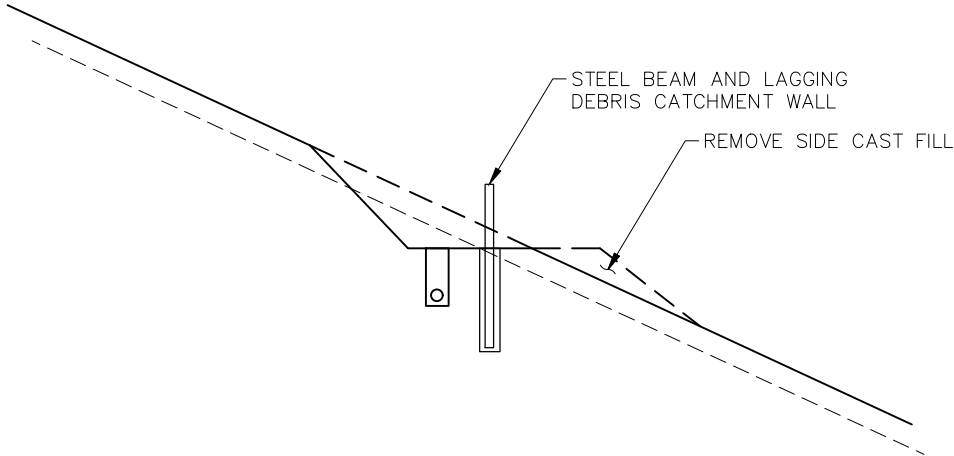
FIGURE 6b

This alternative (see Figure 6B) would mitigate the erosion hazard of side cast fill by removing it from the site. If a nearby site could be located and/or fill were needed for a nearby site, this would be the least expensive method to mitigate the hazard related to the side cast fill.

The upslope cut would be allowed to degrade and slump onto the bench being retained by a catchment wall. It is possible that debris flows upslope of the existing pioneered trail cut could fill and/or overwhelm over top the wall. As a result, the wall would require maintenance to remove debris if the wall became filled by debris.

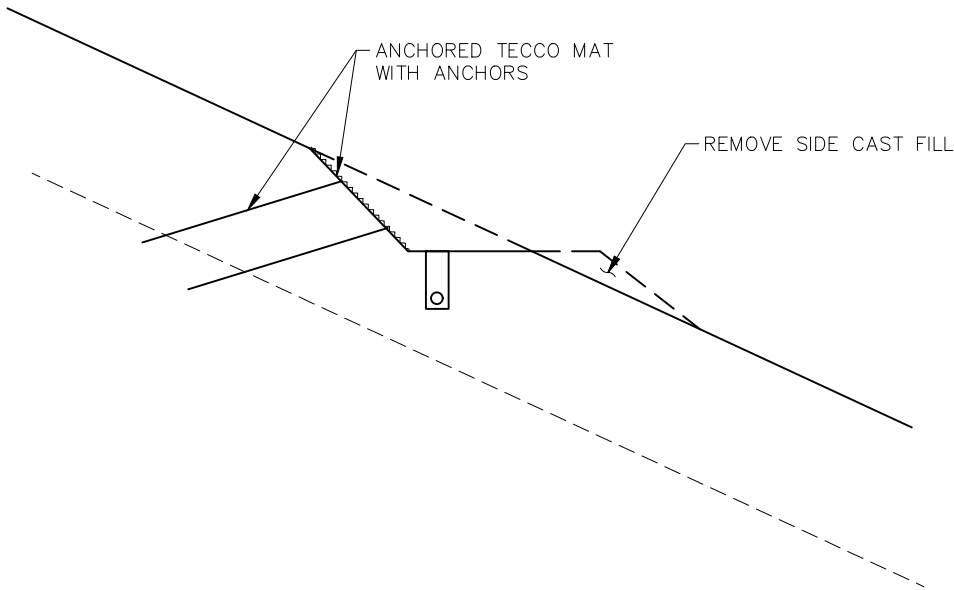
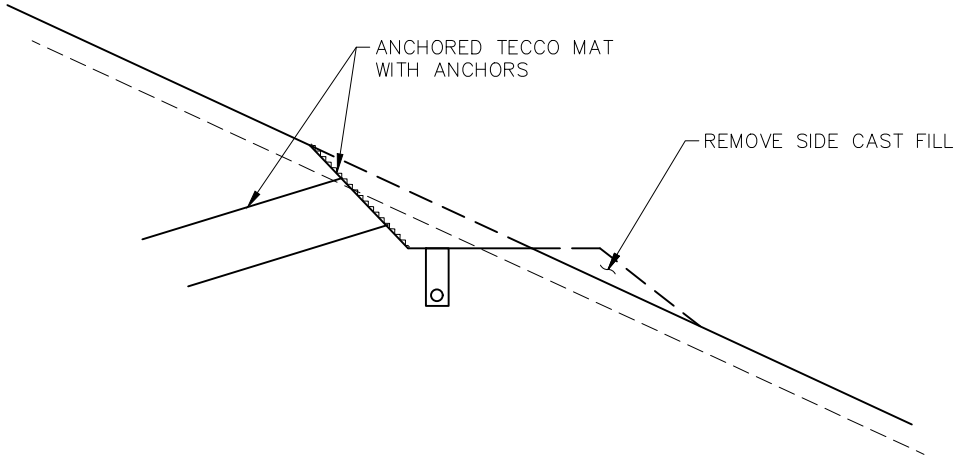
FIGURE 6C

This alternative (see Figure 6C) would mitigate the erosion hazard of side cast fill by removing it from the site, as in Alternative 2. If a nearby site could be located and/or fill was needed for a nearby site, this would be the least expensive method to mitigate the hazard related to the side cast fill when maintenance costs are considered.

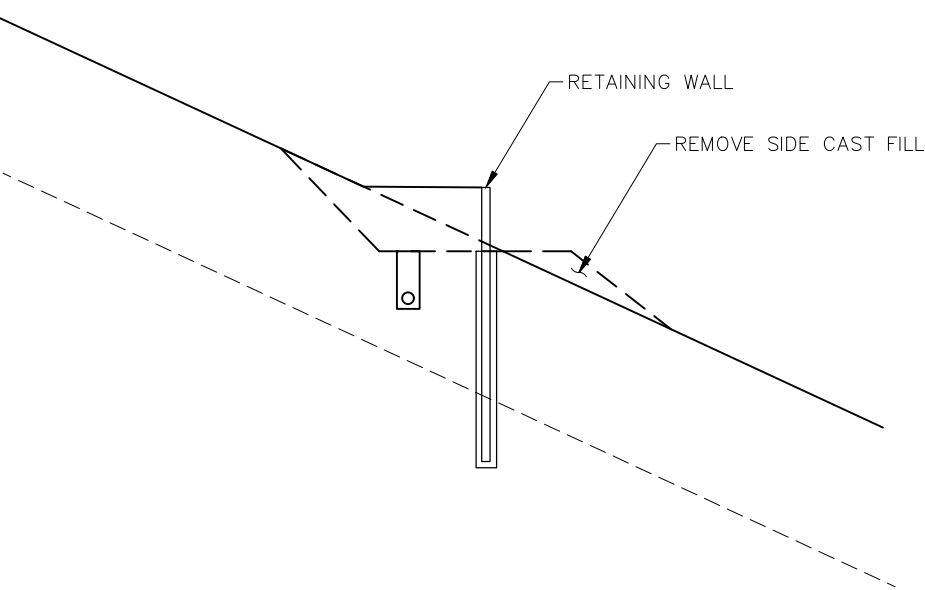
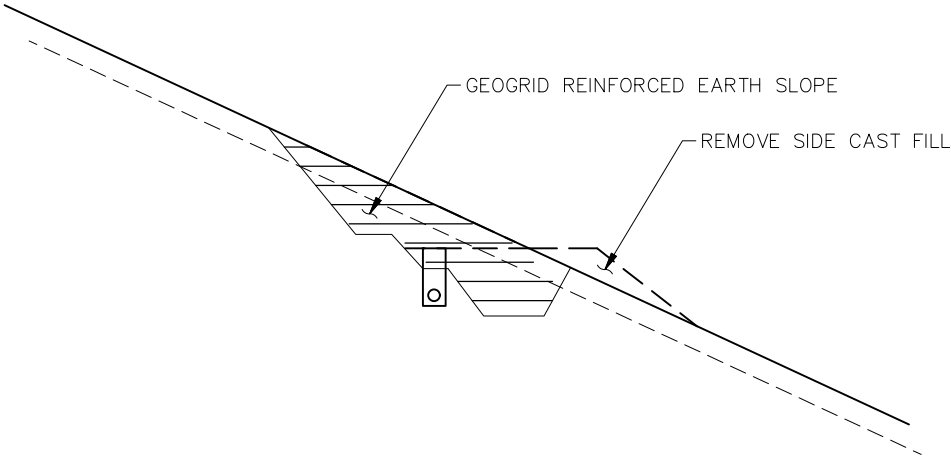
This alternative (see Figure 6D) could use several different wall types. We would recommend that the side cast fill be removed and cleaned of vegetation and other debris to make it suitable for placement as engineered fill along the pioneered trail. CE&G has designed many mechanically stabilized earth retaining walls (MSEW). In areas where downslope conditions contain a significant thickness of creeping soils, the MSEW wall can be further stabilized by a pier-supported grade beam constructed below the wall. This method results in less extensive excavation than would be required for keyways. Additionally, using geogrid reinforced retaining walls or slopes results in substantially lower lateral loads on the piers, resulting in less costly piers when compared to a typical cantilever design. Additionally, if space constraints permit the use of a retaining structure that is closer to the original slope gradient (1H:1V, horizontal:vertical) or flatter, the design could use a geogrid-reinforced slope. For portions of the alignment that are steeper, welded wire forms could be used. Figure 6D shows a steel beam and lagging alternative, and a geogrid reinforced slope alternative.

NOTE:
AT DEEPER SOIL LOCATIONS, DEEPER FOUNDATIONS SHOULD BE USED TO TRANSFER FILL LOADS TO COMPOTENT MATERIALS. THIS EXAMPLE USES A STEEL BEAM AND LAGGING WALL AND MAINTAINS A PATH.
