**GEOTECHNICAL INVESTIGATION
FOR
LYON TANK ACCESS ROAD LANDSLIDE REPAIR
365 Madrone Drive
Boulder Creek, California**

**Prepared For
SAN LORENZO VALLEY WATER DISTRICT
Boulder Creek, California**

**Prepared By
HARO, KASUNICH AND ASSOCIATES, INC.
Geotechnical & Coastal Engineers
Project No. SC4090.1
August 2018**

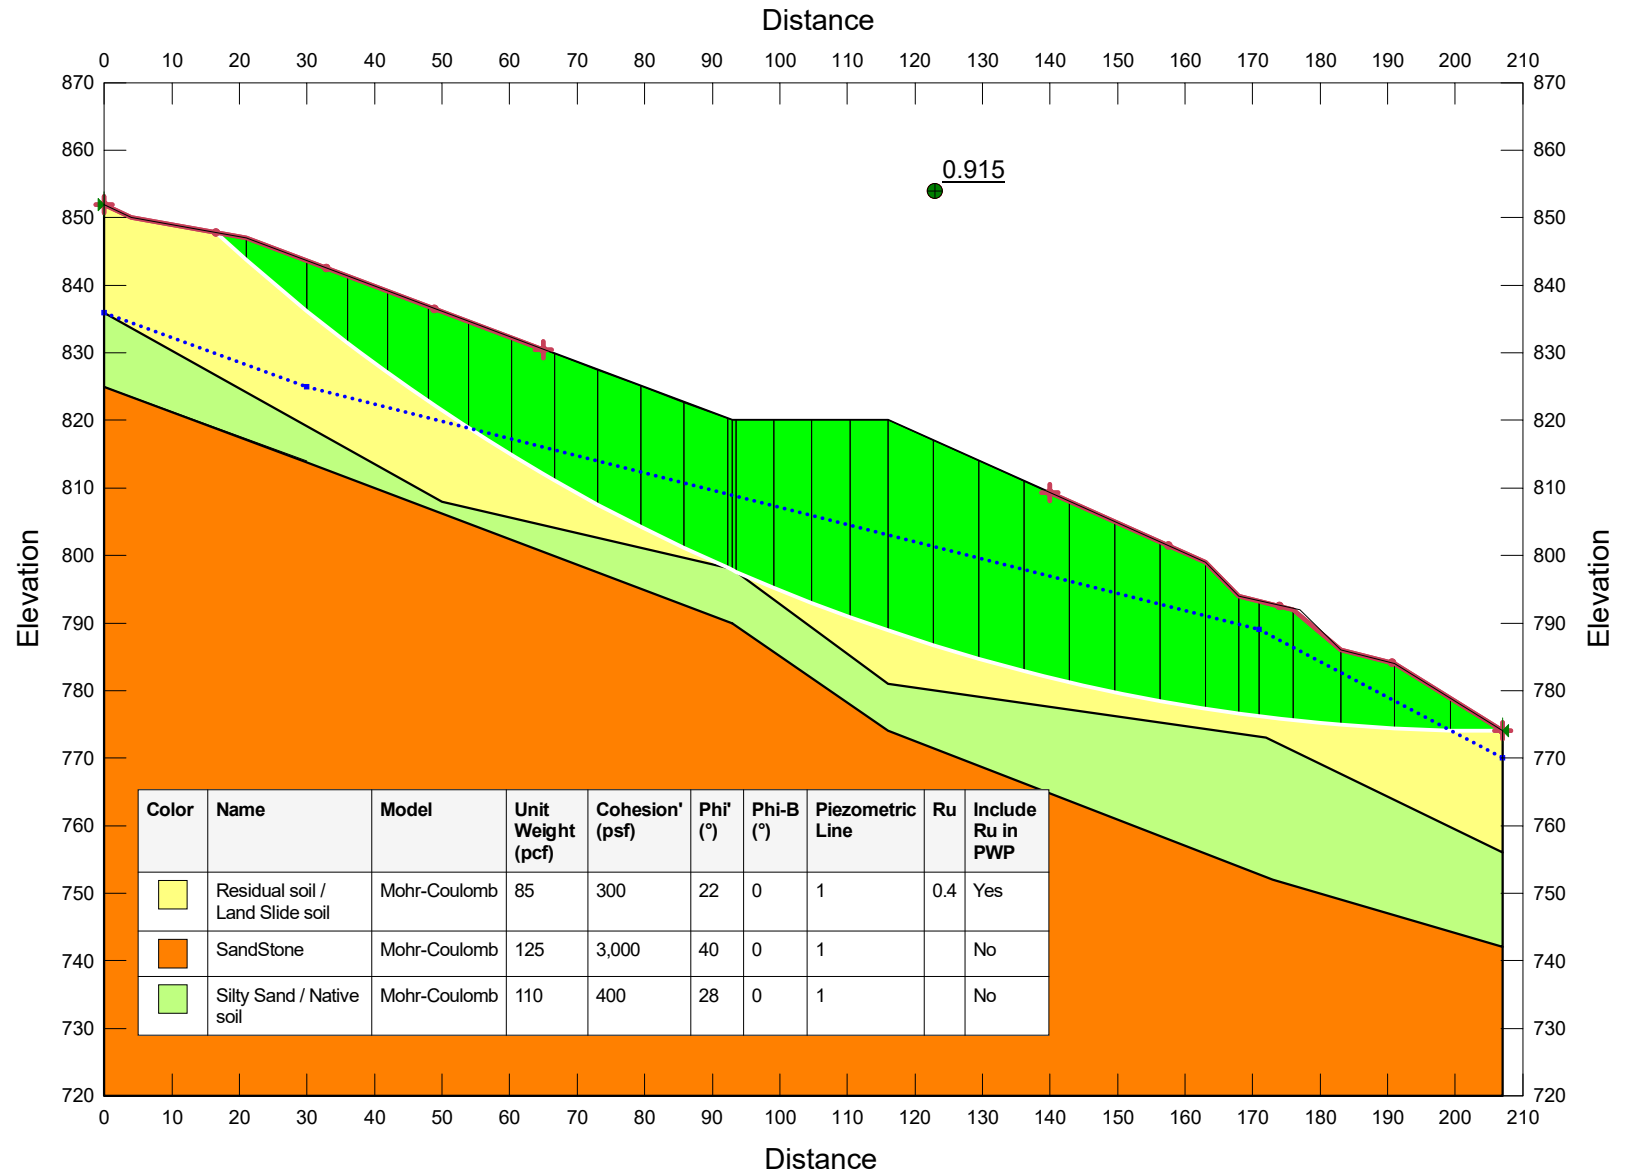
Figure No. 60

Lyon Tank Slope Stability Safety Factor- Cross Section C3- 2017 Landslide Condition - Static

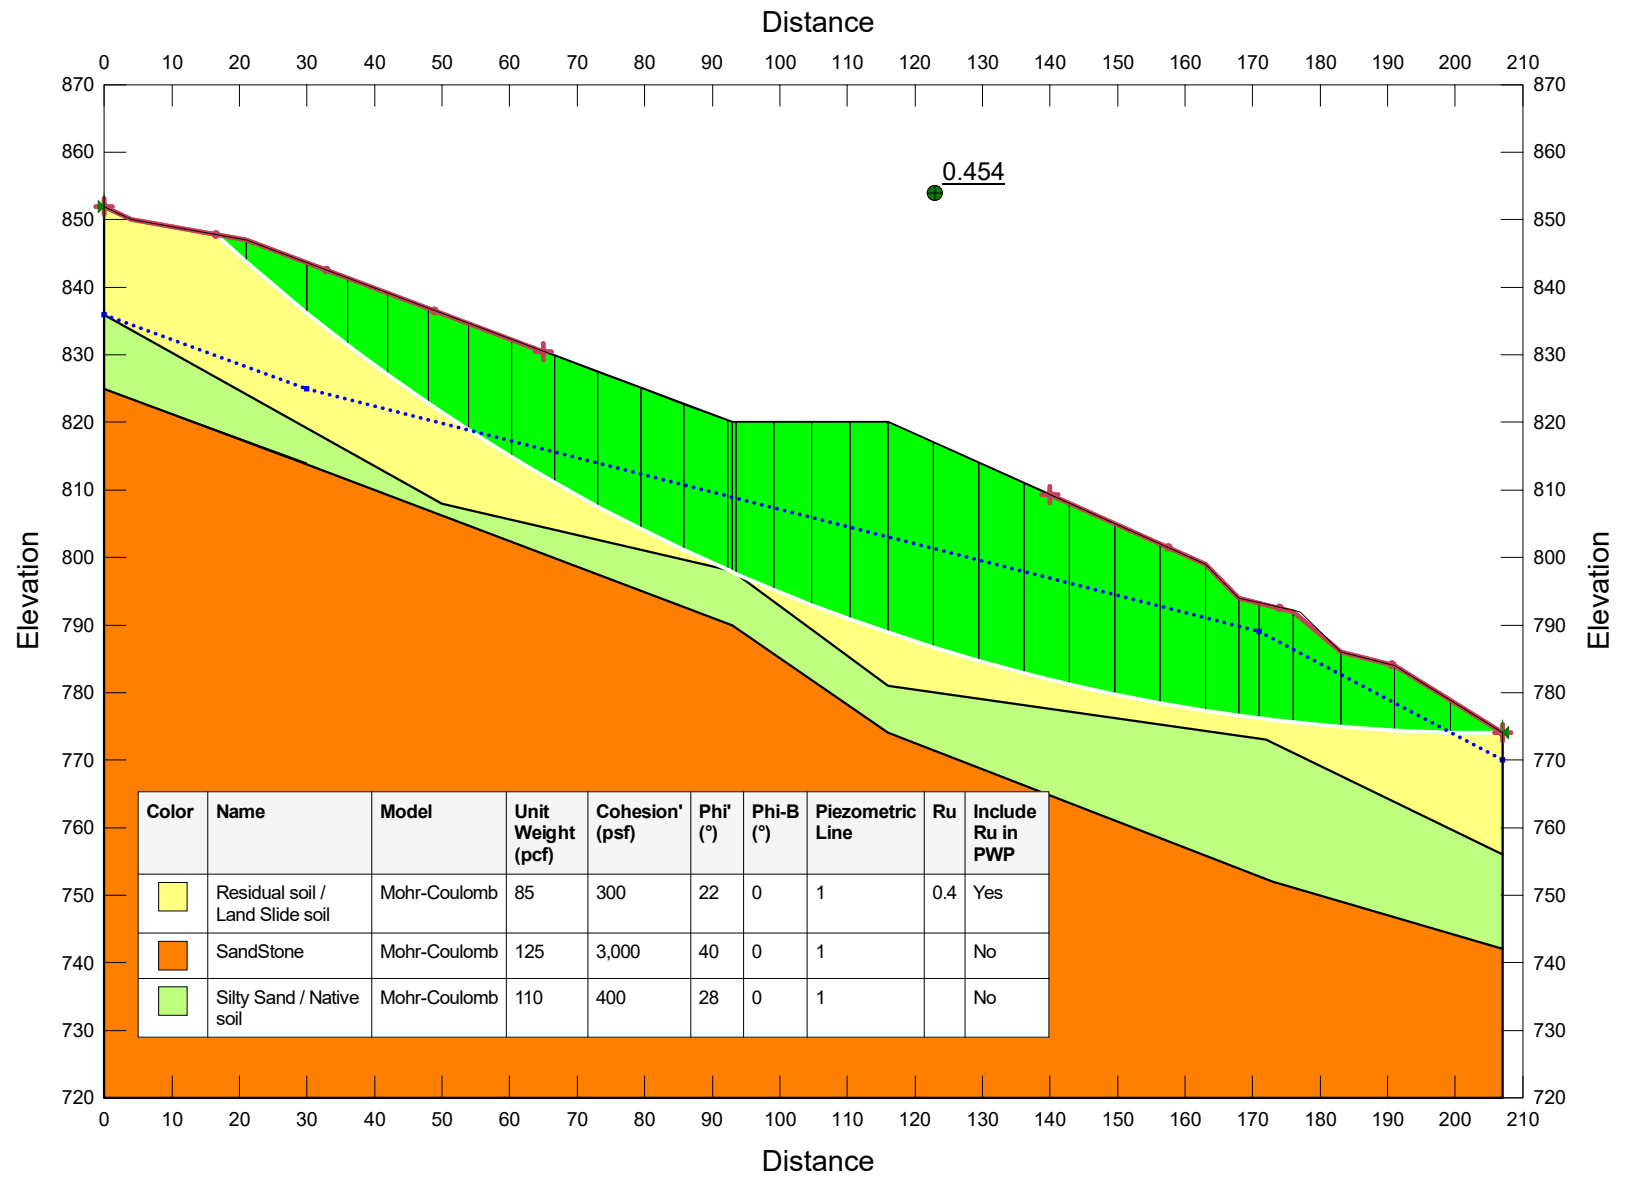
Figure No. 61

Lyon Tank Slope Stability Safety Factor- Cross Section C3- 2017 Landslide Condition - Seismic

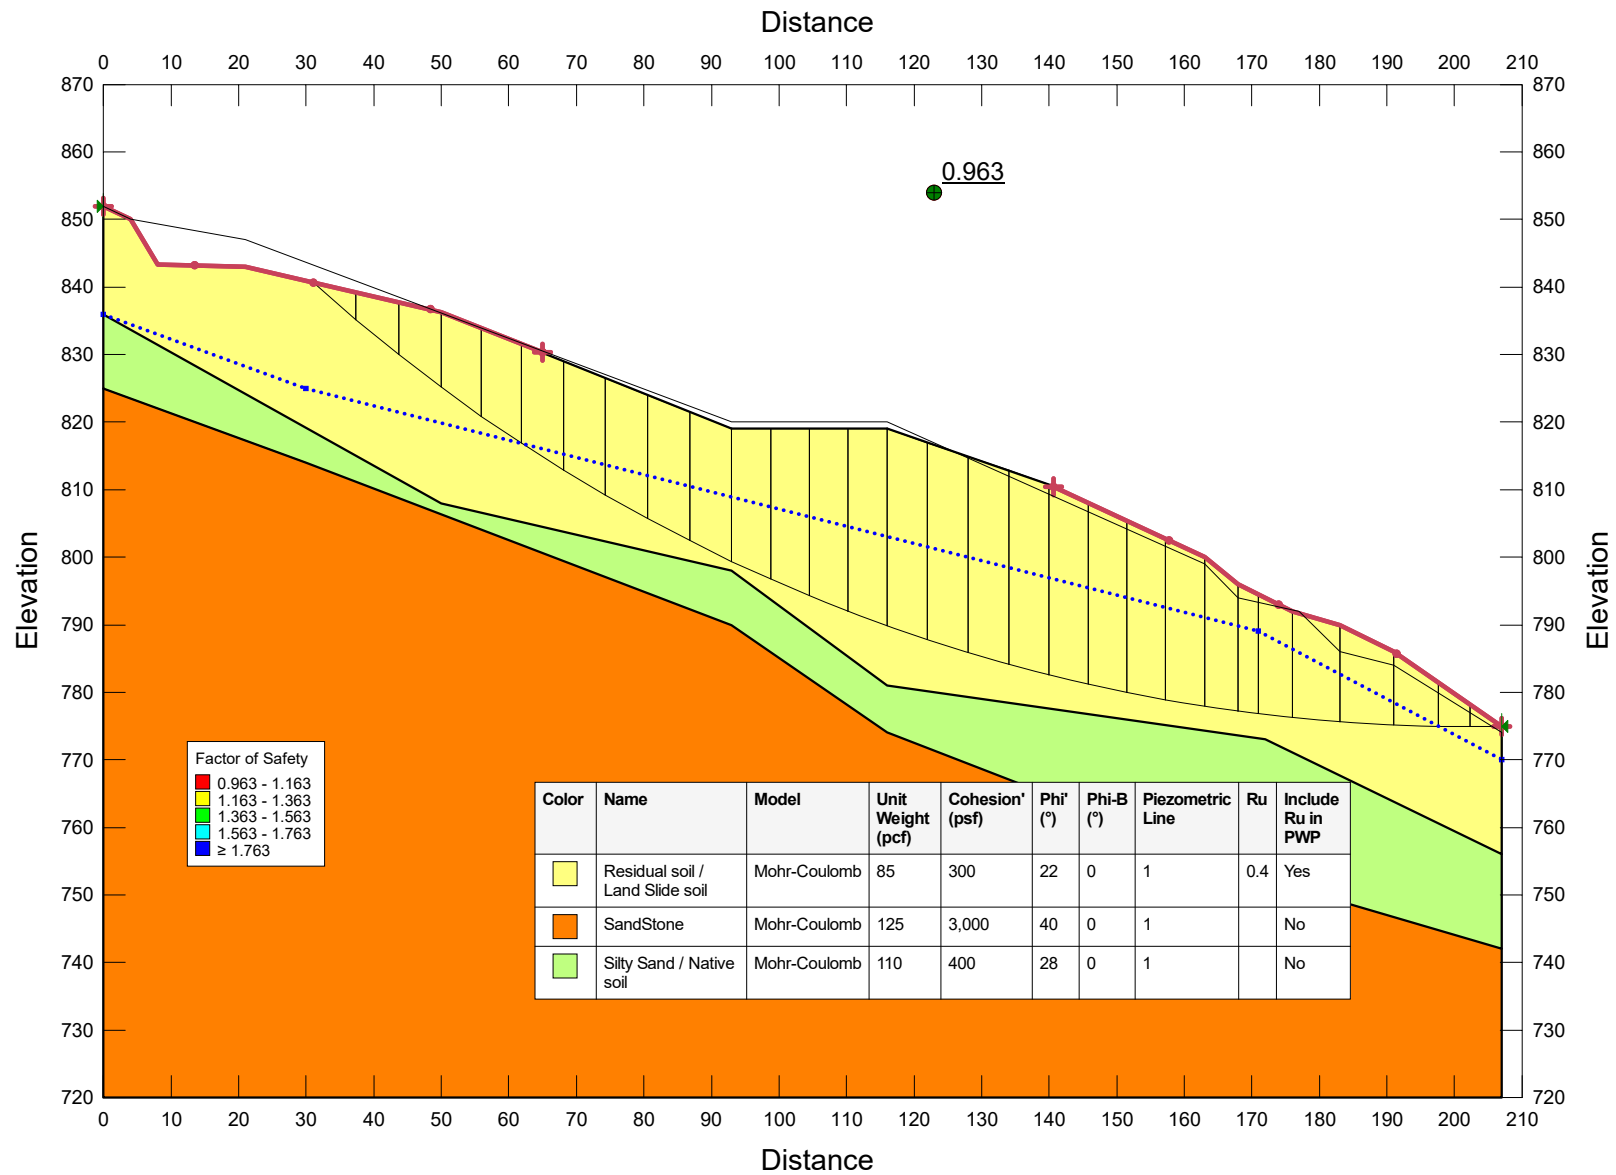
Figure No. 62

Lyon Tank Slope Stability Safety Factor- Cross Section C3- Current Condition - Static

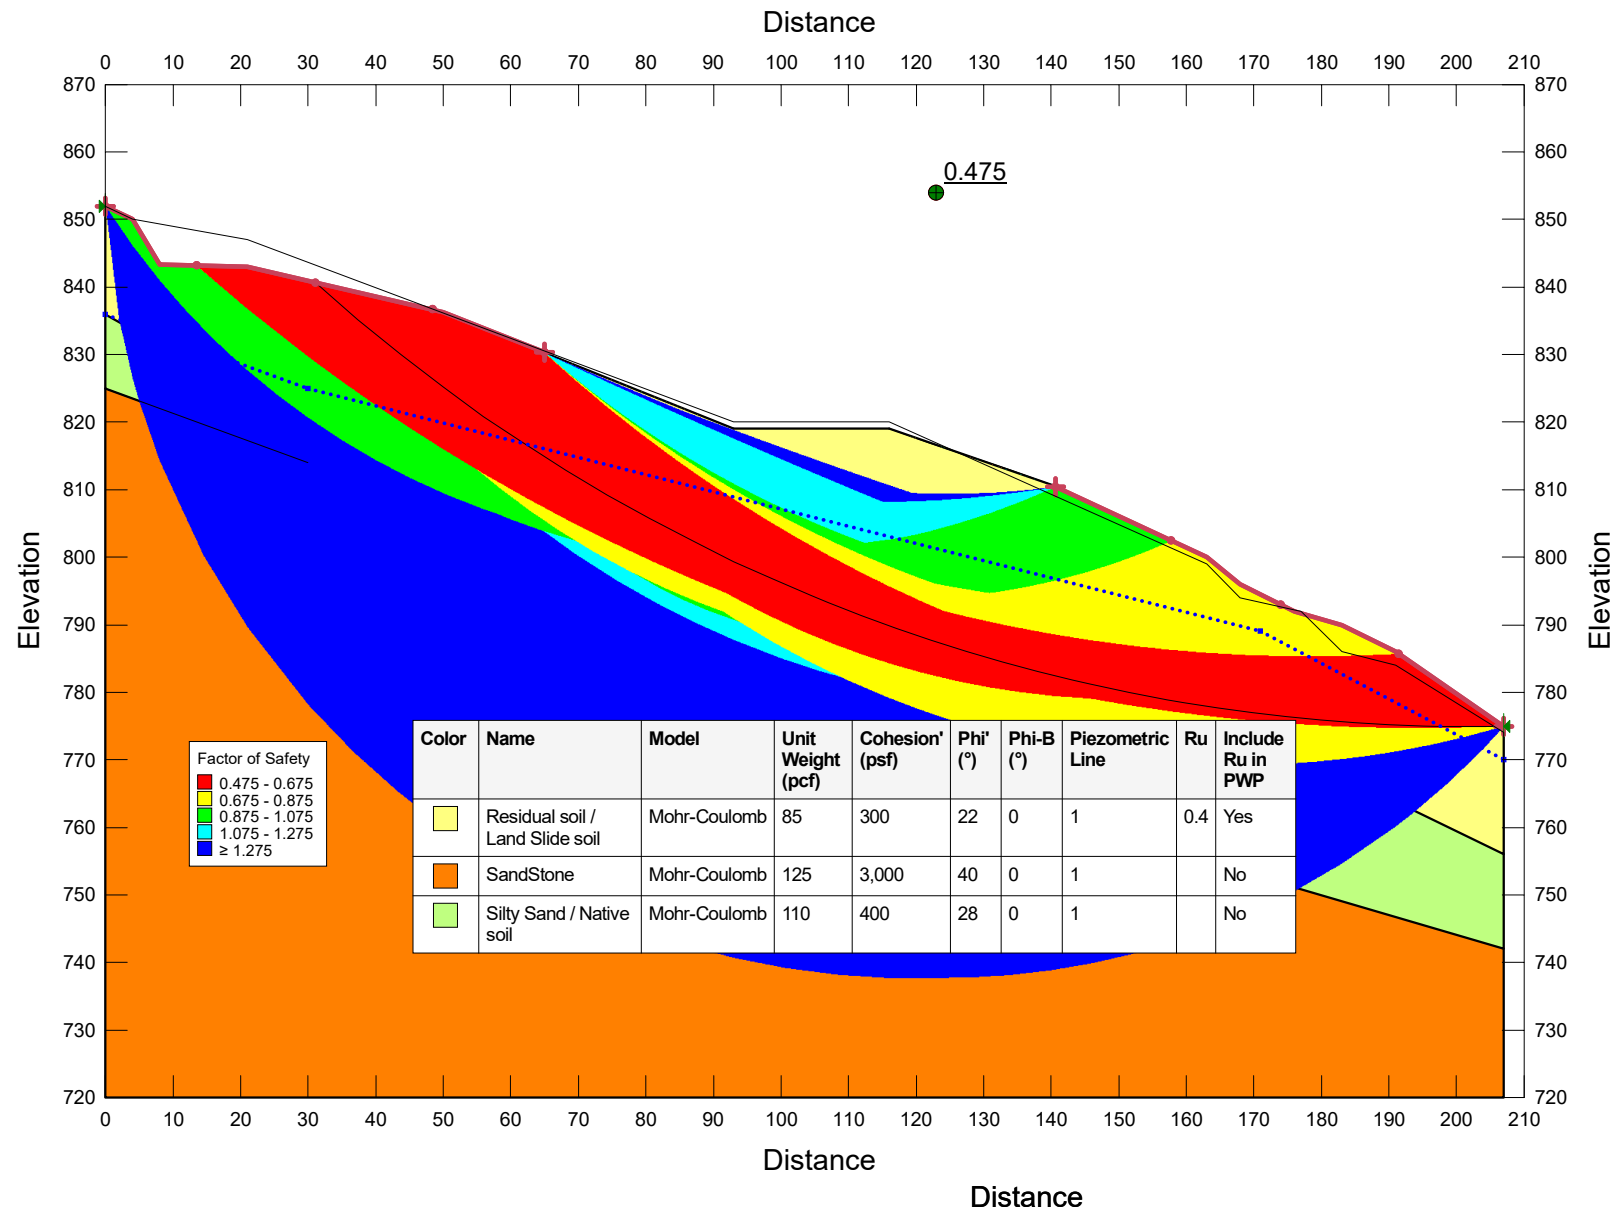
Figure No. 63

Lyon Tank Slope Stability Safety Factor- Cross Section C3- Current Condition - Seismic

Note : The border of light blue and dark blue zones shows the thickness of the future probable landslide. (SF less than 1.1 in seismic condition are considered as instable slope.
