**GEOTECHNICAL INVESTIGATION
FOR
LYON TANK ACCESS ROAD LANDSLIDE REPAIR
365 Madrone Drive
Boulder Creek, California**

**Prepared For
SAN LORENZO VALLEY WATER DISTRICT
Boulder Creek, California**

**Prepared By
HARO, KASUNICH AND ASSOCIATES, INC.
Geotechnical & Coastal Engineers
Project No. SC4090.3
August 2019**

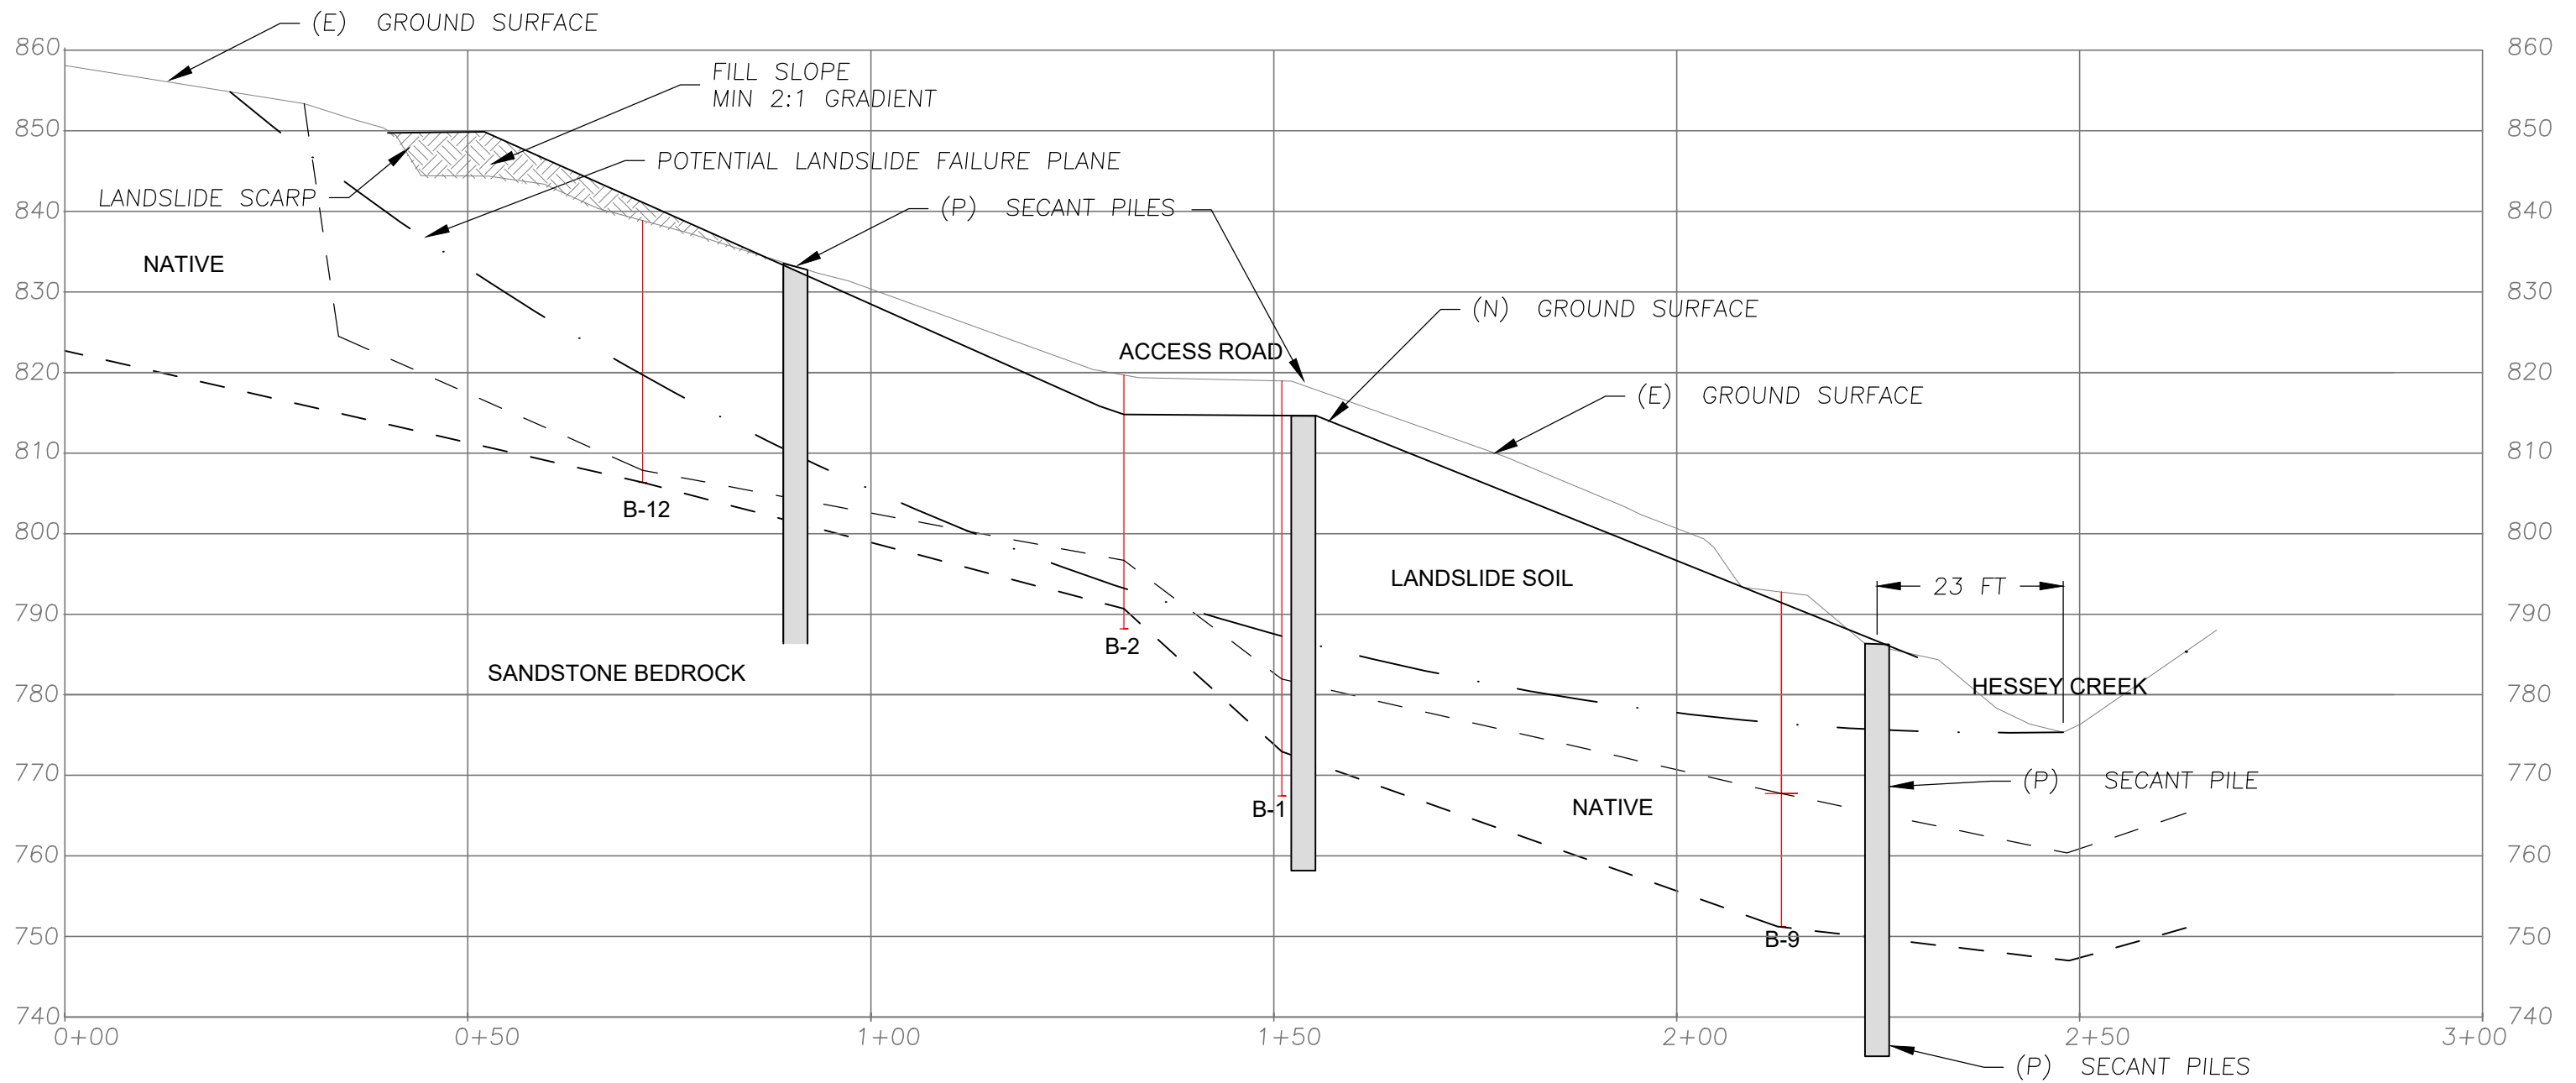
1. THREE SECANT PILES SECURING UPSLOPE AND DOWNSLOPE SLIDE MASS.
