Watershed Emergency Response Team Evaluation

CZU LIGHTNING COMPLEX

CA-CZU-005205

October 1, 2020

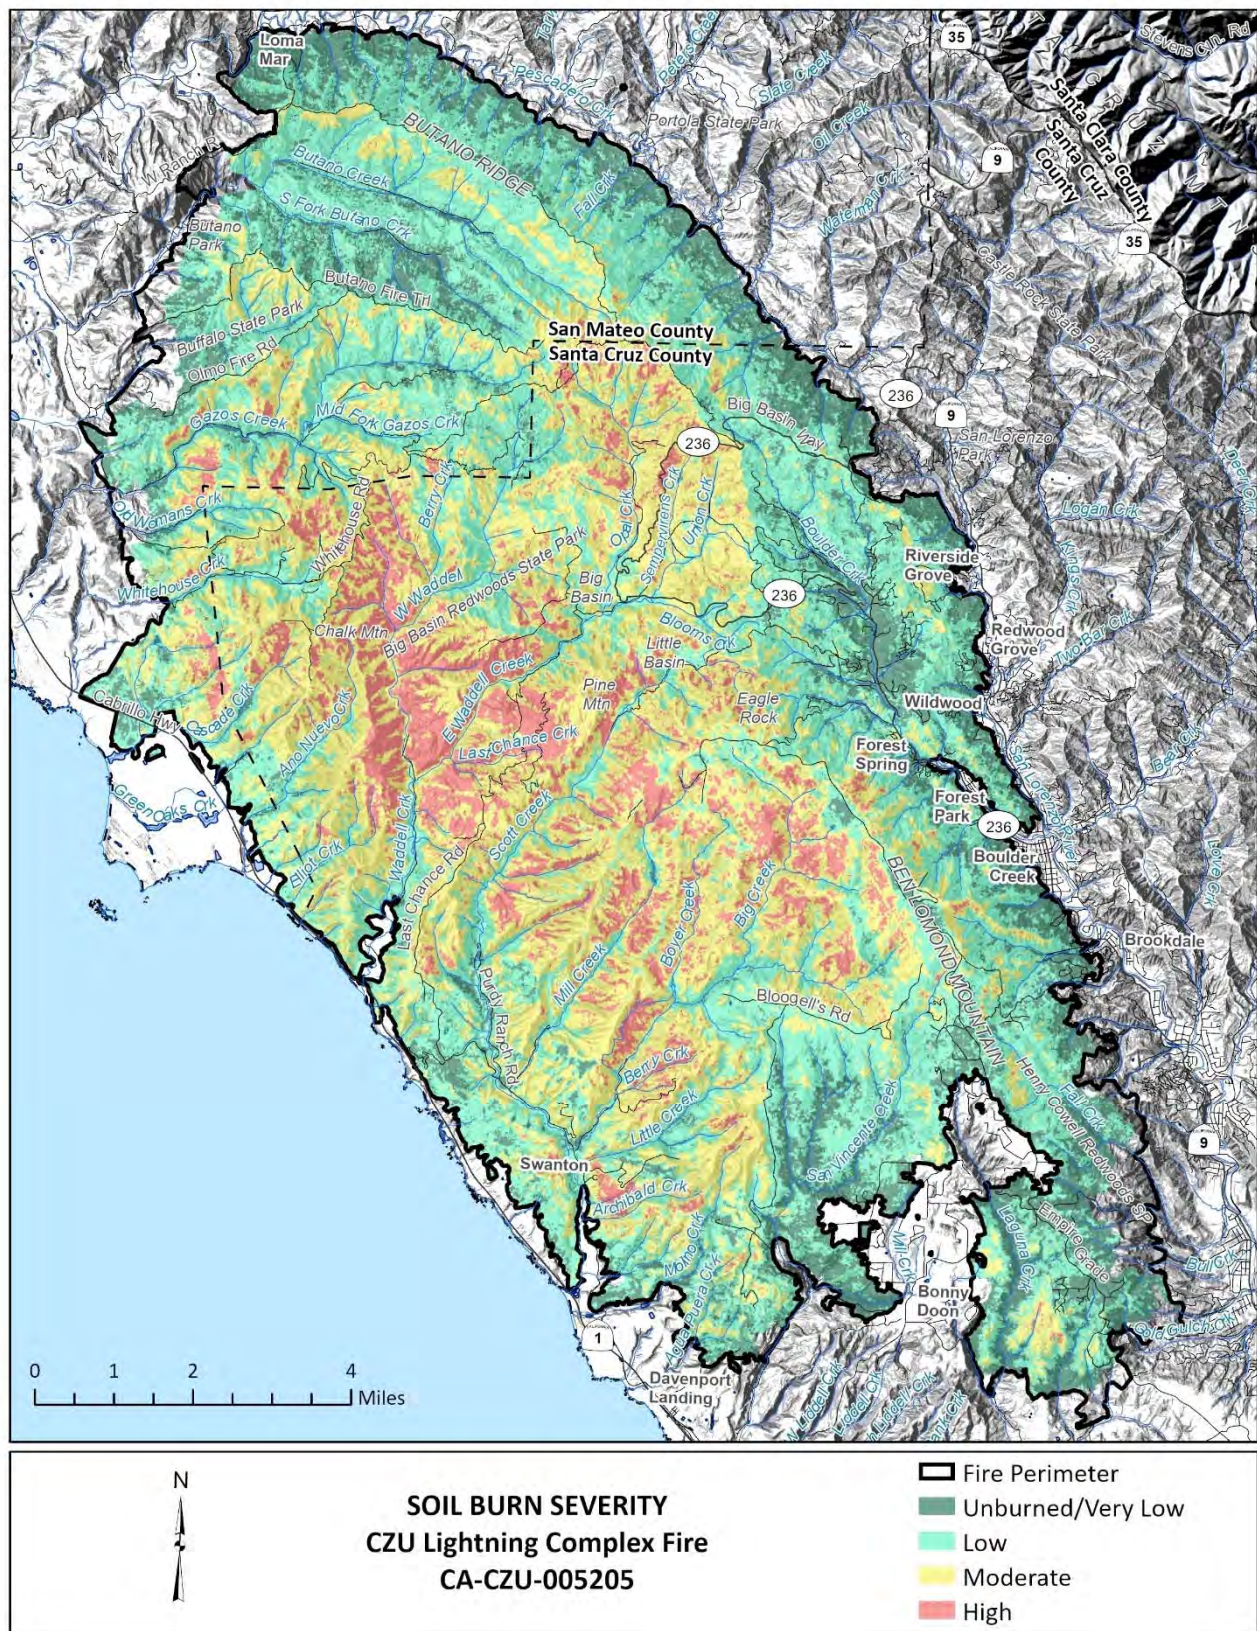
Figure 7. Soil burn severity map for the CZU Lightning Complex.

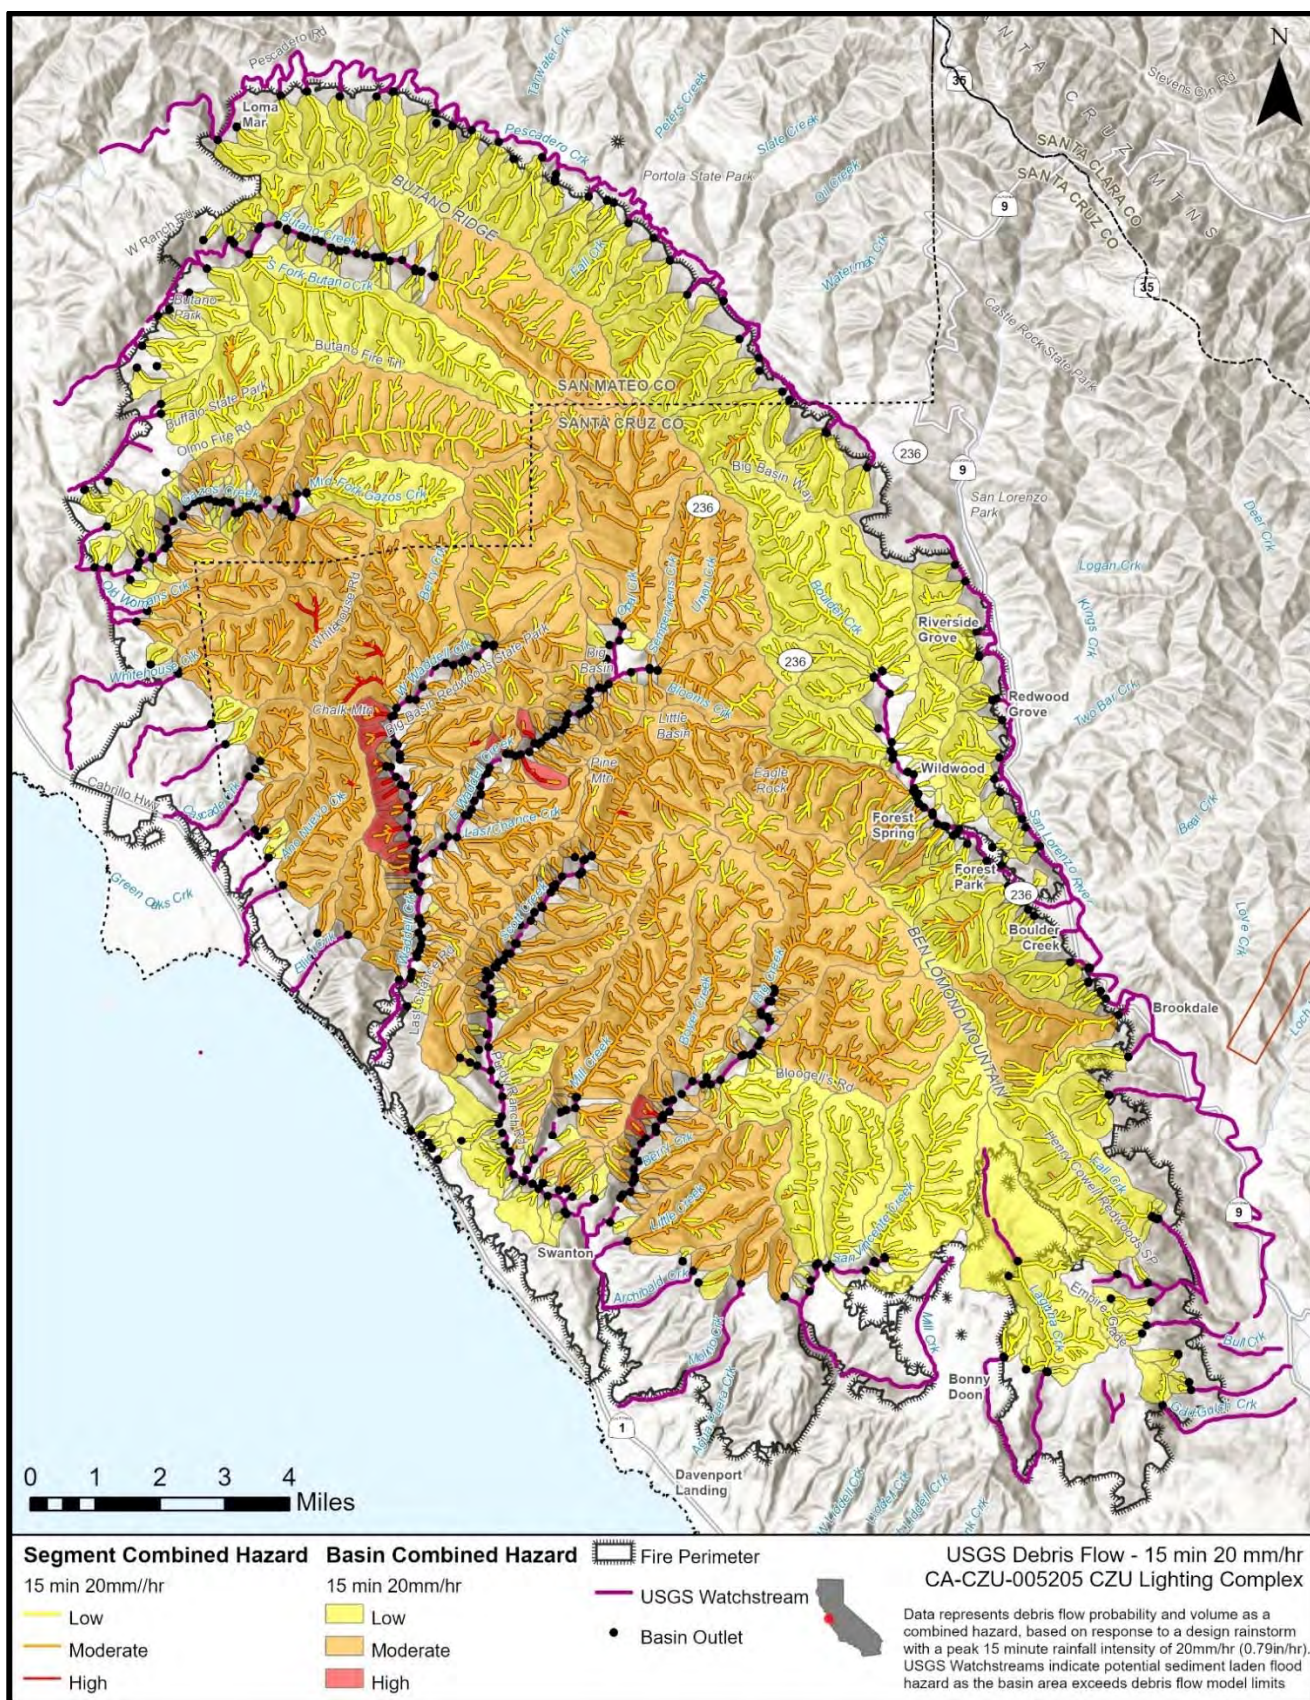
- A storm scenario of approximately 0.20 inches in 15-minutes (i.e., 0.79 in hr^{-1} or 20 mm hr^{-1} for the 15-minute duration) equates to a moderate combined hazard for the western and interior portions of the fire, and generally low combined hazard for the eastern portion of the fire (see Figure 9).

Figure 9. USGS debris flow model results for the 15-min 20 mm hr⁻¹, CZU Lightning Complex.

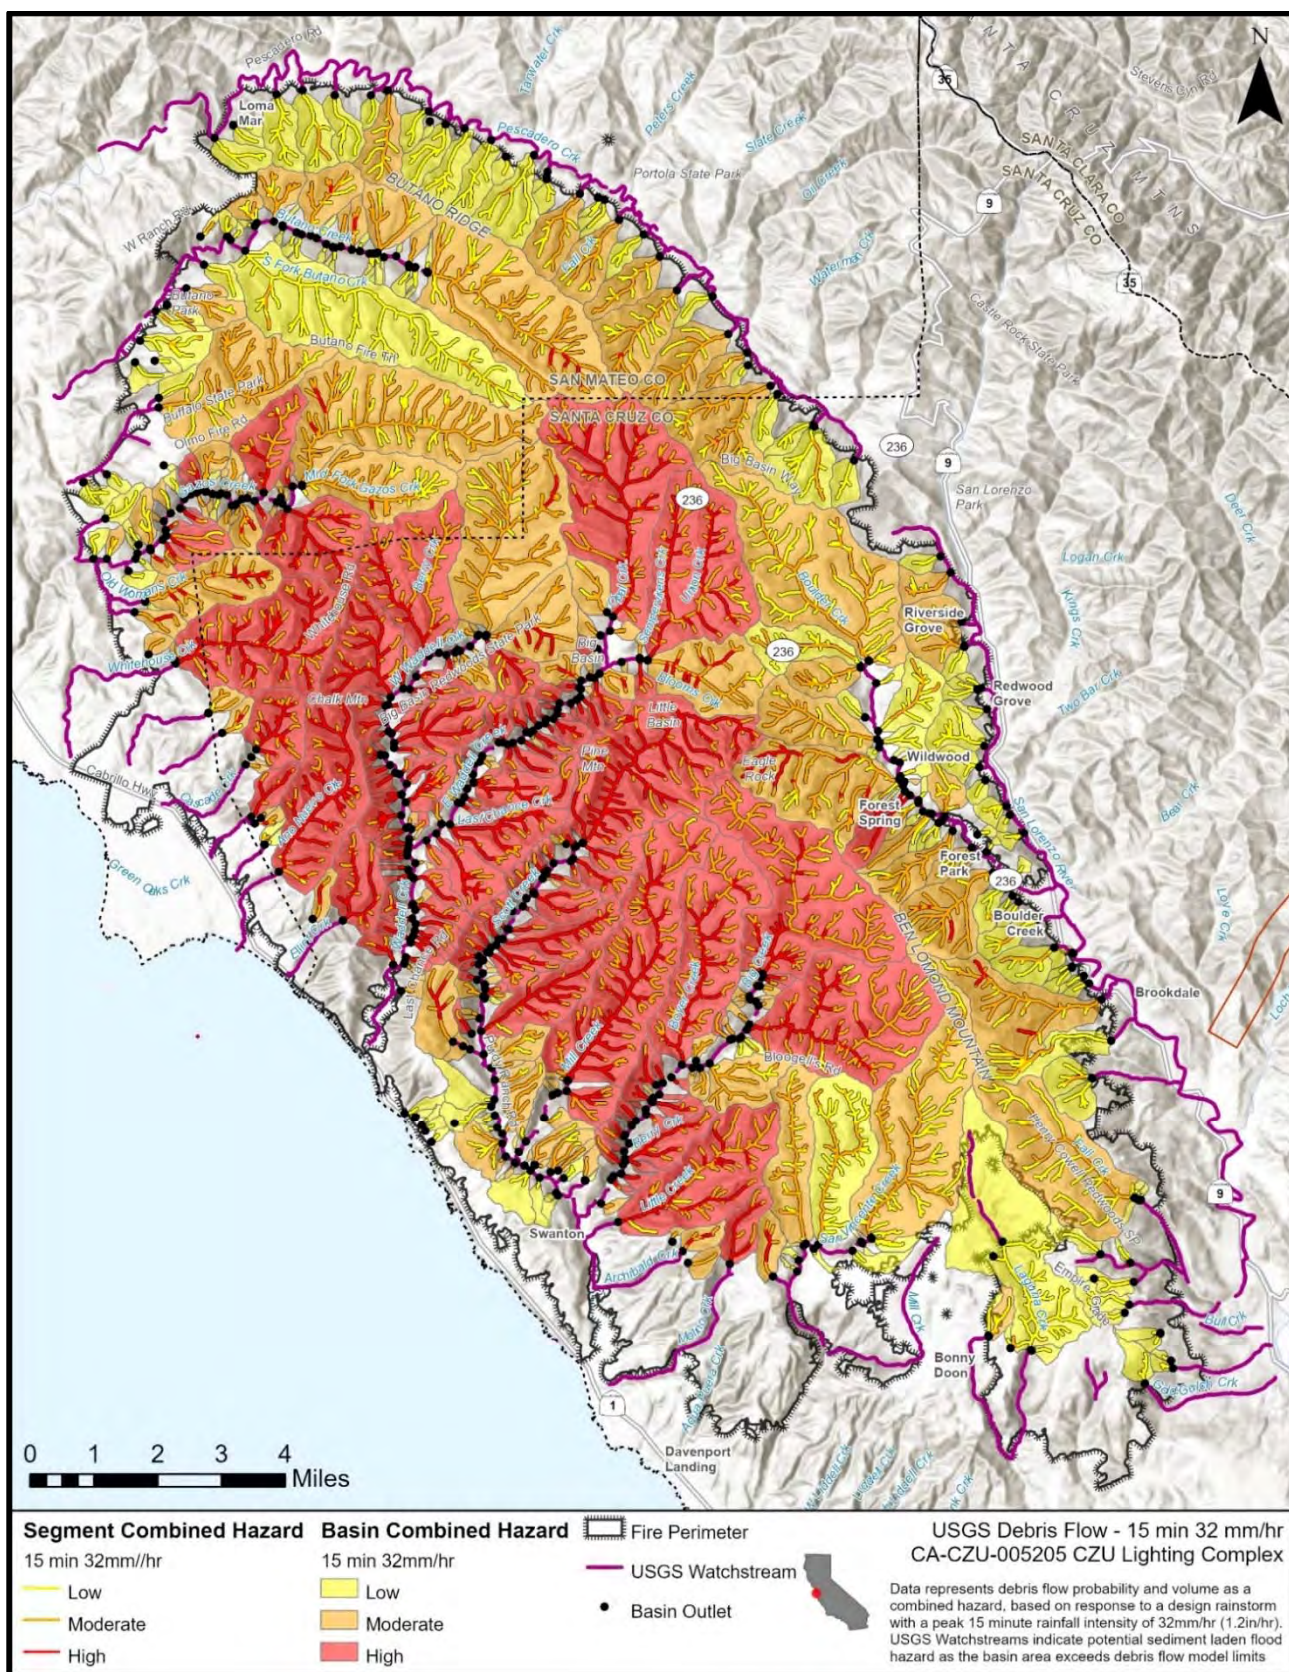
Figure 10. USGS debris flow model results for the 15-min 32 mm hr⁻¹, CZU Lightning Complex.

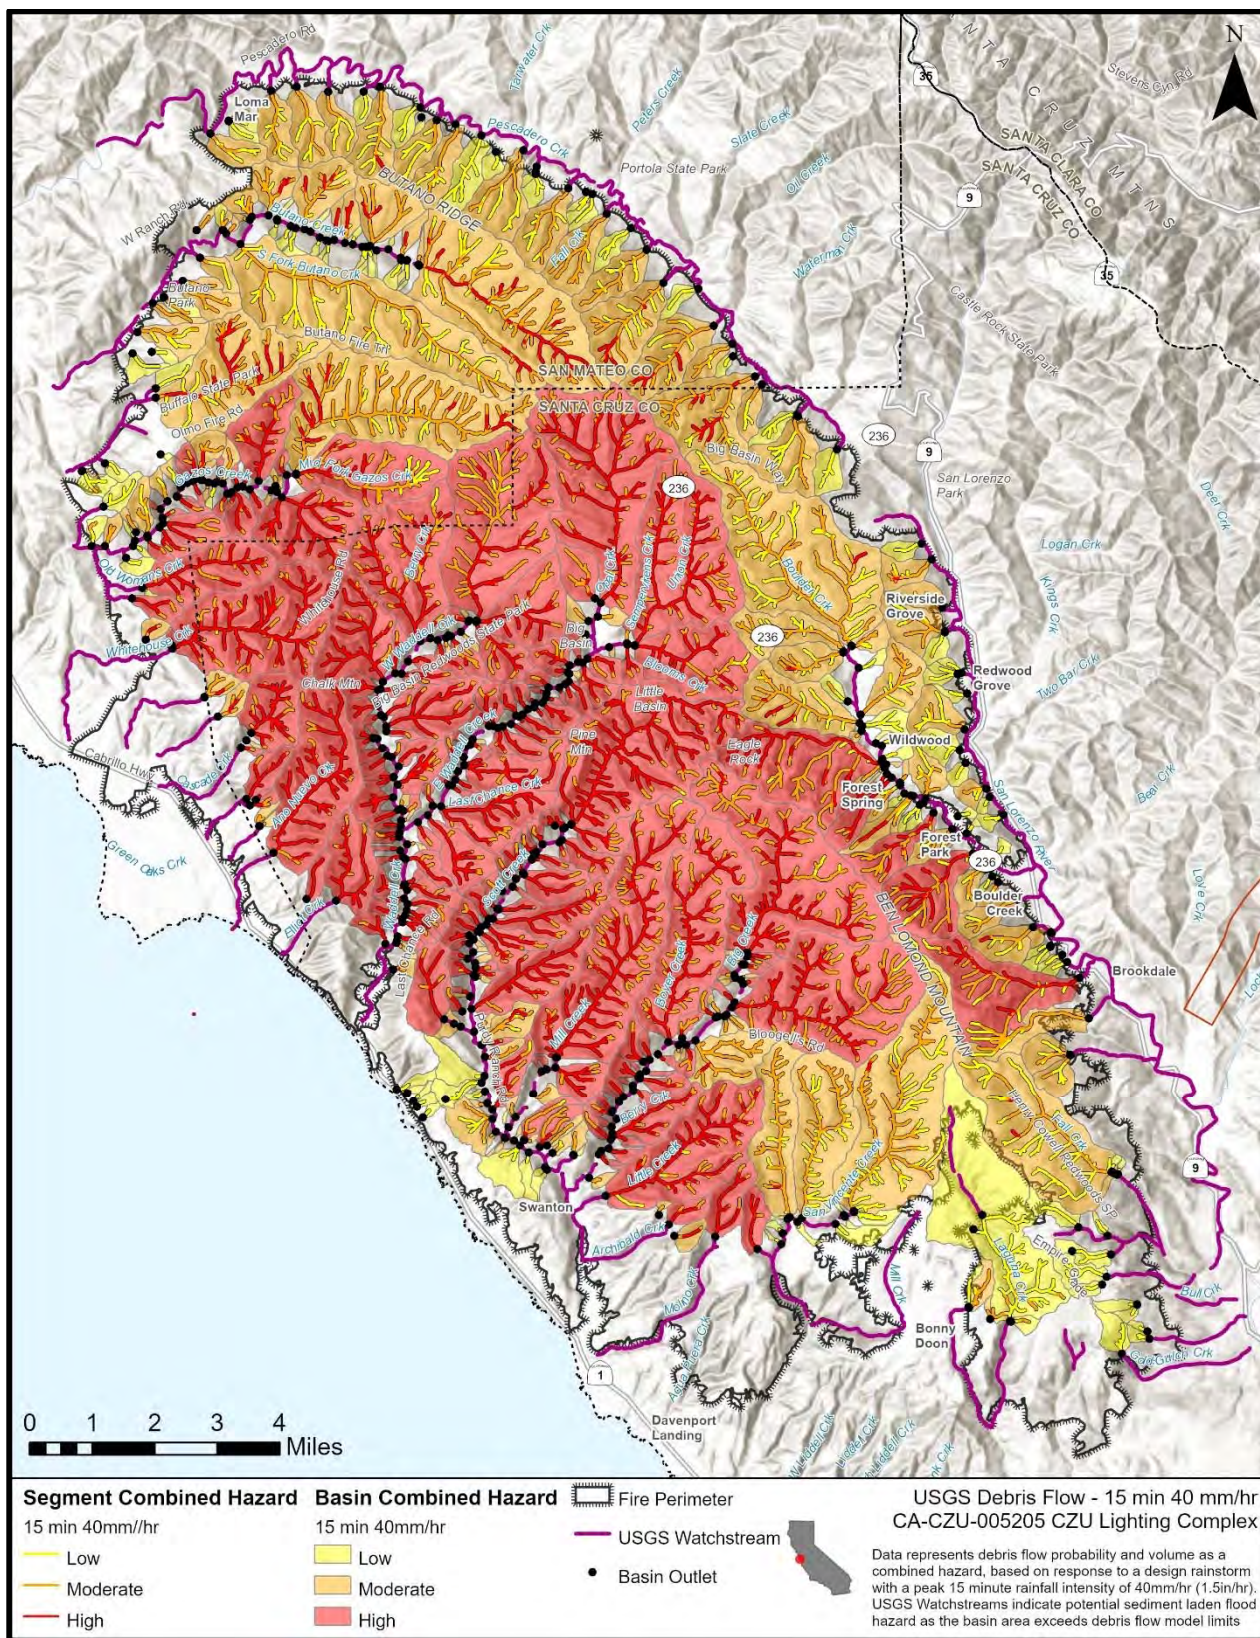
Figure 11. USGS debris flow model results for the 15-min 40 mm hr⁻¹, CZU Lightning Complex.

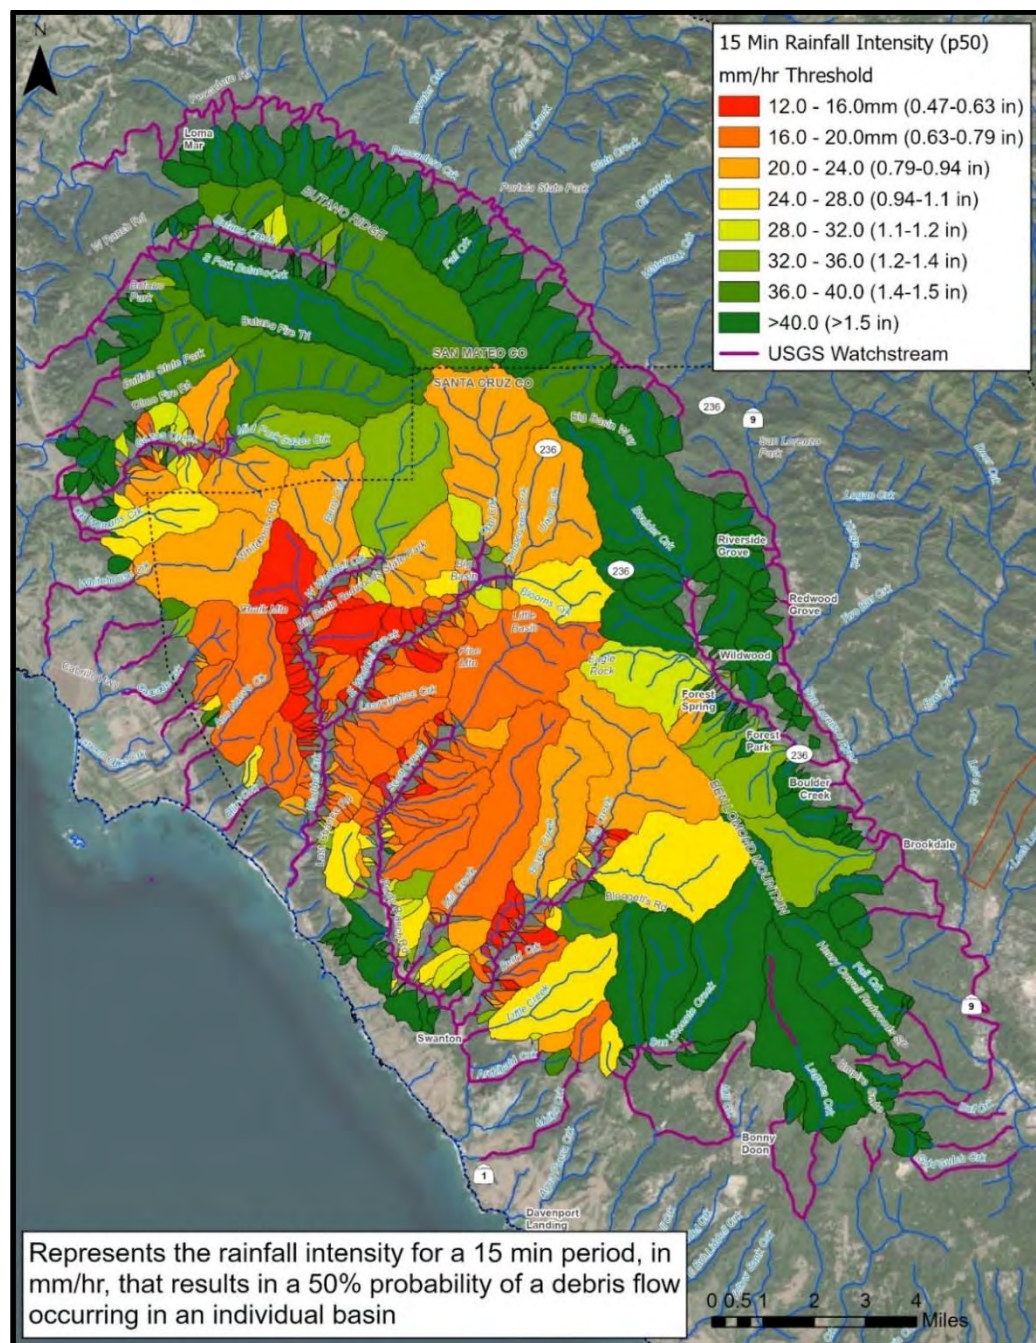
The USGS debris flow model can also calculate the 15-minute rainfall intensity necessary to trigger a debris flow with a probability of 50 percent. Figure 12 indicates that much of the western portion of the fire might see a triggering of debris flows when 15-minute intensities fall within the range of 12 to 24 mm hr⁻¹ (i.e., 0.47 to 0.94 in hr⁻¹). The eastern portion of the fire near the SR 9 and 236 corridors have basins with likely rainfall thresholds that range from 28 to 40 mm hr⁻¹ (1.1 to 1.5 in hr⁻¹). The spatially explicit calculation of basin specific rainfall thresholds can be a useful tool for revising rainfall thresholds if the initial Early Warning System threshold is deemed too conservative based on monitoring and observations.

Figure 12. 15-minute rainfall intensity necessary to trigger a debris flow with a probability of 50 percent for the CZU Lightning Complex.

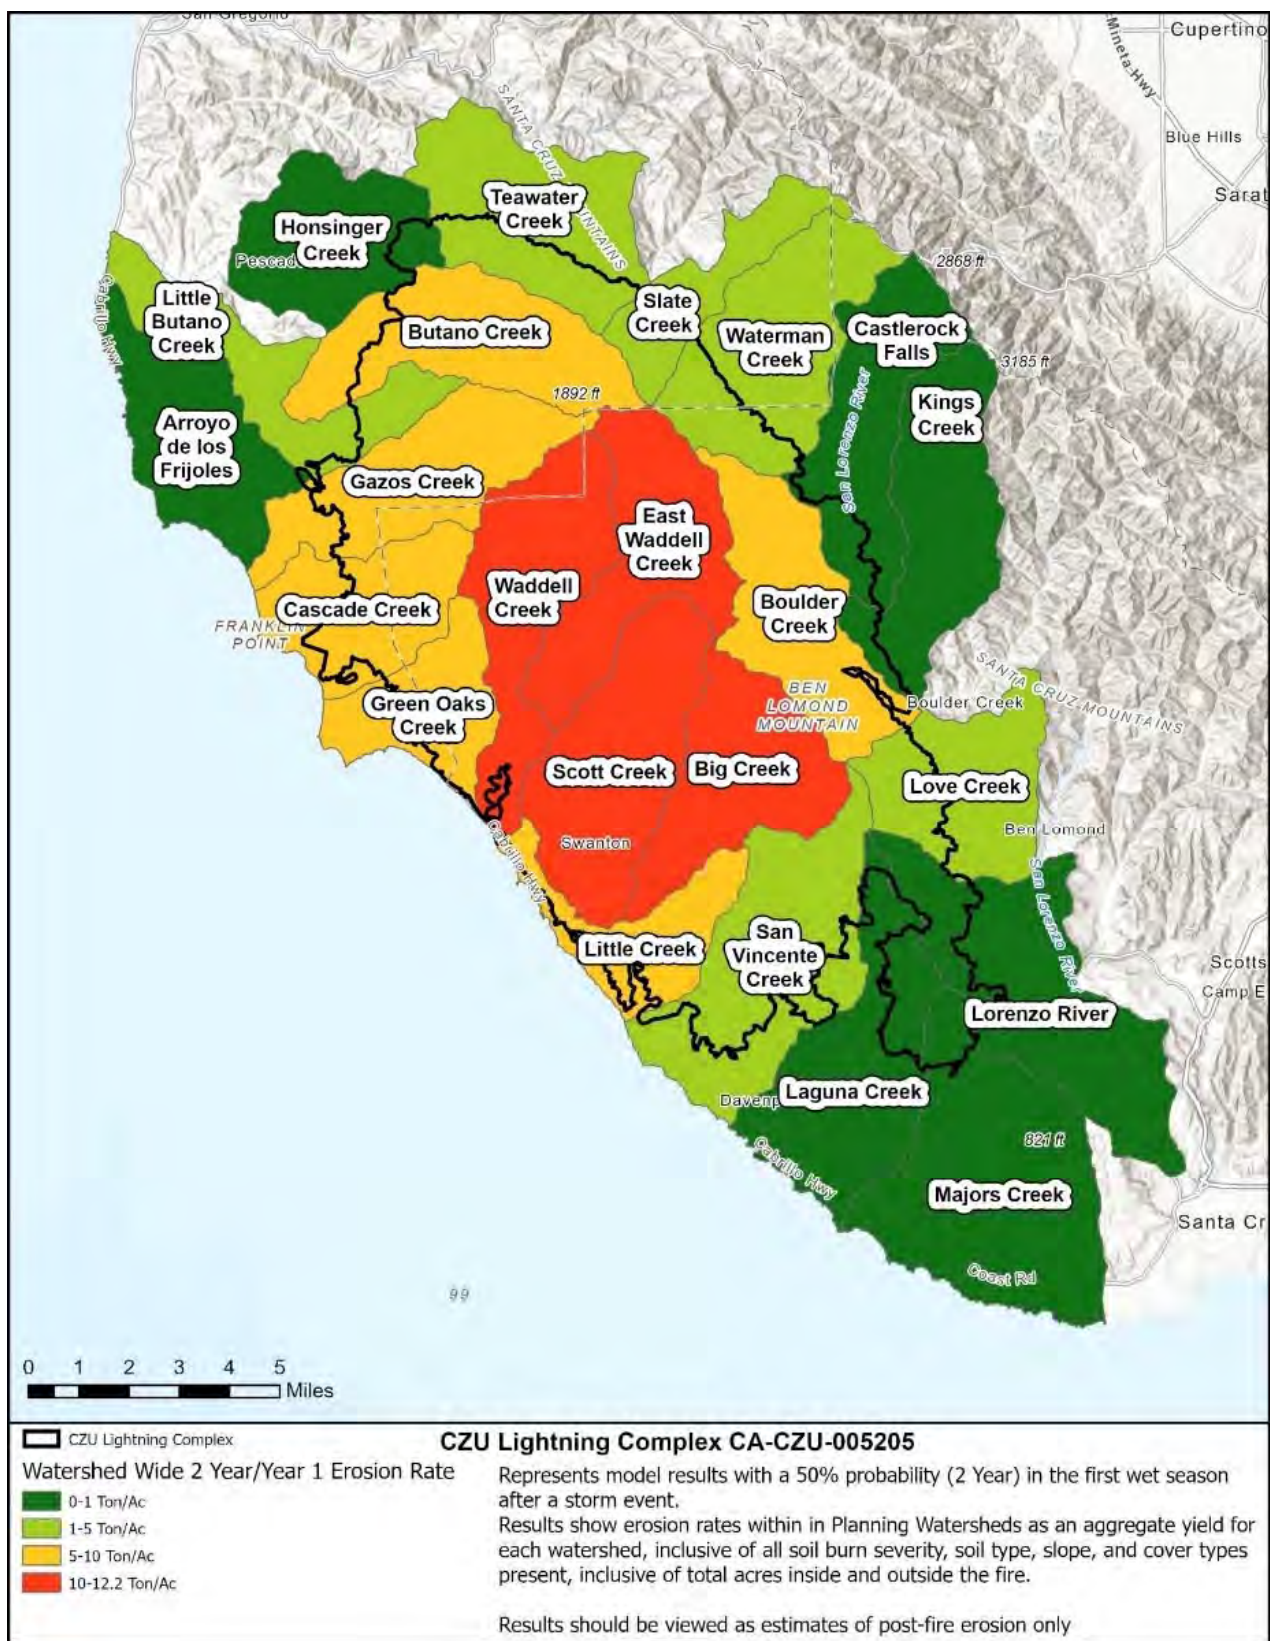
Figure 13. Watershed averaged erosion rates (tons per acre) on the CZU Lightning Complex for the first year 2-year storm event predicted using the Erosion Risk Management Tool (ERMIT).

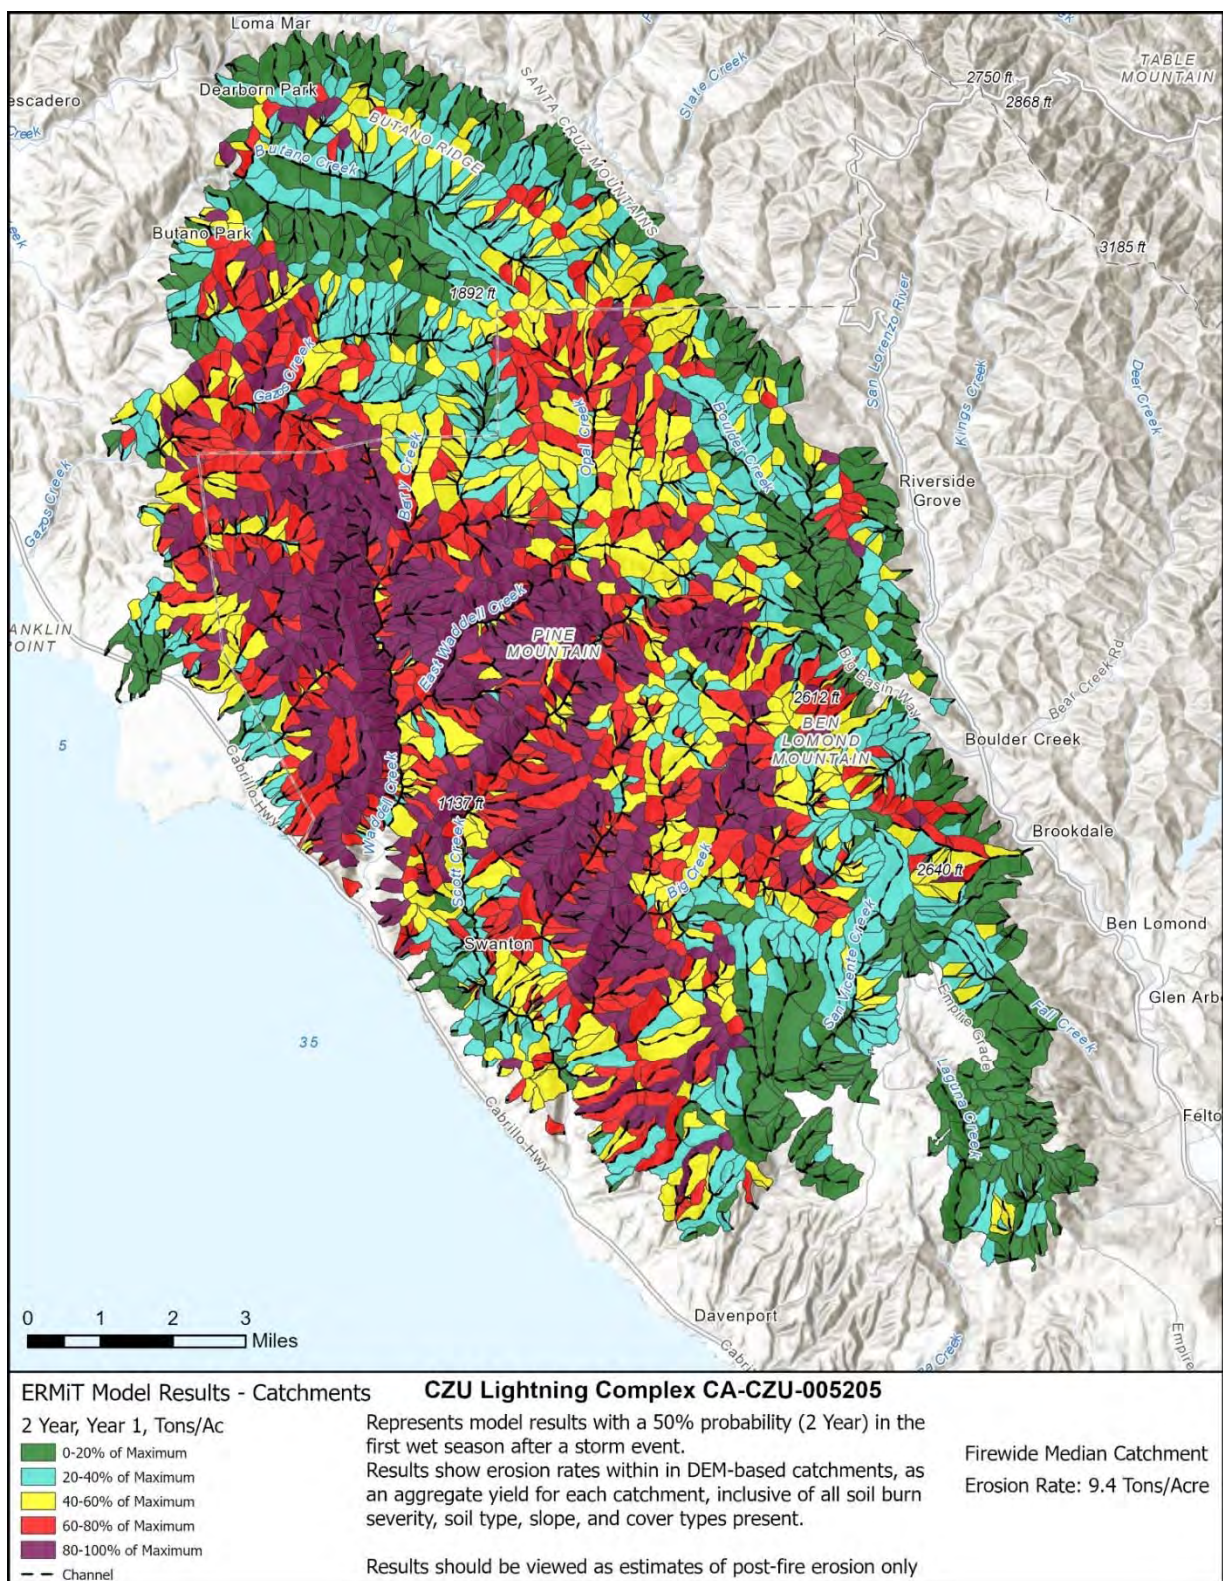
Post-fire surface erosion was modeled using the Erosion Risk Management Tool (ERMiT) from the United State Forest Service's Rocky Mountain Research Station. The ERMiT model run calculated first year sediment production following a 2-year recurrence interval storm event. Figure 13 shows watershed averaged post-fire erosion rates for planning watersheds within the CZU Lightning Complex burned area. Modeling indicates that watershed averaged erosion rates are more than 10 tons per acre for the Waddell Creek, Scott Creek, and Big Creek watersheds. Butano Creek, Gazos Creek, Cascade Creek, Green Oaks Creek, Little Creek, and Boulder Creek have basin averaged erosion rates predicted to be in the range of 5 to 10 tons per acre. Figure 14 shows erosion rates as a percentage of the maximum rate for smaller basins (i.e., approximately 20 acres in size). It can be assumed that for the majority of the burned area, the post-fire erosion rates shown on Figures 13 and 14 are significantly higher than the pre-fire erosion rates. Overall, the firewide median erosion rate is predicted to be 8.6 to 9.4 tons per acre depending upon the scale of the model unit. ERMiT also suggest that the firewide median rate can be reduced by a factor of 5 if mulch is applied at a rate of 2 tons per acre.

Figure 14. CZU Lightning Complex predicted surface erosion rates for the 2-year storm event using the Erosion Risk Management Tool (ERMiT).

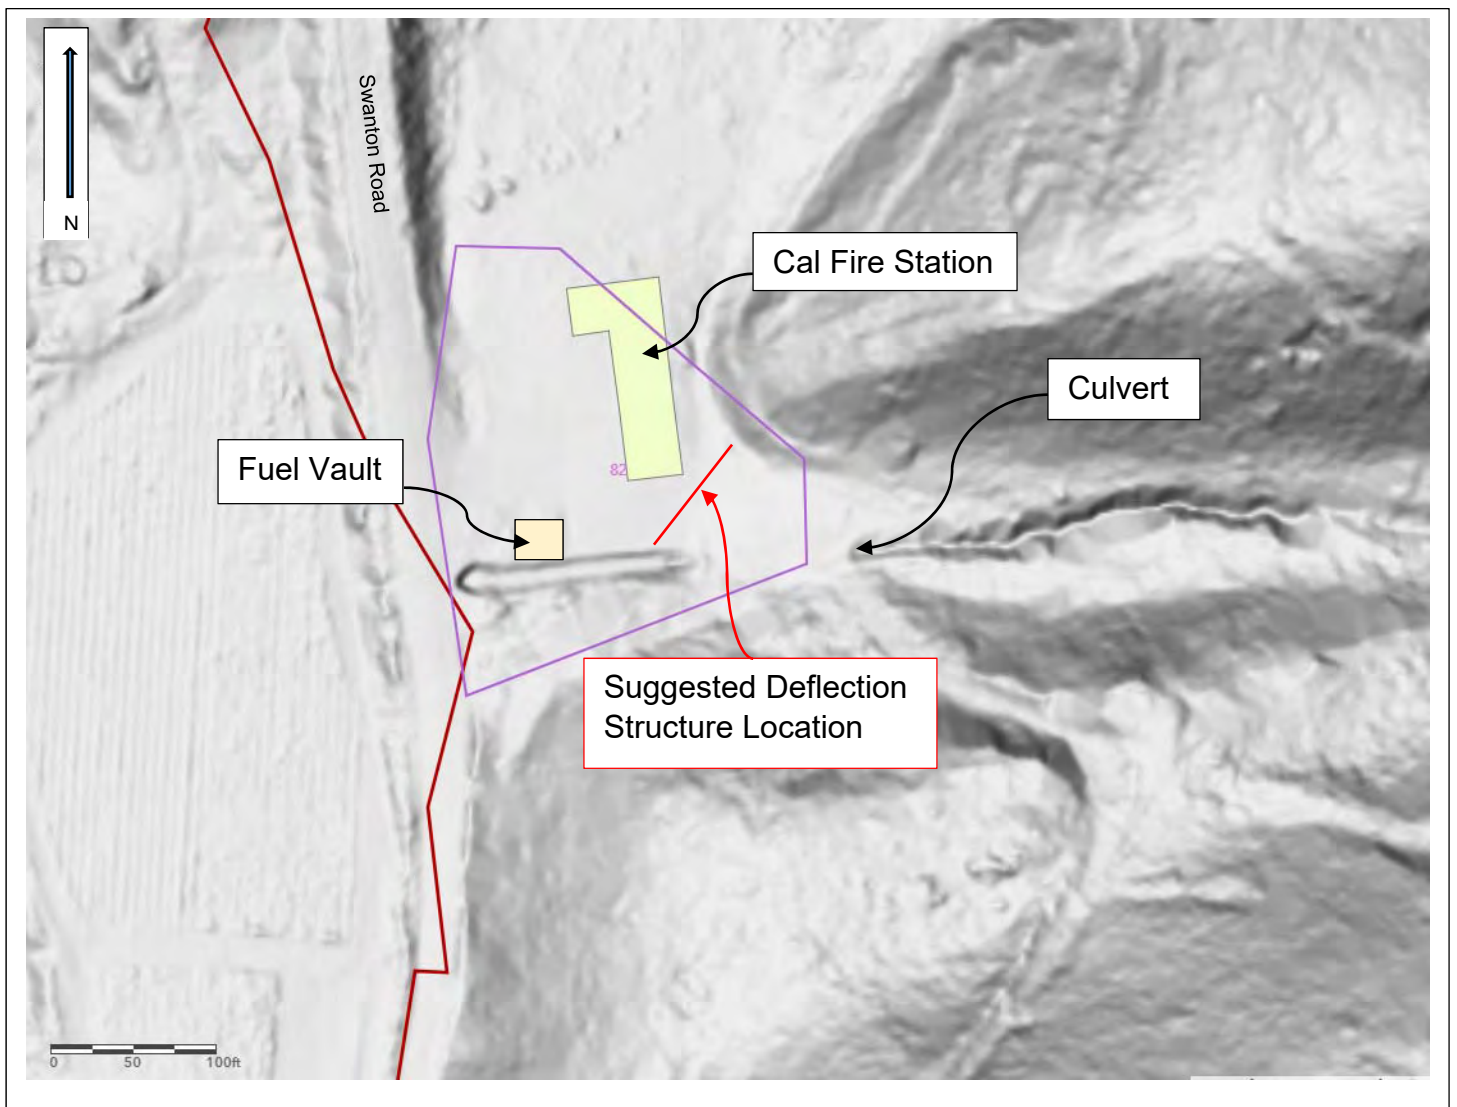
Infrastructure within the Swanton area (VARs 82 through 96) are located downslope of drainages with a moderate to high potential for debris flows and flooding. Bridges along Swanton Road could potentially plug and impact access to critical infrastructure. The CAL FIRE station (CZU Station #33 (Big Creek)) along Swanton Road (VAR 82) is located at the base of Winter Creek where it appears that if a culvert is plugged, flow would be directed towards the fire station and fuel vault (Figure 15).

Figure 15. Site map of CAL FIRE station (VAR 82) showing the potential location of a properly designed deflection structure. The culvert denotes the location where debris could plug the structure and flow towards the station and fuel vault.

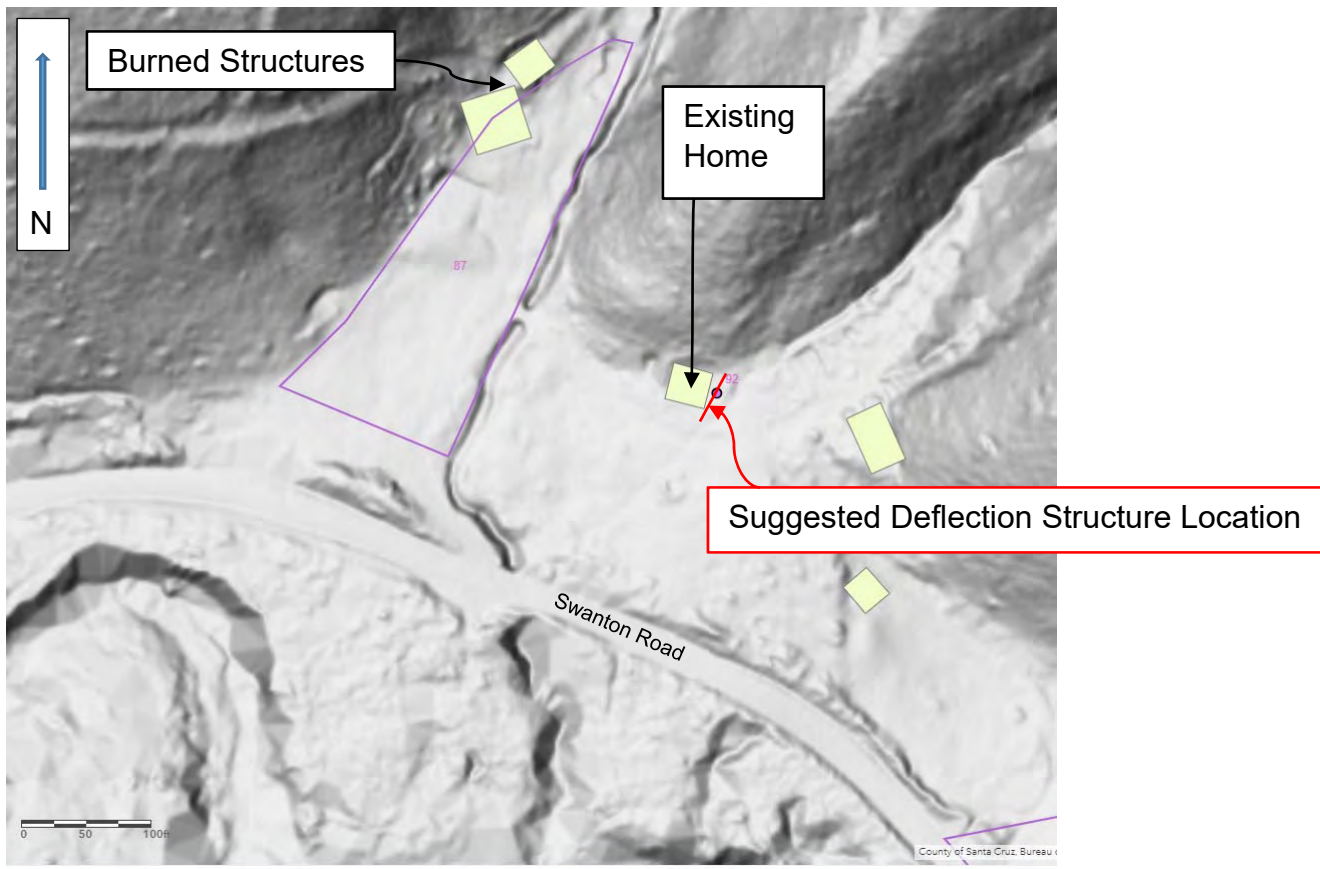
Several homes and a fish hatchery appear to be at risk from debris flows in the Big Creek watershed (VARs 84, 85, 89, and 90). VAR 92 consists of an existing unburned home located at the mouth of a drainage where it appears a deflection structure could help to limit the potential for flows impacting the home (Figure 16).

Figure 16. Site map of an existing home (VAR 92) showing the general location of a potential deflection structure. Any deflection structure would need to be properly designed for site conditions.

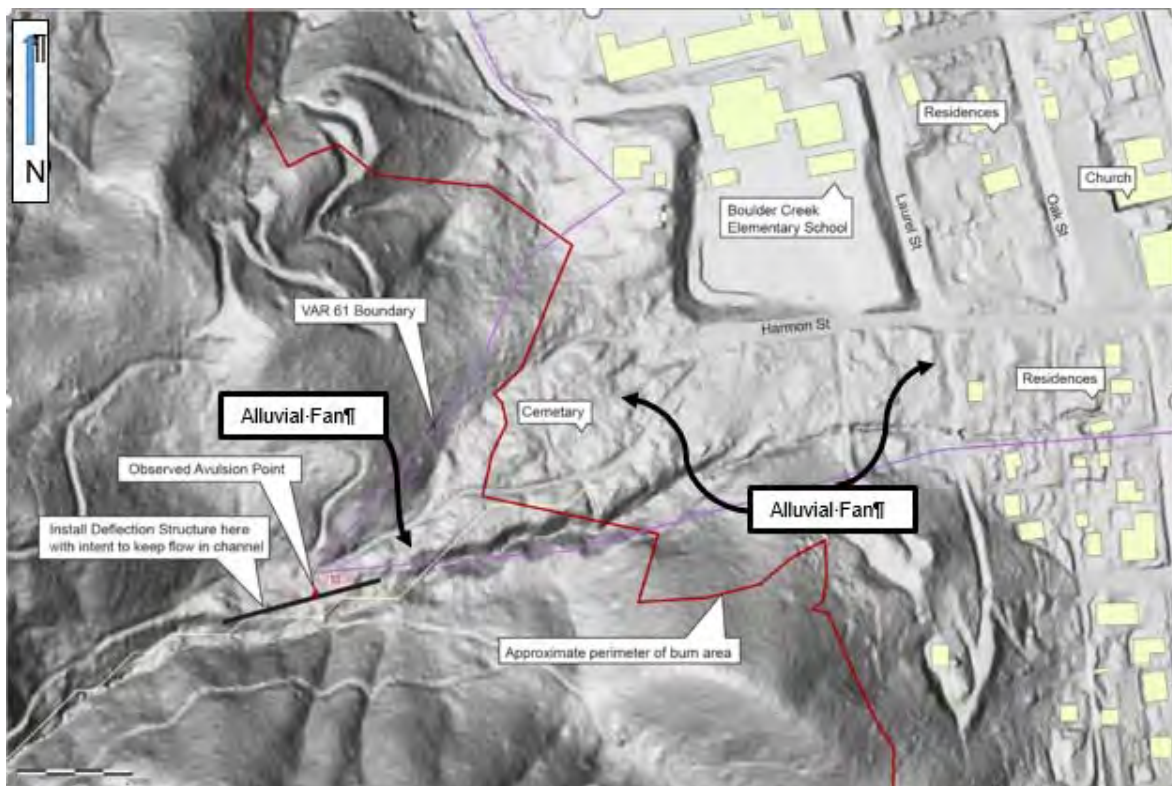
Based on our limited field reconnaissance a properly designed and located deflection structure may reduce the potential for avulsion from the current channel on an unnamed watercourse immediately upslope of Boulder Creek Elementary School and the adjoining residential neighborhood (VAR 61). A figure showing the location of the area is shown in Figure 17.

Figure 17. Site map of Boulder Creek (VAR 61) showing the potential location of a properly designed deflection structure to reduce the chance of avulsion from the current channel on an unnamed tributary southwest of the town. The red triangle denotes the location of the observed avulsion point.

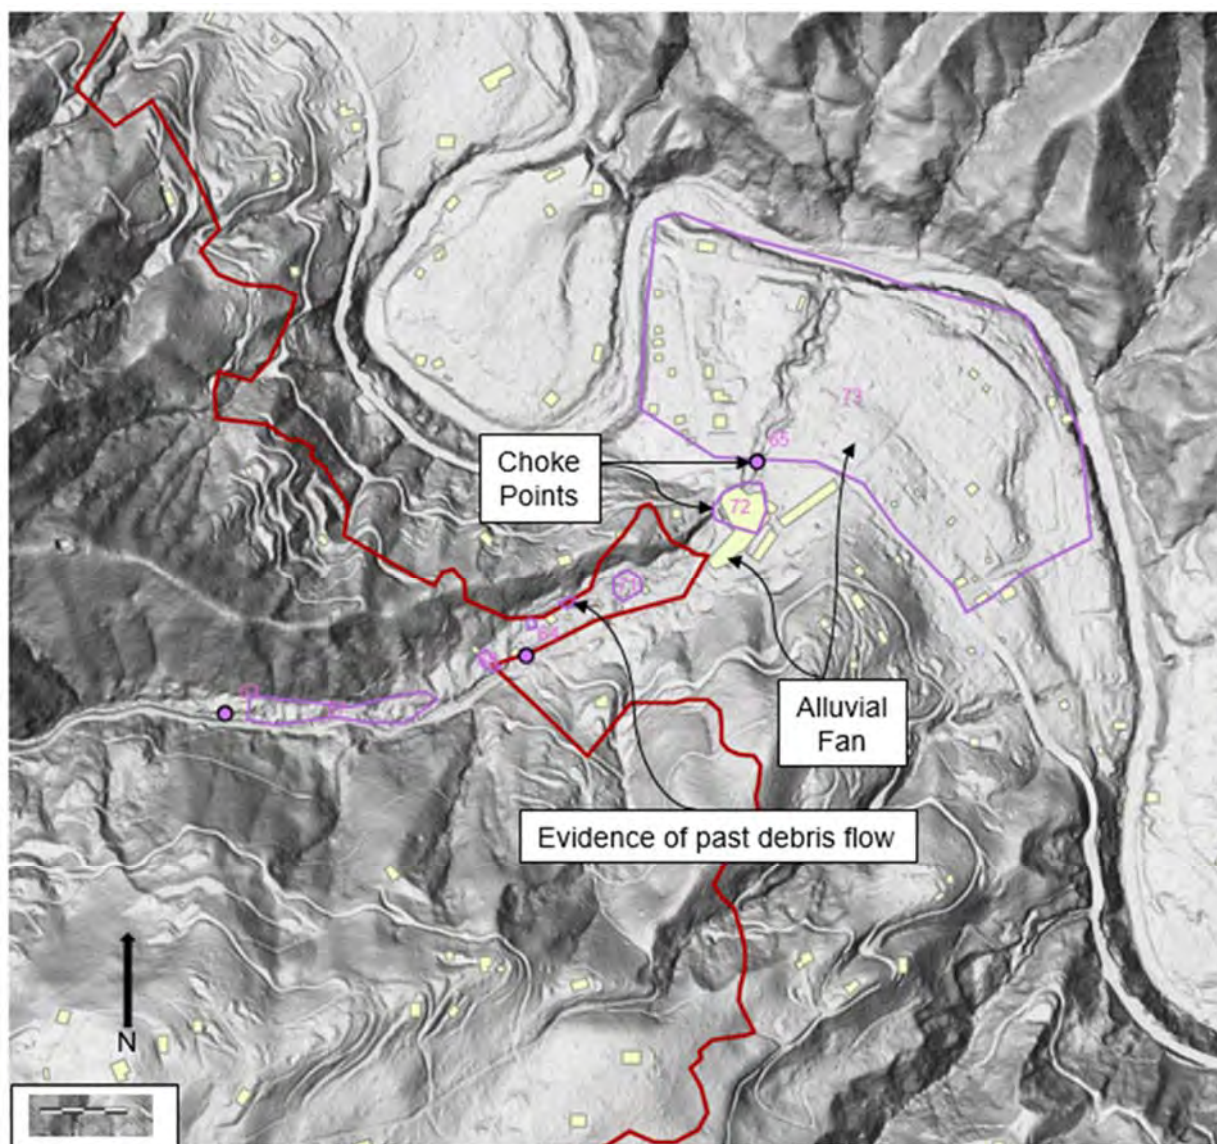
Flow paths on alluvial fan surfaces can be unpredictable and are influenced by roads, buildings, and other man-made infrastructure (Figure 18). The actual debris flow pathways are highly uncertain and were difficult to predict during this rapid evaluation. Deflection structures may prove effective in reducing the chance for avulsion in other areas where the potential for post-fire debris flow and flooding impacts were observed. For these reasons, we recommend further observations and determinations be made by a State-Certified Professional Geologist (PG) and Professional Engineer (PE).

Figure 18. Site map of Clear Creek and Brookdale (VARs 65 – 73) showing potential locations of choke points (potential avulsion points) and alluvial fans. Past debris flow deposits were observed in the channel.
