**NOTICE OF
ENGINEERING/ENVIRONMENTAL
COMMITTEE
SPECIAL MEETING
October 18, 2023**

To: Engineering and Environmental Committee
From: District Manager
Prepared By: Director of Operations
SUBJECT: SYSTEM WIDE WATER LINE LEAK DETECTION ANALYSIS
DATE: October 18, 2023

Re: June 2023 Water Leak Detection Survey and Pinpointing Project

LEAK DETECTION EXECUTIVE SUMMARY

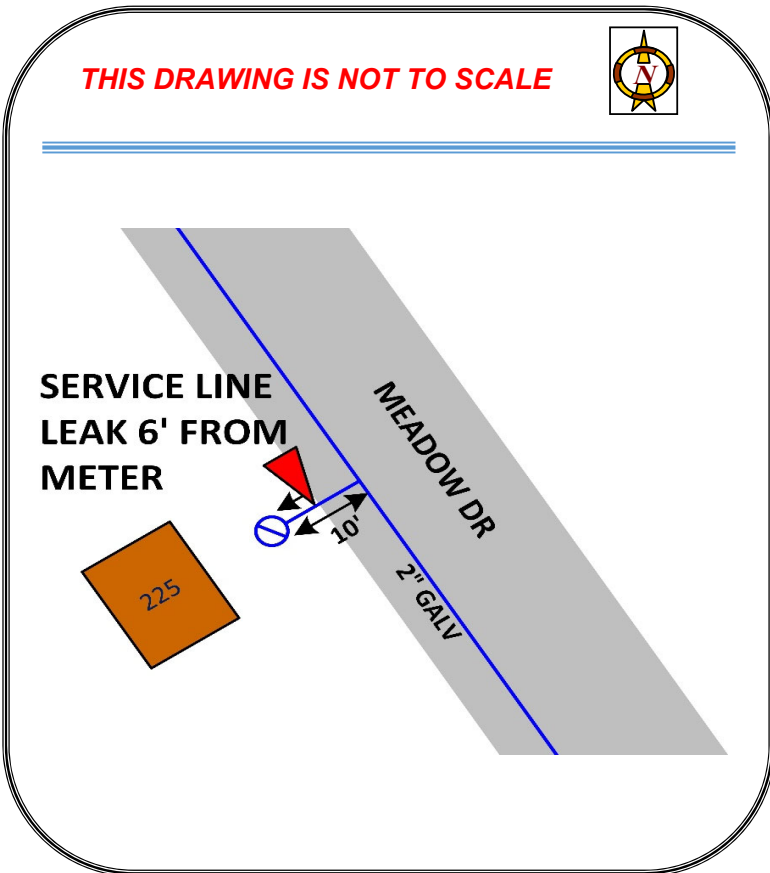
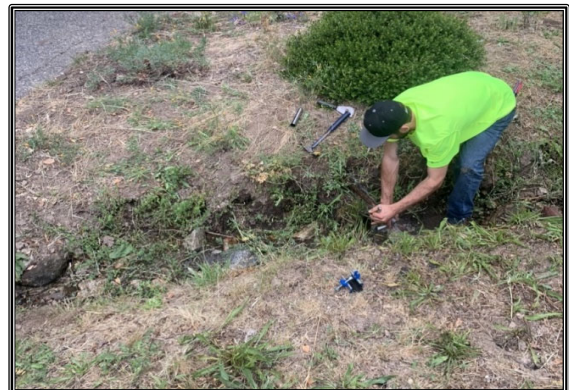
REMARKS
 VISIBLE LEAK IN DITCH ON EXPOSED SERVICE LINE. GALVANIZED SERVICE LINE IS HEAVILY CORRODED AND SHOULD BE REPLACED SOON. LEAK WORSENERD WHEN PRIMARY REPAIRS WERE ATTEMPTED.

LEAK INFORMATION	
Leak Consultant:	EK
Leak Class:	III
Leak Rate (GPM):	1.00
Cover Type:	SOIL
Site Marked:	NO
Mins. Pinpointing:	30

Water Loss (gallons)	
Daily:	1,440
Weekly:	10,080
Monthly:	43,800
Annual:	525,600

Action(s) Taken: _____
 Recommendation(s): REPAIR / REPLACE

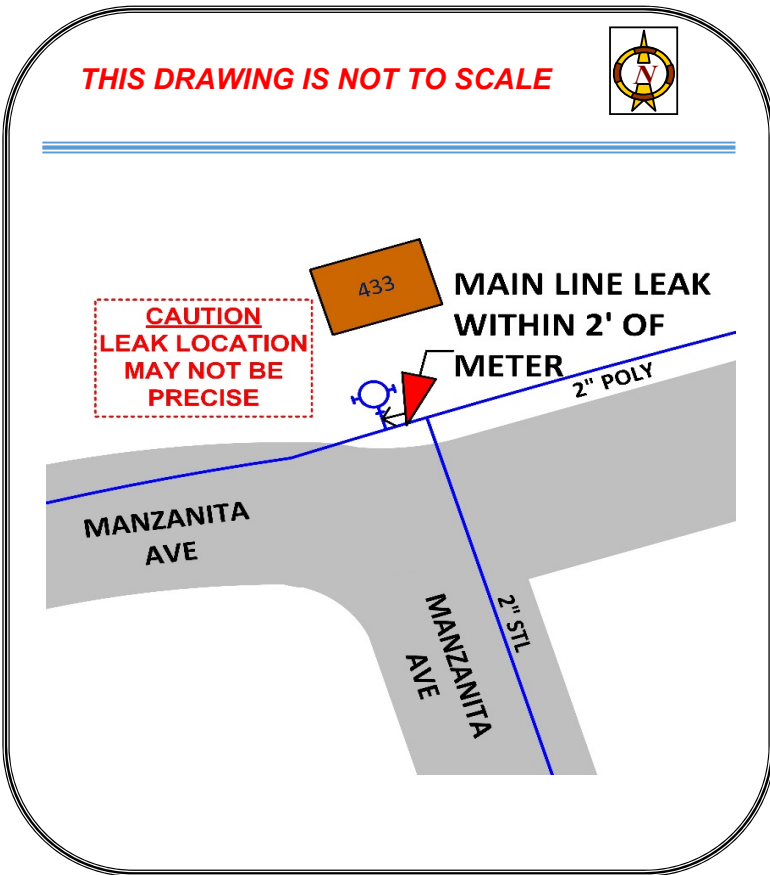
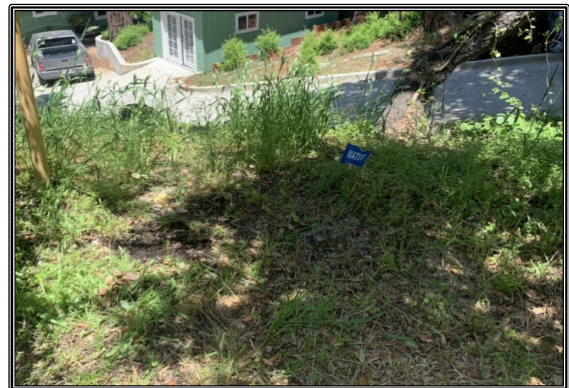
LEAK INFORMATION	
Leak Consultant:	<i>EK</i>
Leak Class:	<i>III</i>
Leak Rate (GPM):	<i>3.00</i>
Cover Type:	<i>GRAVEL</i>
Site Marked:	<i>NO</i>
Mins. Pinpointing:	<i>30</i>

Water Loss (gallons)	
Daily:	<i>4,320</i>
Weekly:	<i>30,240</i>
Monthly:	<i>131,400</i>
Annual:	<i>1,576,800</i>

Recommendation(s): EXCAVATE & REPAIR

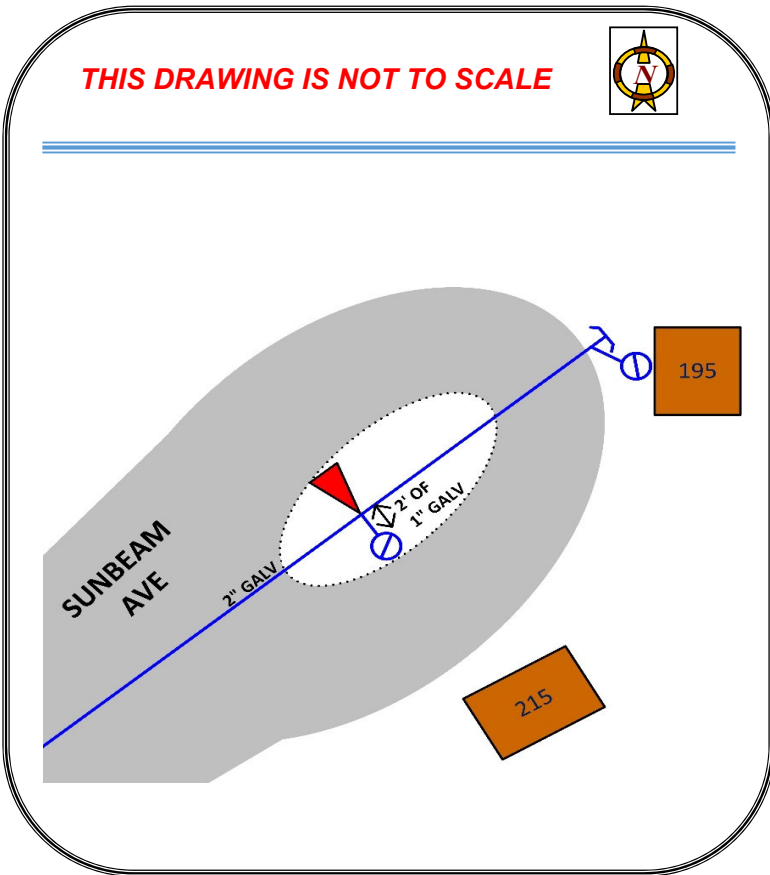
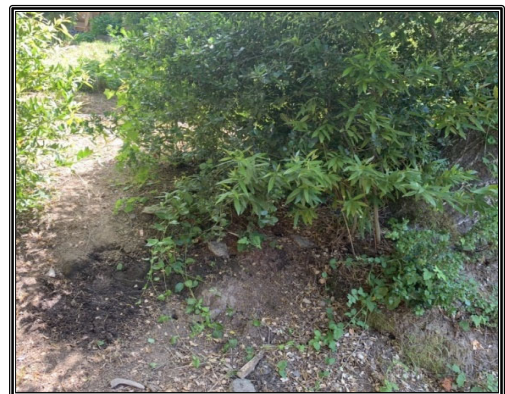
LEAK INFORMATION	
Leak Consultant:	<i>EK</i>
Leak Class:	<i>III</i>
Leak Rate (GPM):	<i>3.00</i>
Cover Type:	<i>GRAVEL</i>
Site Marked:	<i>NO</i>
Mins. Pinpointing:	<i>45</i>

Water Loss (gallons)	
Daily:	<i>4,320</i>
Weekly:	<i>30,240</i>
Monthly:	<i>131,400</i>
Annual:	<i>1,576,800</i>

Recommendation(s): REPAIR / REPLACE

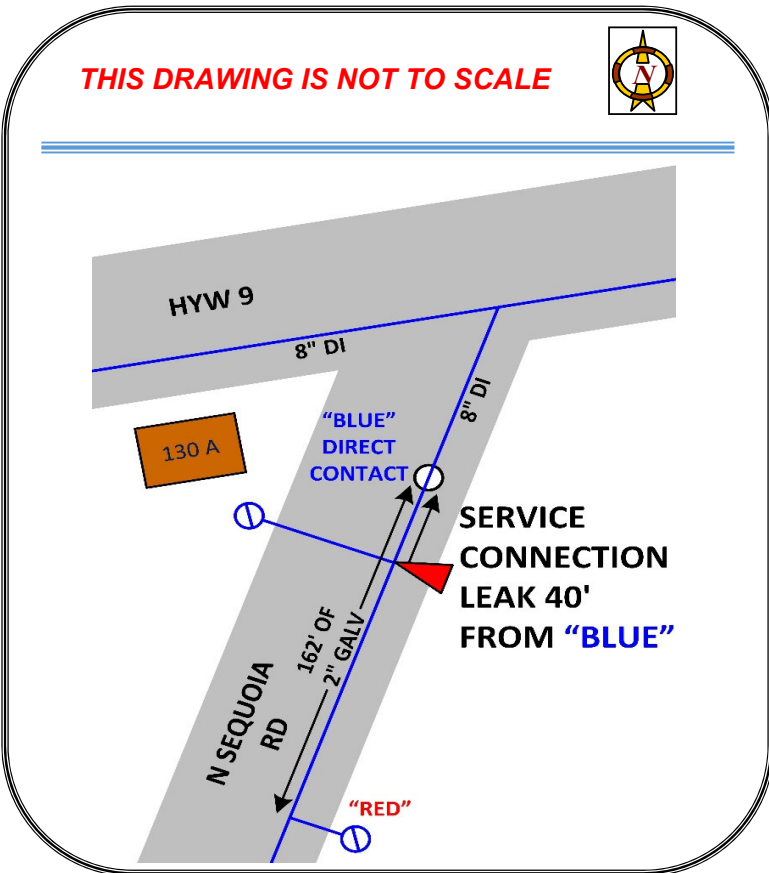
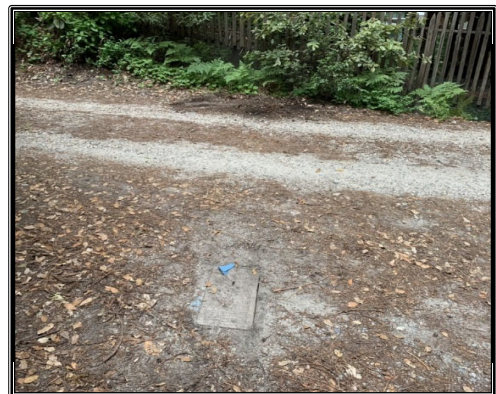
REMARKS
 PINPOINTED SERVICE CONNECTION LEAK WITH EXCELLENT CORRELATION. SOIL IS MOIST IN PINPOINTED AREA.

LEAK INFORMATION	
Leak Consultant:	EK
Leak Class:	III
Leak Rate (GPM):	2.00
Cover Type:	GRAVEL
Site Marked:	NO
Mins. Pinpointing:	60

Water Loss (gallons)	
Daily:	2,880
Weekly:	20,160
Monthly:	87,600
Annual:	1,051,200

Action(s) Taken: _____
 Recommendation(s): REPAIR / REPLACE

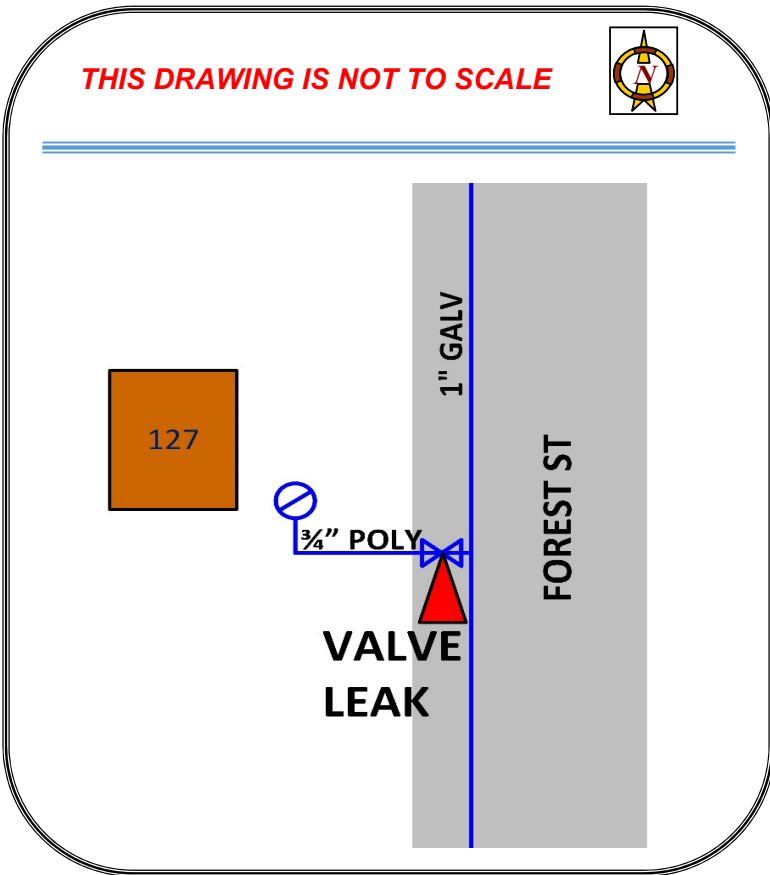
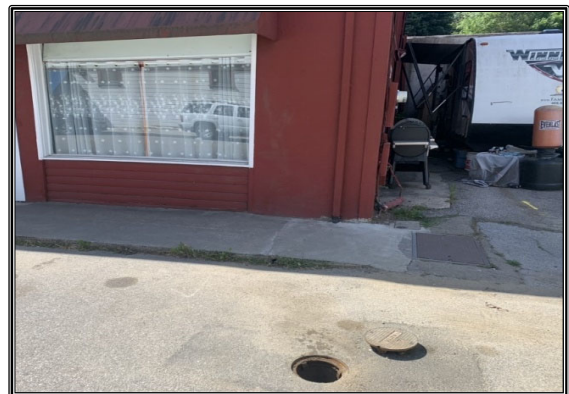
REMARKS
 VALVE LEAK. WATER INSIDE VALVE CAN. VERY HIGH FREQUENCY LEAK NOISE DETECTED. LEAK IS EITHER A FLANGE FITTING, NIPPLE, OR PACKING LEAK.

LEAK INFORMATION	
Leak Consultant:	EK
Leak Class:	II
Leak Rate (GPM):	3.00
Cover Type:	ASPHALT
Site Marked:	NO
Mins. Pinpointing:	30

Water Loss (gallons)	
Daily:	4,320
Weekly:	30,240
Monthly:	131,400
Annual:	1,576,800

Action(s) Taken: _____
 Recommendation(s): REPAIR / REPLACE

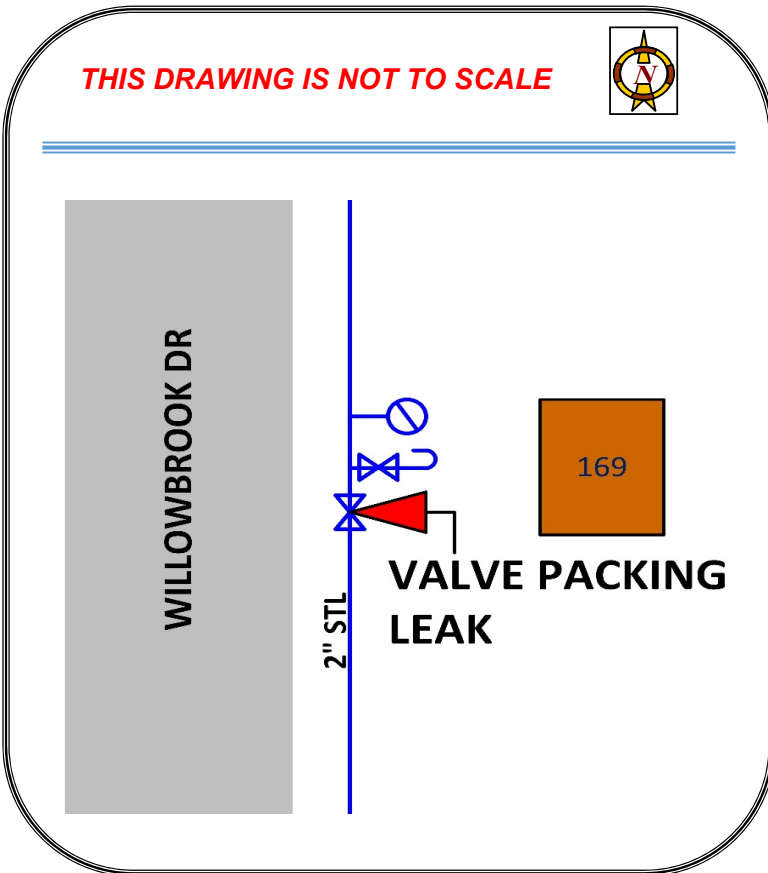
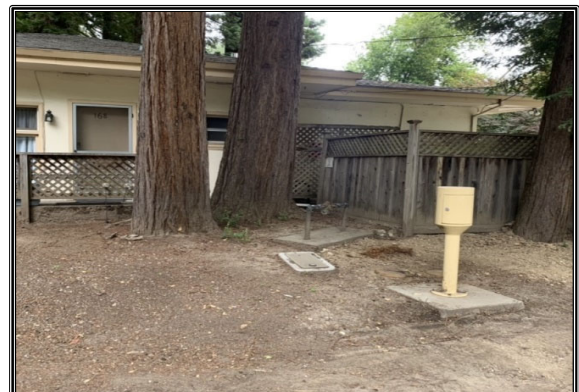
REMARKS
 VALVE PACKING LEAK. WATER IN VALVE CAN.

LEAK INFORMATION	
Leak Consultant:	EK
Leak Class:	III
Leak Rate (GPM):	1.00
Cover Type:	ASPHALT
Site Marked:	NO
Mins. Pinpointing:	20

Water Loss (gallons)	
Daily:	1,440
Weekly:	10,080
Monthly:	43,800
Annual:	525,600

Action(s) Taken: _____
 Recommendation(s): REPAIR / REPLACE

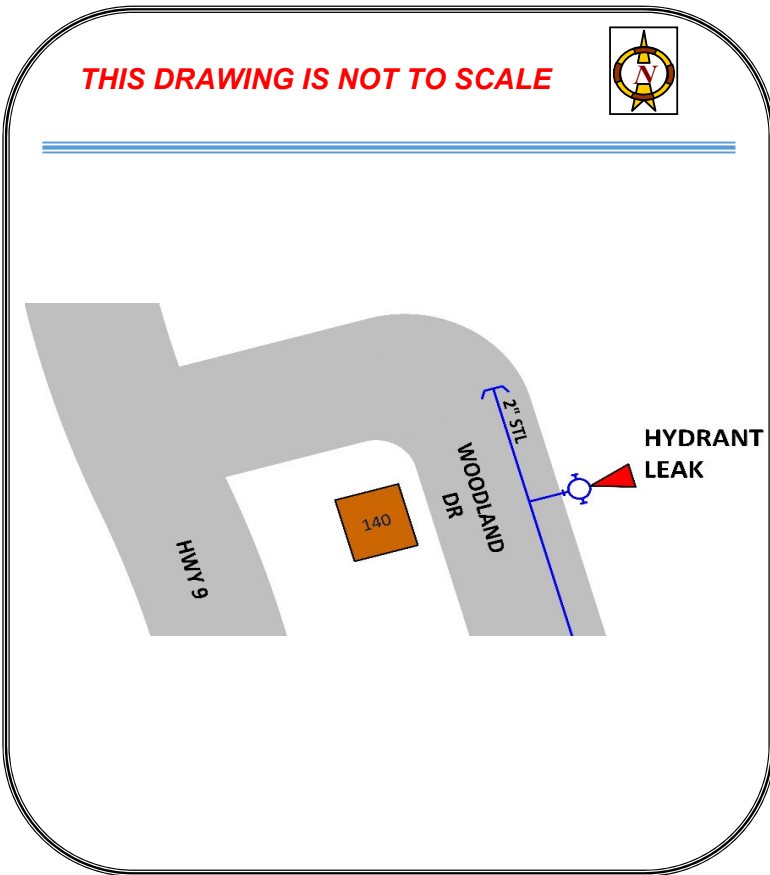
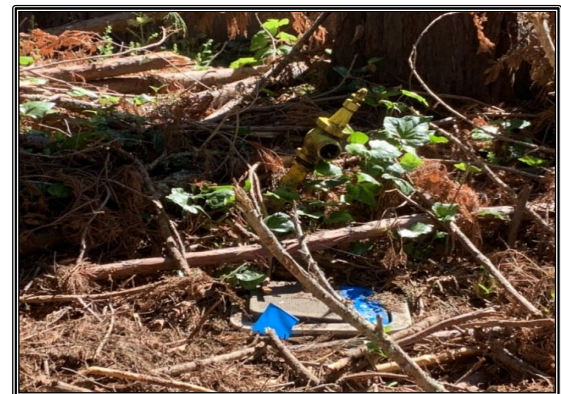
REMARKS
 SMALL LEAK ON DAMAGED WHARF HYDRANT. HYDRANT HAS BEEN HIT BY TREE DEBRIS AND ANGLED AT APPROXIMATELY 45 DEGREE ANGLE.

LEAK INFORMATION	
Leak Consultant:	EK
Leak Class:	III
Leak Rate (GPM):	0.50
Cover Type:	GRAVEL
Site Marked:	NO
Mins. Pinpointing:	20

Water Loss (gallons)	
Daily:	720
Weekly:	5,040
Monthly:	21,900
Annual:	262,800

Action(s) Taken: _____
 Recommendation(s): REPAIR / REPLACE

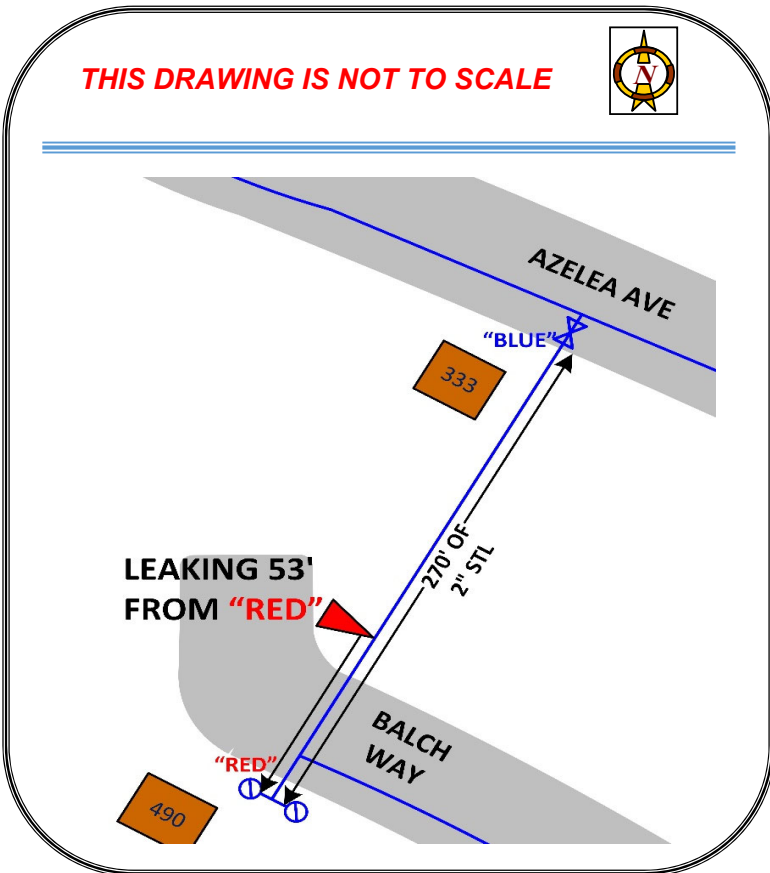
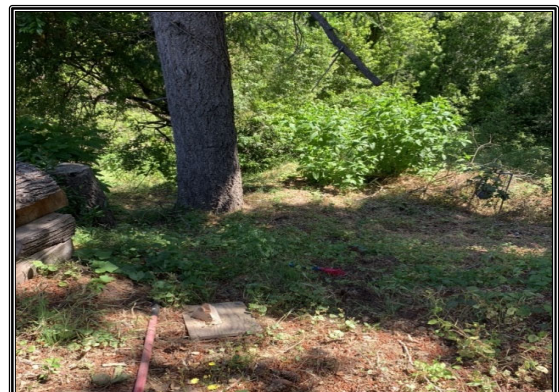
VERY GOOD LEAK NOISE DETECTED AT "BLUE". GOOD CORRELATION WITH ESTIMATED DISTANCE (PIPE LENGTH). EXACT LOCATION OF MAIN LINE ALONG CROSS COUNTRY PATH IS UNKNOWN.

LEAK INFORMATION	
Leak Consultant:	EK
Leak Class:	II
Leak Rate (GPM):	5.00
Cover Type:	SOIL
Site Marked:	NO
Mins. Pinpointing:	60

Water Loss (gallons)	
Daily:	7,200
Weekly:	50,400
Monthly:	219,000
Annual:	2,628,000

Action(s) Taken: _____
 Recommendation(s): **REPAIR / REPLACE**

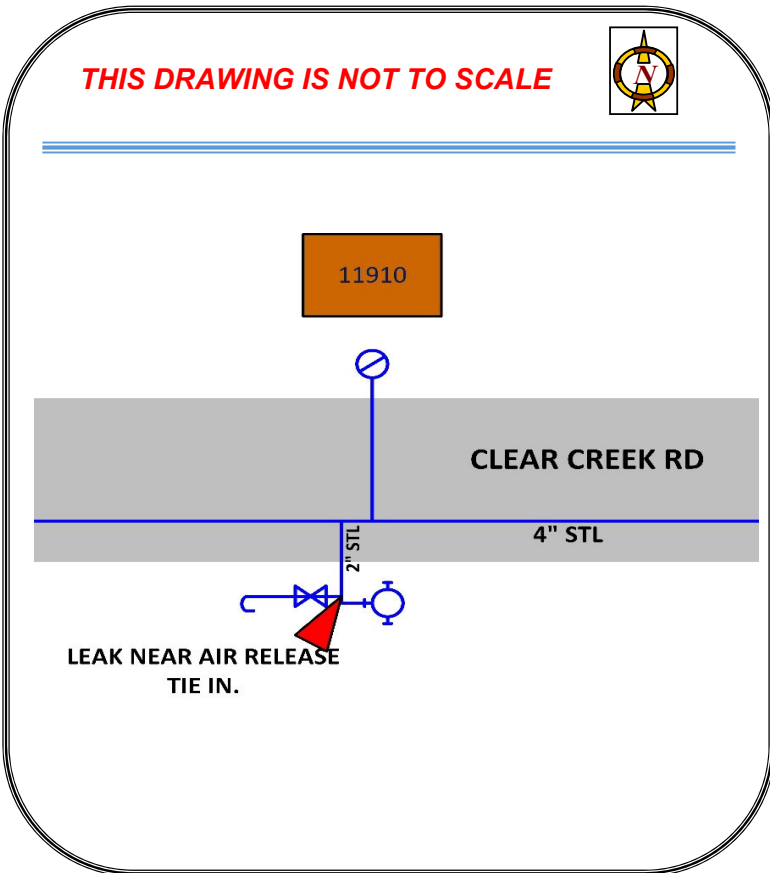
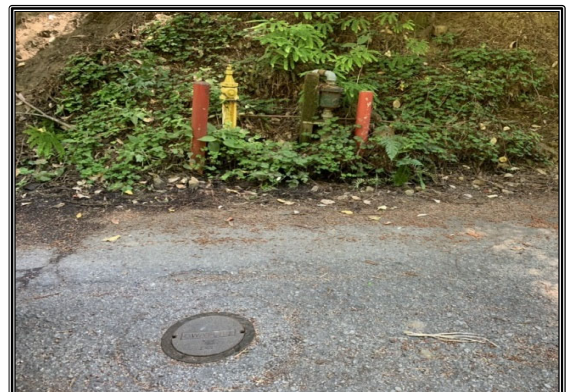
REMARKS
 LEAK NEAR AIR RELEASE TIE IN ON WHARF HYDRANT LEATERAL. VERY STRONG LEAK NOISE DETECTED AND WATER FLOWING FROM AFFECTED AREA.

LEAK INFORMATION	
Leak Consultant:	EK
Leak Class:	II
Leak Rate (GPM):	5.00
Cover Type:	GRAVEL
Site Marked:	NO
Mins. Pinpointing:	30

Water Loss (gallons)	
Daily:	7,200
Weekly:	50,400
Monthly:	219,000
Annual:	2,628,000

Action(s) Taken: _____
 Recommendation(s): REPAIR / REPLACE

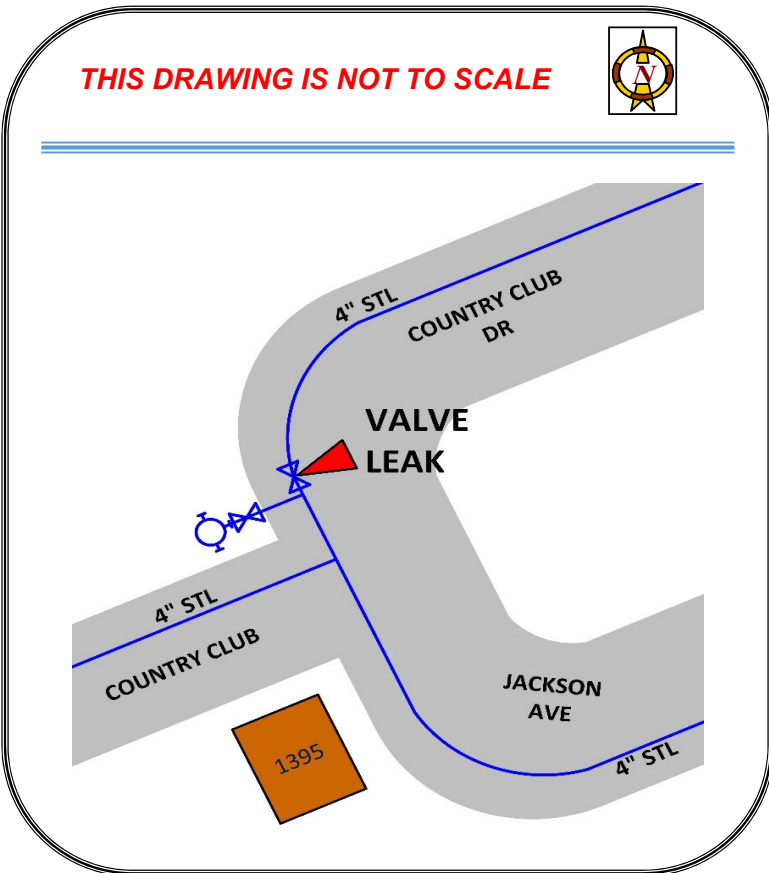
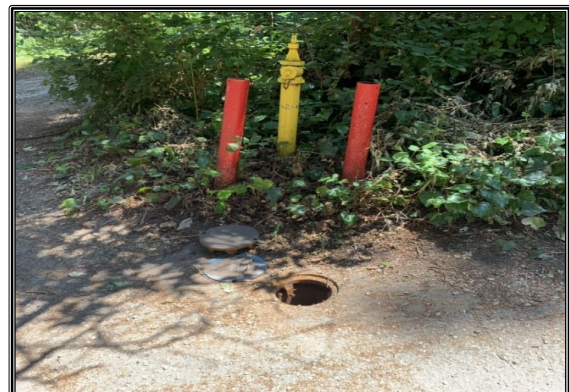
REMARKS
 VALVE LEAK. VERY HIGH FREQUENCY LEAK NOISE DETECTED AT INLINE VALVE. BOTH VALVES HAVE LEAK NOISE WITH THE INLINE VALVE REGISTERING THE MOST LEAK NOISE. WATER VISIBLE IN BOTH VALVE CANS. POSSIBLE PACKING OR FLANGE LEAK.

LEAK INFORMATION	
Leak Consultant:	EK
Leak Class:	III
Leak Rate (GPM):	1.00
Cover Type:	ASPHALT
Site Marked:	NO
Mins. Pinpointing:	40

Water Loss (gallons)	
Daily:	1,440
Weekly:	10,080
Monthly:	43,800
Annual:	525,600

Action(s) Taken: _____
 Recommendation(s): REPAIR / REPLACE

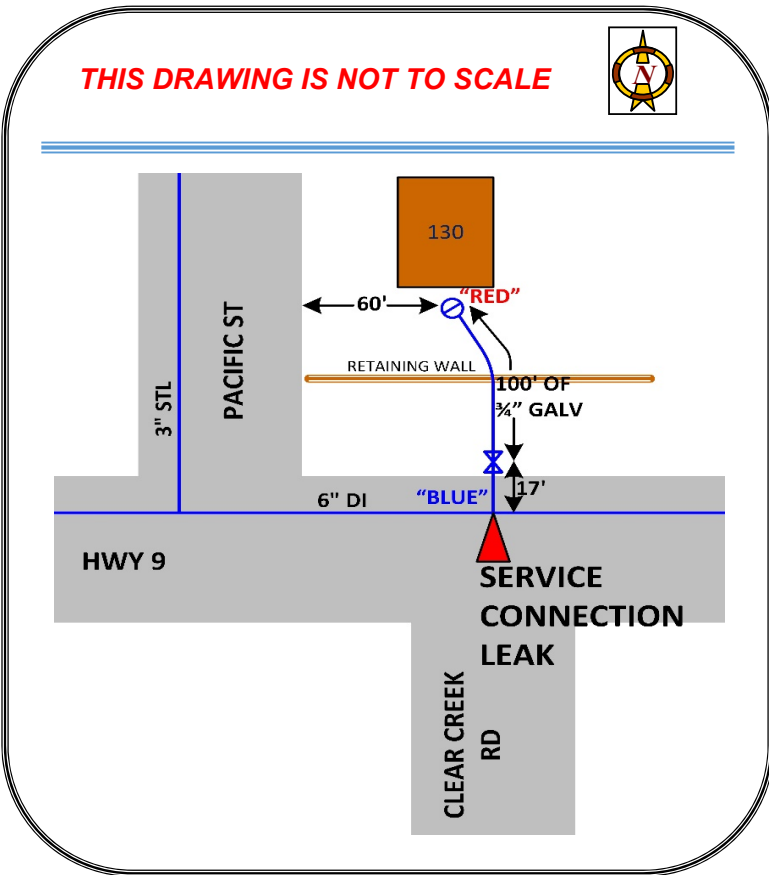
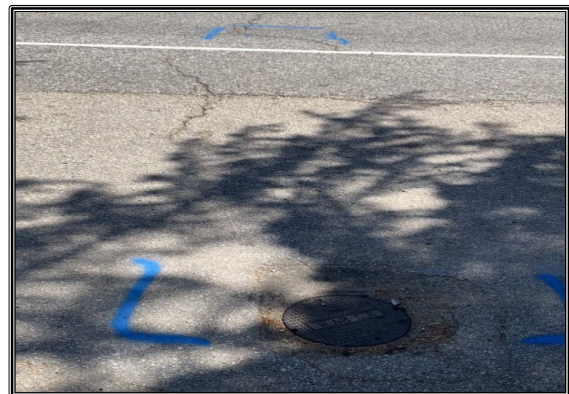
REMARKS
 CORRELATION FROM METER TO VALVE PINPOINTED LEAK AT VALVE "BLUE". GROUND MIC PINPOINTED THE LEAK AT SERVICE CONNECTION WHICH IS ON HWY 9 THROUGH A CORNER PROPERTY TO THE DUPLEX / HOUSE. NO WATER IN VALVE CAN "BLUE". DID NOT OPERATE THIS VALVE WHICH APPEARED TO BE A 3/4" GATE VALVE.

EQUIPMENT USED	
	S-30
	LD-12
	LC-2500
LEAK INFORMATION	
Leak Consultant:	EK
Leak Class:	I
Leak Rate (GPM):	20.00
Cover Type:	ASPHALT
Site Marked:	YES
Mins. Pinpointing:	45

Water Loss (gallons)	
Daily:	28,800
Weekly:	201,600
Monthly:	876,000
Annual:	10,512,000

Action(s) Taken: _____
 Recommendation(s): REPAIR / REPLACE
