**SAN LORENZO VALLEY WATER DISTRICT
CROSS COUNTRY PIPELINE CONSTRUCTABILITY
PEER REVIEW OF FREYER & LAURETA STUDY AND MEMO**

**Peer Review of March 2022 Study and
Draft Supplemental Evaluation Dated April 6, 2022**

24 NOVEMBER 2022
PROJECT NO. 12196

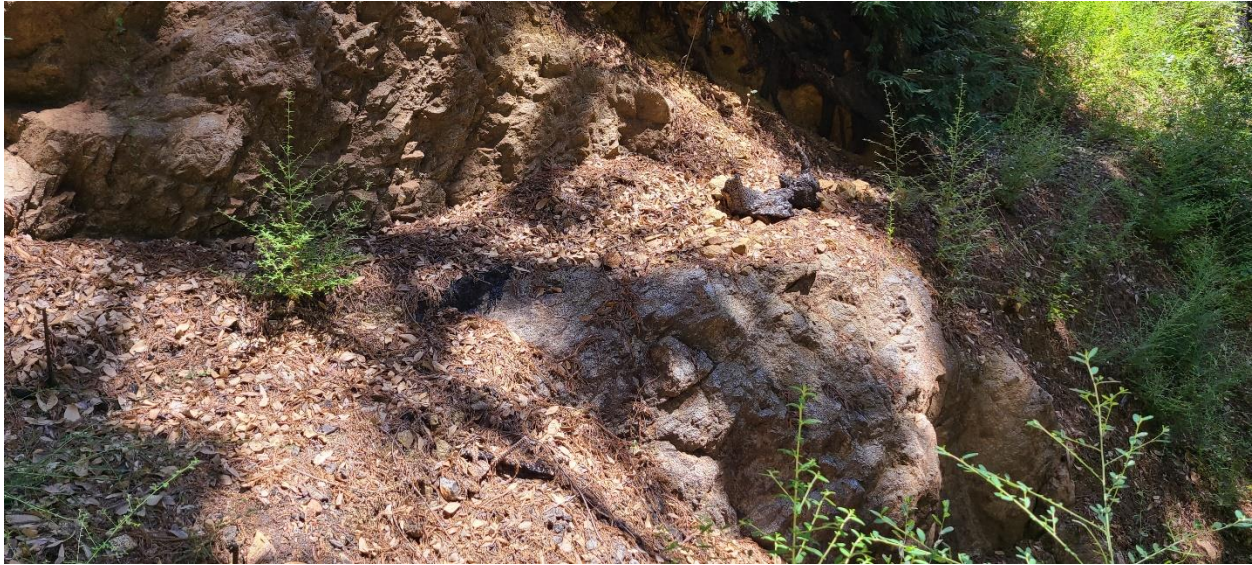
Photograph 1: Example of Extremely Steep Slopes Along Existing Waterline Bench at North side of Clear Creek #1 crossing

An example of this is found where the waterline crosses what is referred to as Clear Creek 1 (Photo 1). At the north side of this crossing there is a roughly 50 to 100 foot long segment of the very steep channel bank with slope gradients exceeding 150%. Based on our experience, it will not be feasible to cross this area with equipment without very significant retaining structures which may be cost prohibitive and may not be permissible (due to the regulatory requirements that give preference toward selection of the least environmentally damaging design alternative). As will be discussed later, issues like this present significant constraints for equipment access with some areas likely being inaccessible within the economic constraints of the project.

Clear Creek #1 crossing: The north side of Clear Creek #1 crossing is characterized by essentially a 50 to 100 foot long cliff exposing bedrock (See Photo 1). Access past this point with equipment is unlikely.

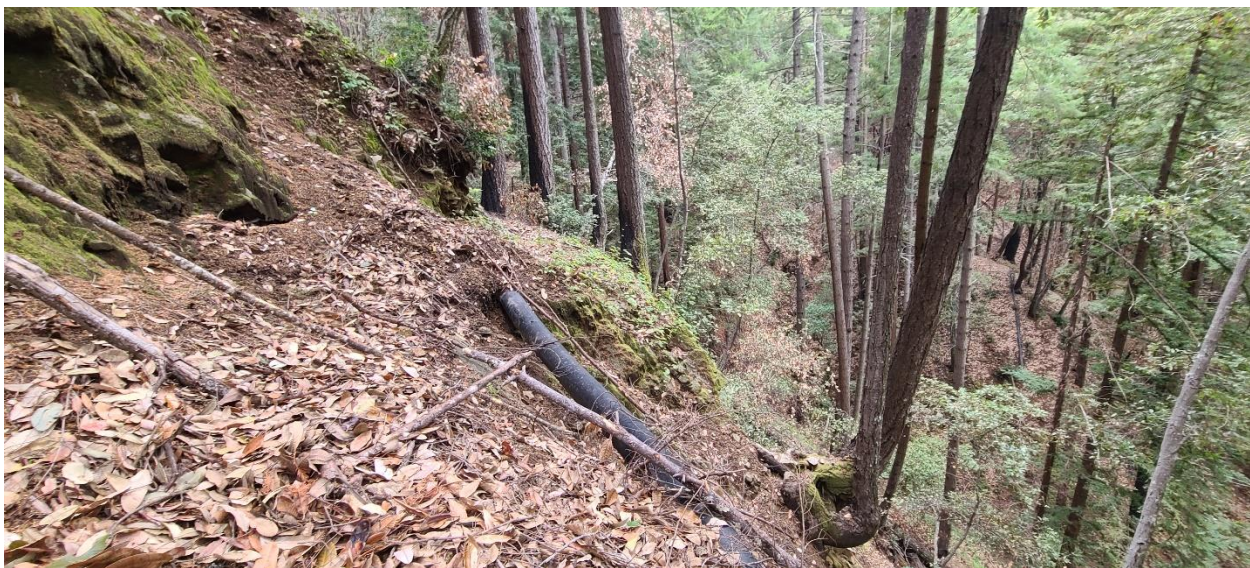
Photograph 2: Example of Extremely Steep Slopes Along Existing Waterline Bench with Black HDPE Pipeline Visible

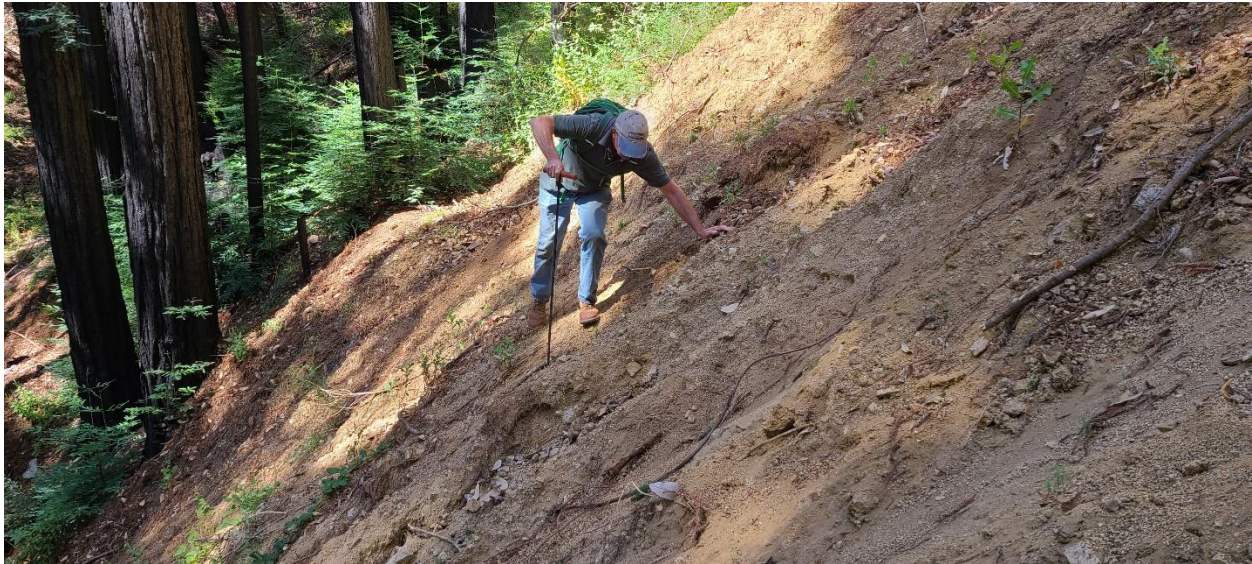
a concern than fillslope and downslope instability but large cutbank failures have occurred along the waterline with slide debris overtopping the bench and extending downslope to watercourses. More study is appropriate to evaluate the potential hazard and risk from cutbank instability

Photograph 3: Area of Extremely Steep Slopes where Cutbank Landsliding Impacted Existing Waterline Bench

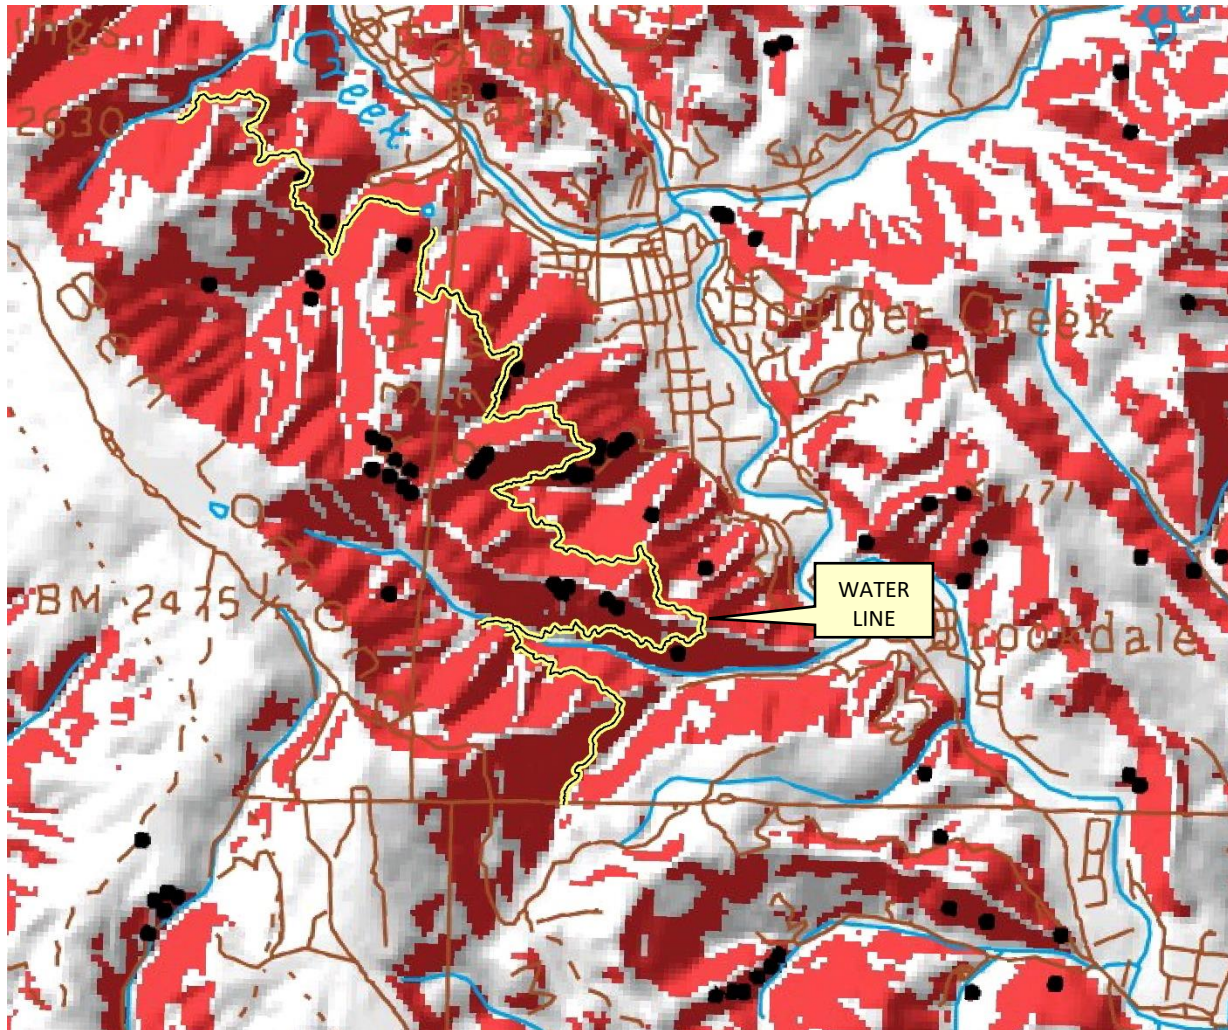
FIGURE 2: DEBRIS FLOW SOURCE AREAS

Ellen and Others (1997) prepared a map identifying the principal areas in the San Francisco Bay region that are likely to produce debris flow landslides. This map also shows the location of debris flow landslides mapped after the catastrophic January 1982 storm. The map shows nearly the entire alignment to be located on “principal predicted debris-flow source areas” and identified multiple historical 1982 debris flow landslides along the hillside in the general vicinity of the waterline. The CEG report does not discuss these past failures.

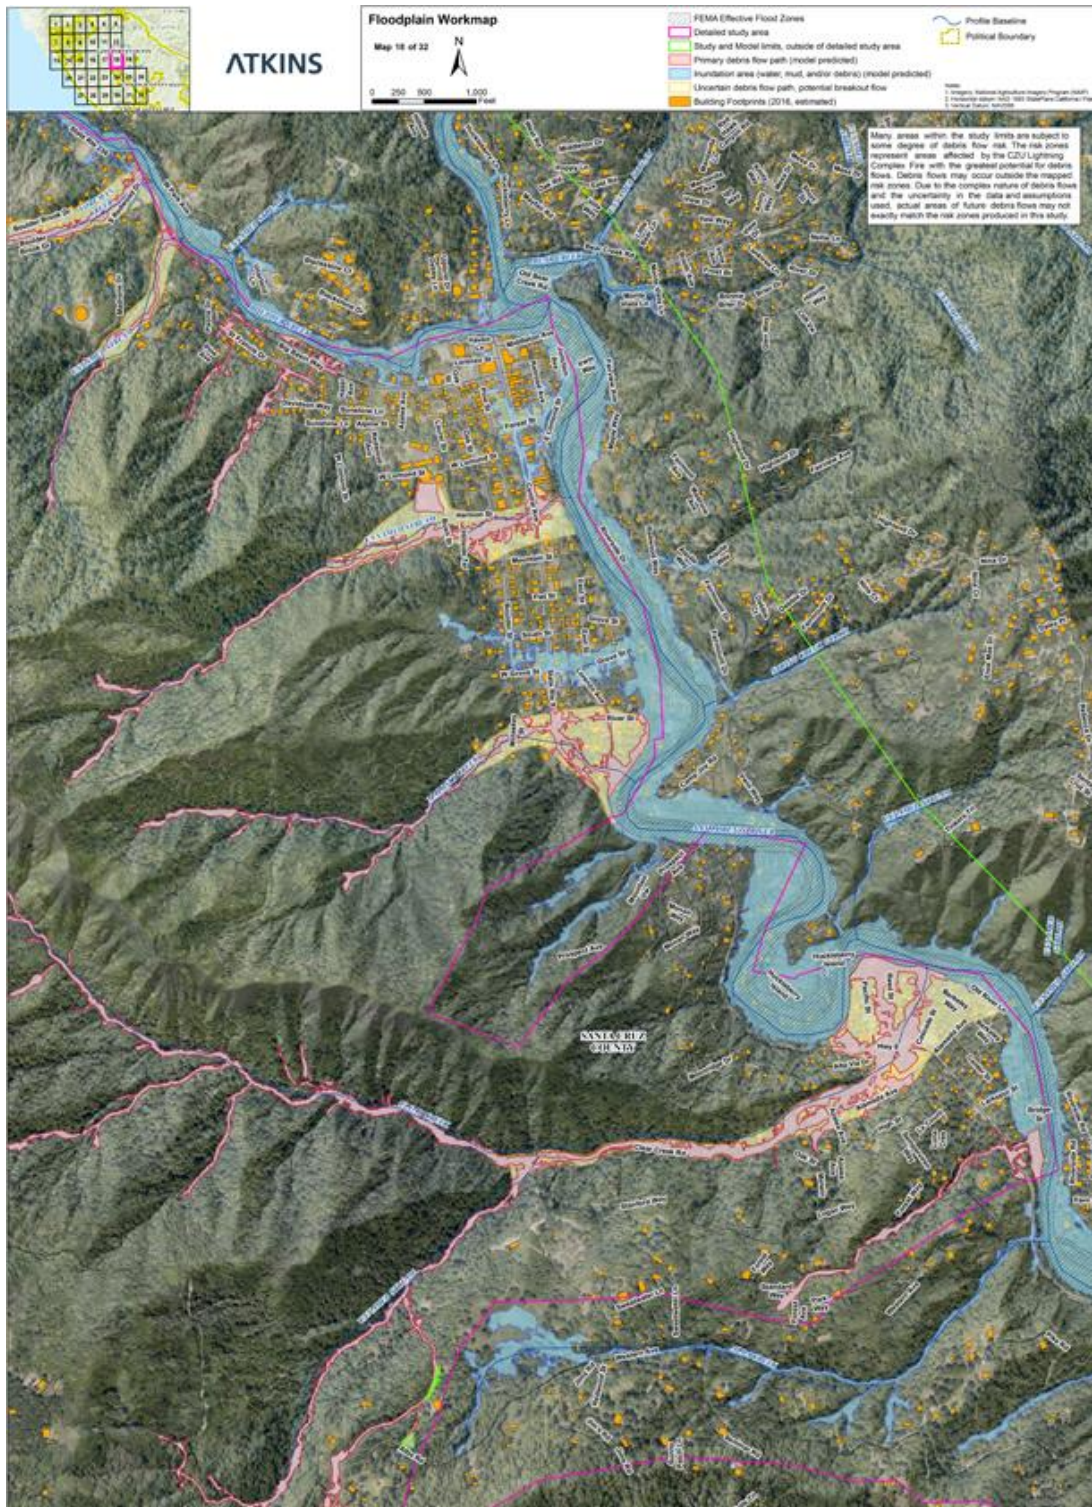
FIGURE 3: DEBRIS FLOW INUNDATION AREAS
A Portion of Debris Flow Floodplain Workmap # 18 for the CZU Fire Zone
(from Atkins/Lavalin, September 2021)

A copy of a portion of the Atkins/Lavalin Group map that shows primary debris flow paths, inundation areas (water, mud, and/or debris) and uncertain debris flow paths all as predicted by their modeling is shown below in Figure 3.

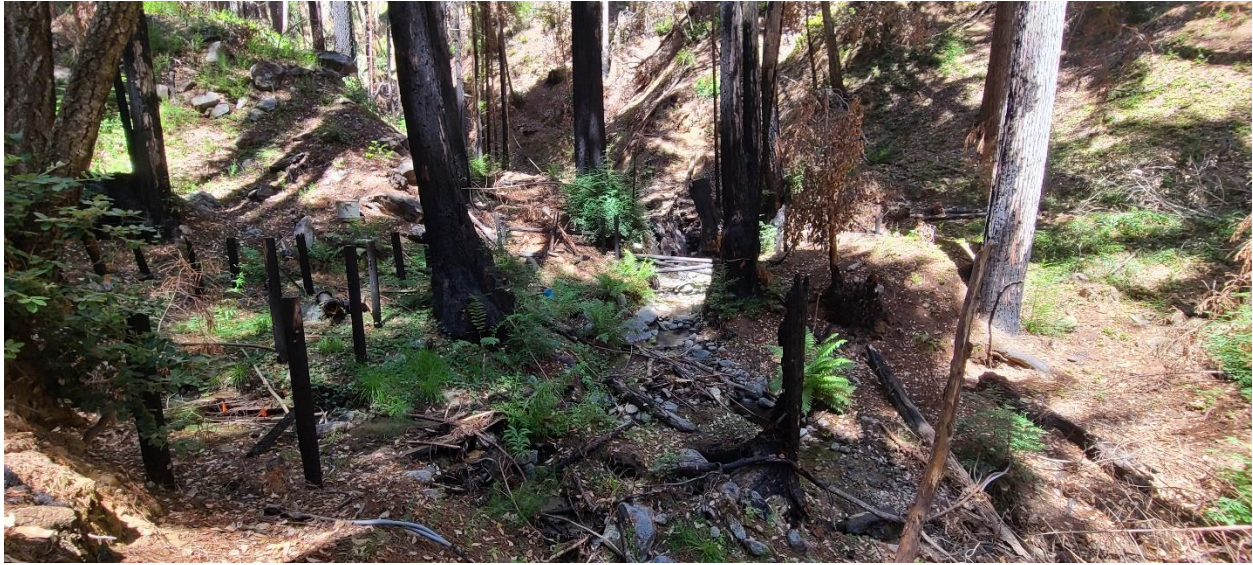
Photograph 4: Clear Creek #1 Crossing with Remains of Above Grade Crossing Structure

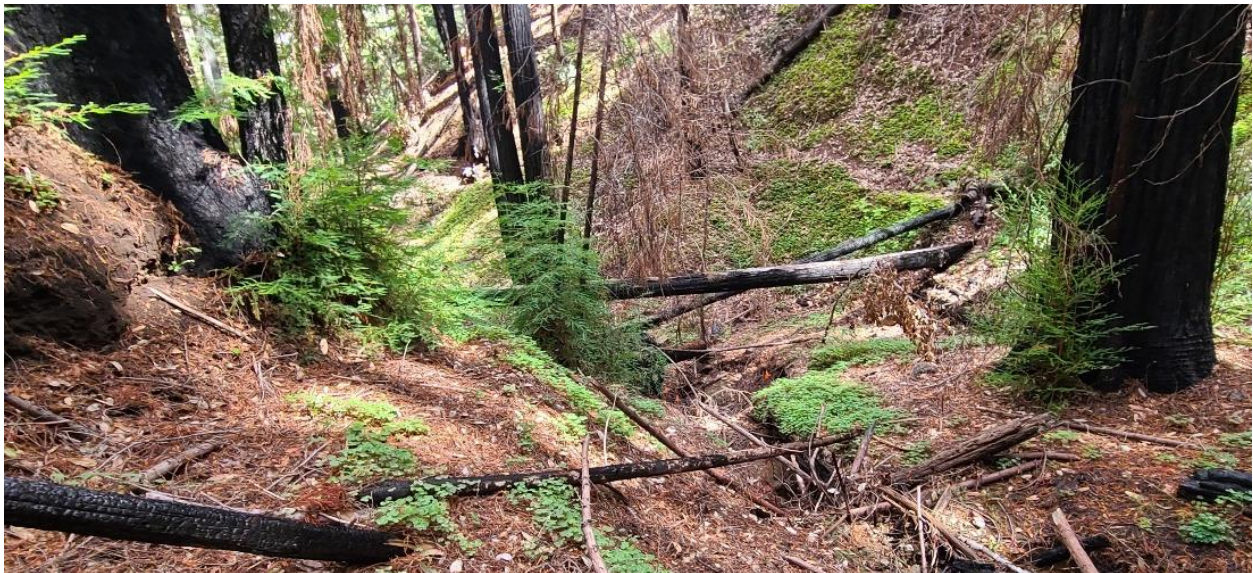
Photograph 5: Looking Downstream where the Prior Waterline Spanned the Creek on Top of the Visible Log

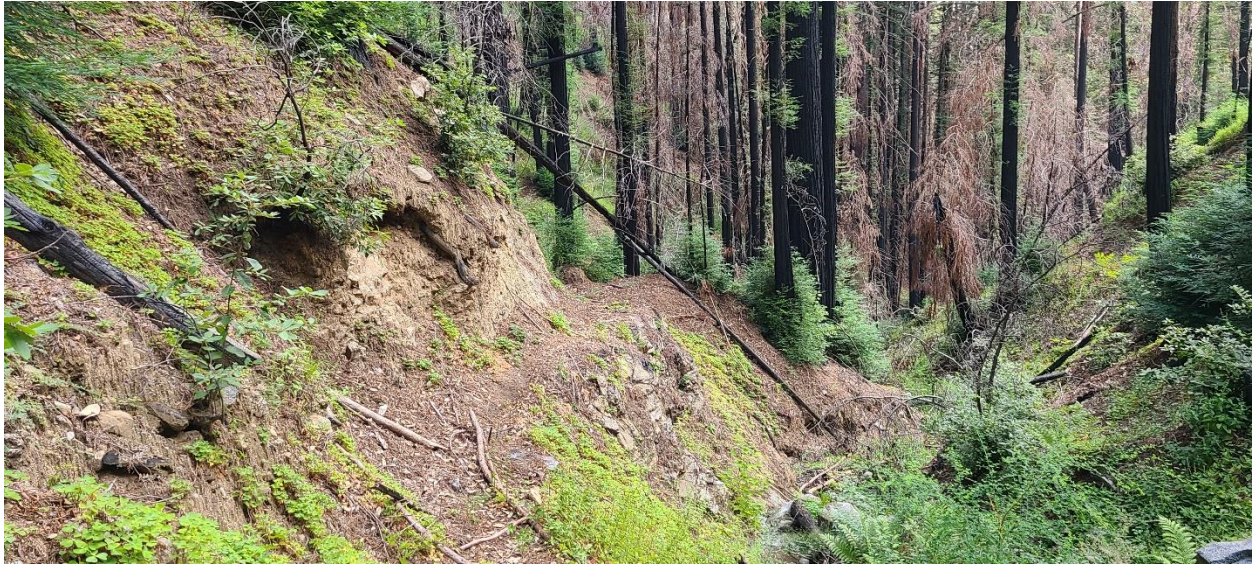
Photograph 6: Example of Steep Streamside Slopes and Hard Bedrock Along Existing Streamside Waterline Bench above Sweetwater Creek

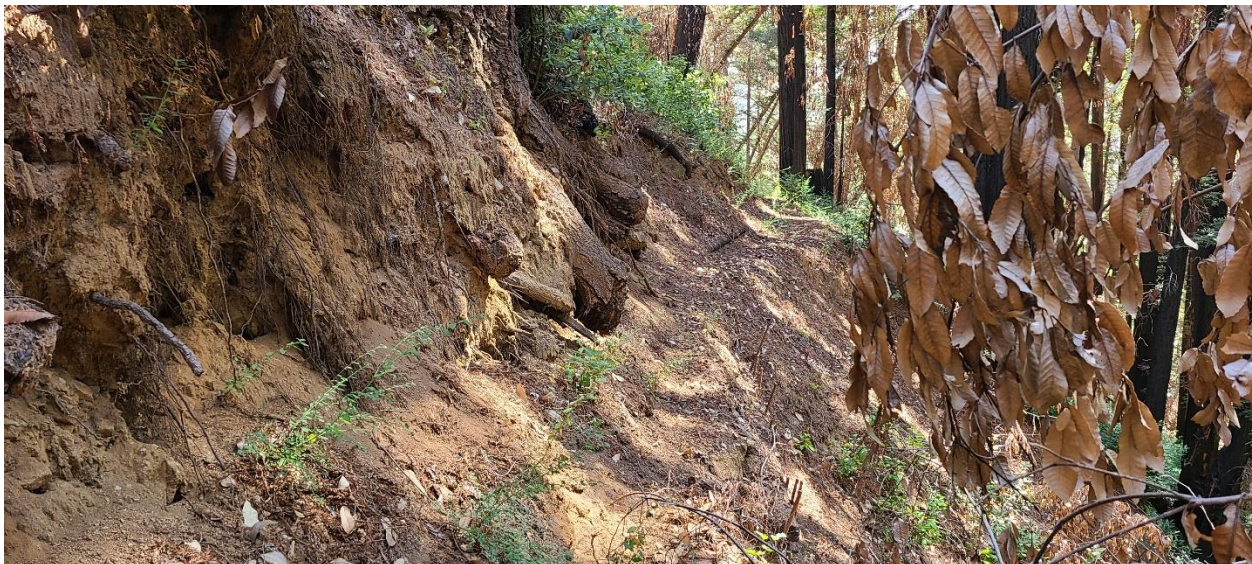
Photograph 7: Example of Extremely Steep Slopes, Unstable Conditions and Large Root Wad Along Existing Waterline Bench

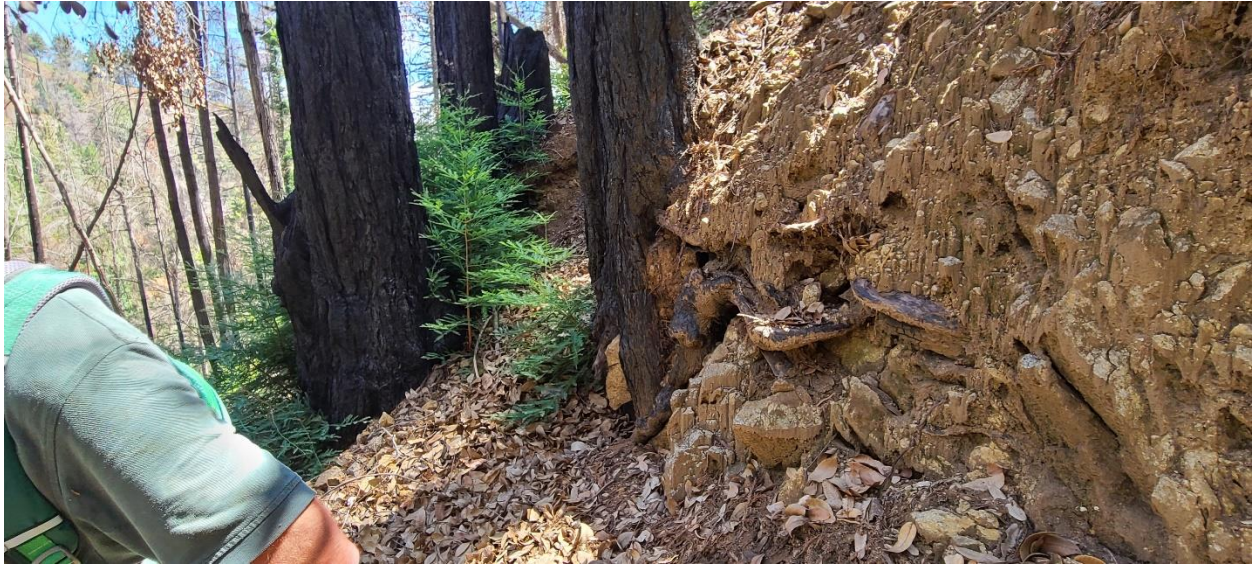
Photograph 8: Example of Extremely Steep Slopes, Unstable Conditions and Closely Spaced Trees along Existing Waterline Bench

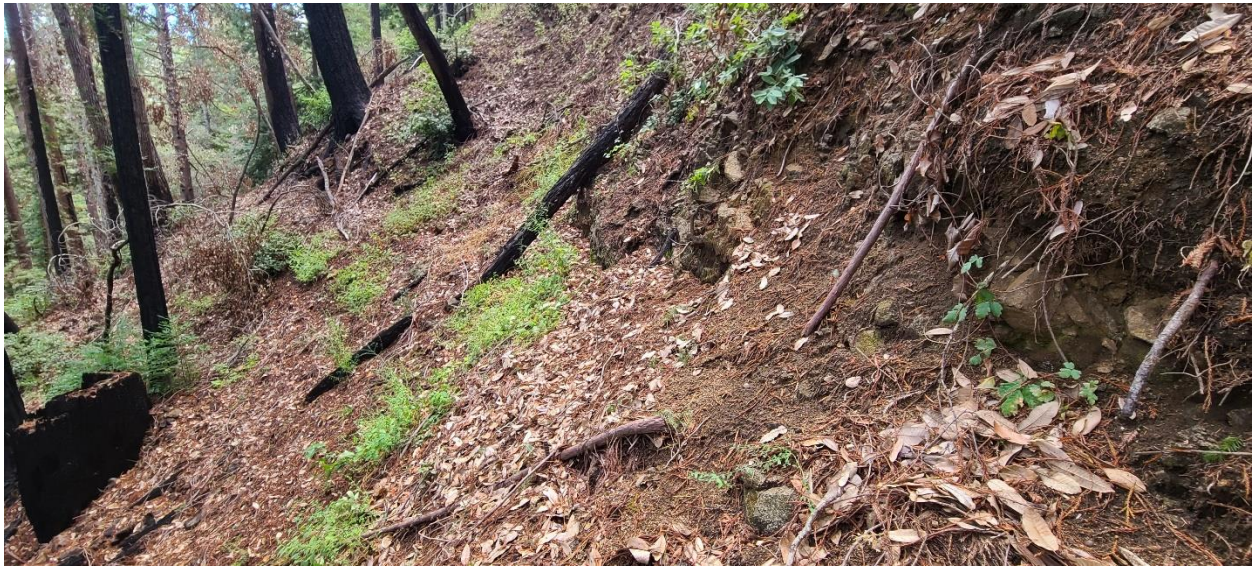
Photograph 8: Example of Steep Failing Slopes along Existing Waterline Bench

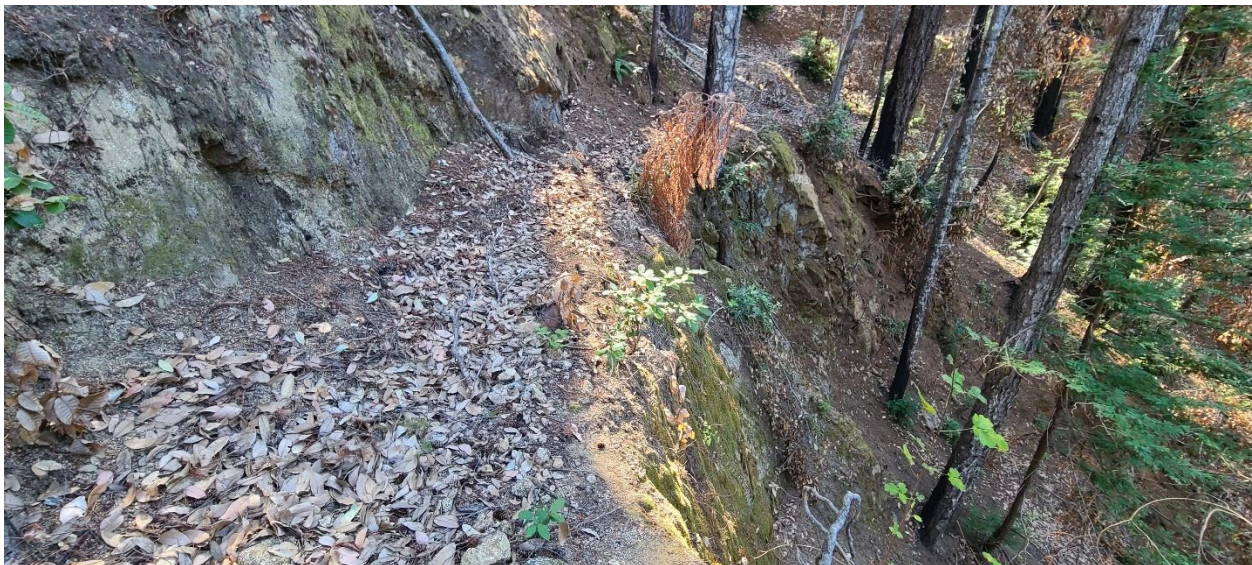
Photograph 9: Example of Extremely Steep Slope, Hard Bedrock, and Outboard Slope Failure along Existing Waterline Bench

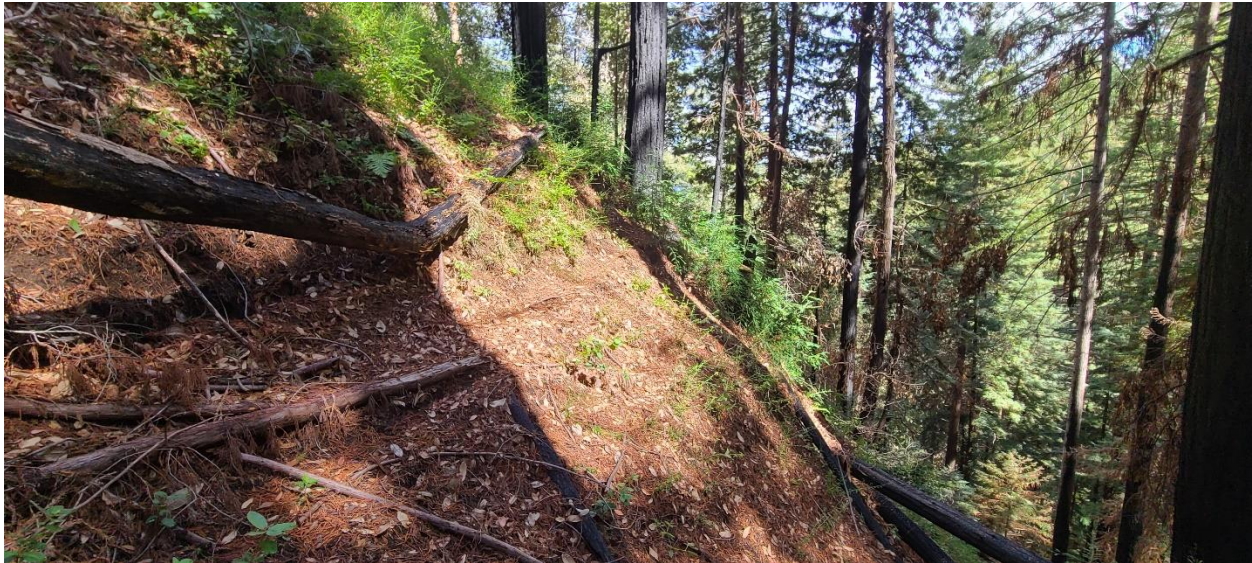
Photograph 10: Example of Extremely Steep Slope and Outboard Slope Failure along Existing Waterline Bench

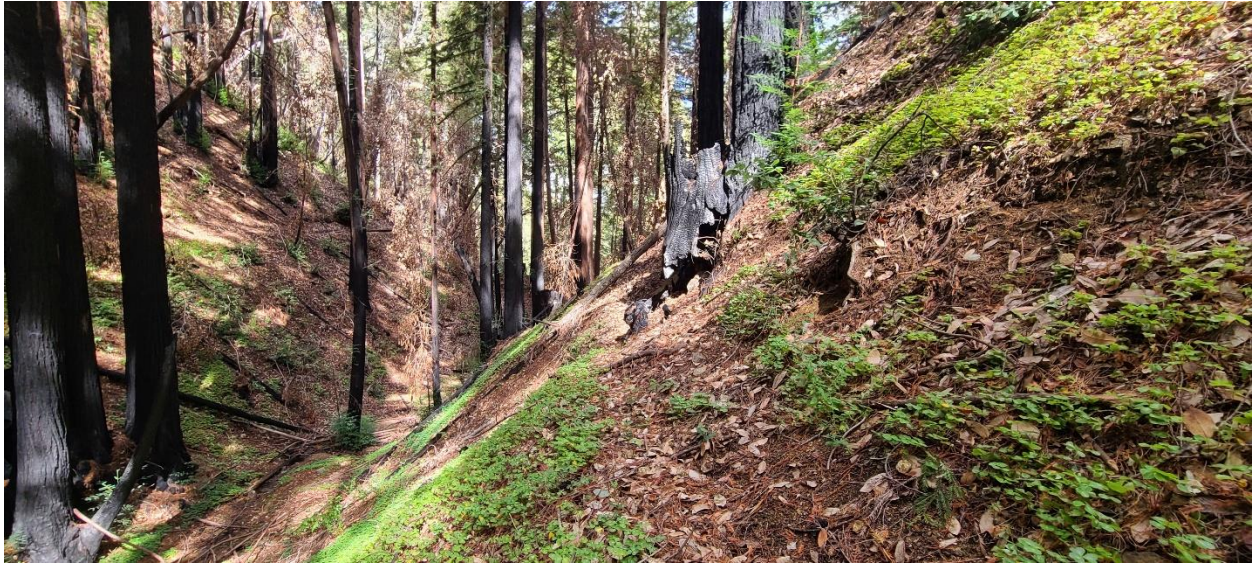
Photograph 11: Example of a Steep Streamside Slope

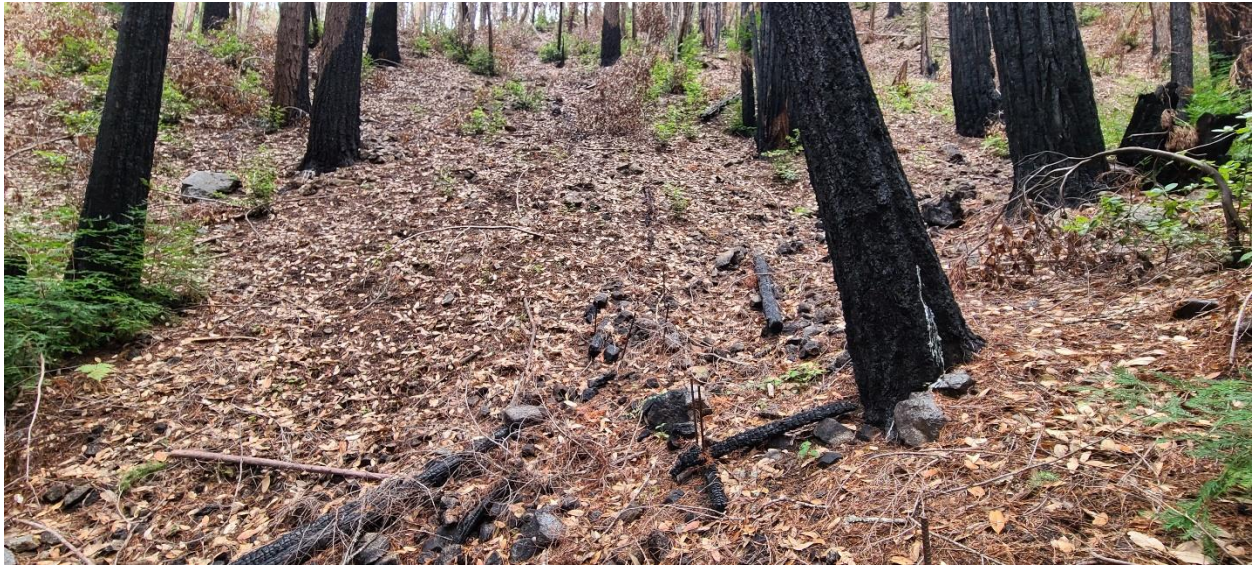
Unnamed tributary south of Lyon Tank (5-Mile): At this location the pipe extends about 350 feet straight up ~70% gradient slopes before reaching the bench on which the waterline continues along contour. Granitic bedrock appears to be at a shallow depth with bedrock locally exposed. The alignment is too steep for equipment, though a walking (spider) excavator (Menzi Muck) might be able to be winched up it. Regardless, the bench at the top of this reach can be accessed from the other direction.

***Photograph 12: Looking Up Steep 70% Fall Line Waterline Alignment
Above Unnamed Tributary south of Lyon Tank***

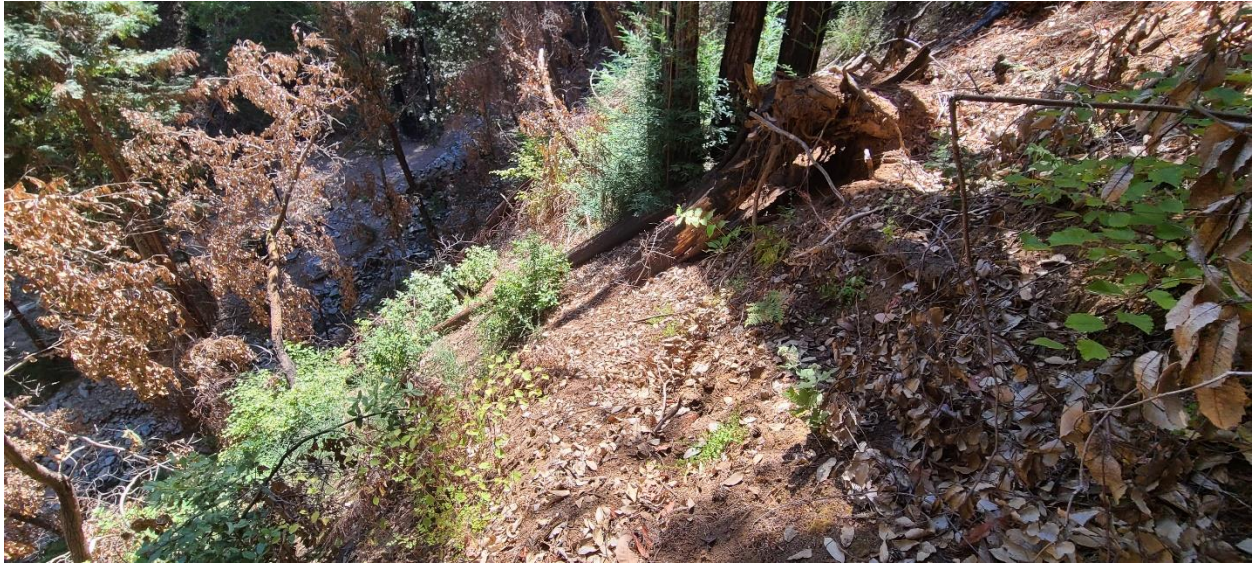
- **Foreman Creek (Peavine):** At this location the pipe angles steeply up the hillside for 350+ feet before reaching a bench in the topography where the waterline then contours across the hillside. The hillside that the waterline climbs is steep at 70% to 90% gradient. Shallow instability was observed along the steep streamside slopes of Foreman Creek. There is an intermittent narrow bench at 50% grade, which is generally too steep for small equipment to safely climb. The problem with this site is that the entire Peavine Waterline extending north past this site is inaccessible by equipment unless equipment can climb this slope, which is unlikely without significant engineering and construction effort to build new access roads that equipment can safely traverse.

**Photograph 13: Looking Down Steep 70% to 90% Fall Line
Waterline Alignment above Foreman Creek. Foreman Creek and
Adjacent Access Road are Visible towards the Center Left of the Photo.**
