## ENGINEERING COMMITTEE MEETING Minutes November 7, 2019

Reference: Lyon Tank Access Road Landslide Repair 365 Madrone Drive Boulder Creek, California

In accordance with the request of the San Lorenzo Valley Water District (SLVWD), Haro, Kasunich and Associates, Inc. (HKA) have performed a Geotechnical Investigation for the repair of the access road that services the Lyon Tank in Boulder Creek, California.

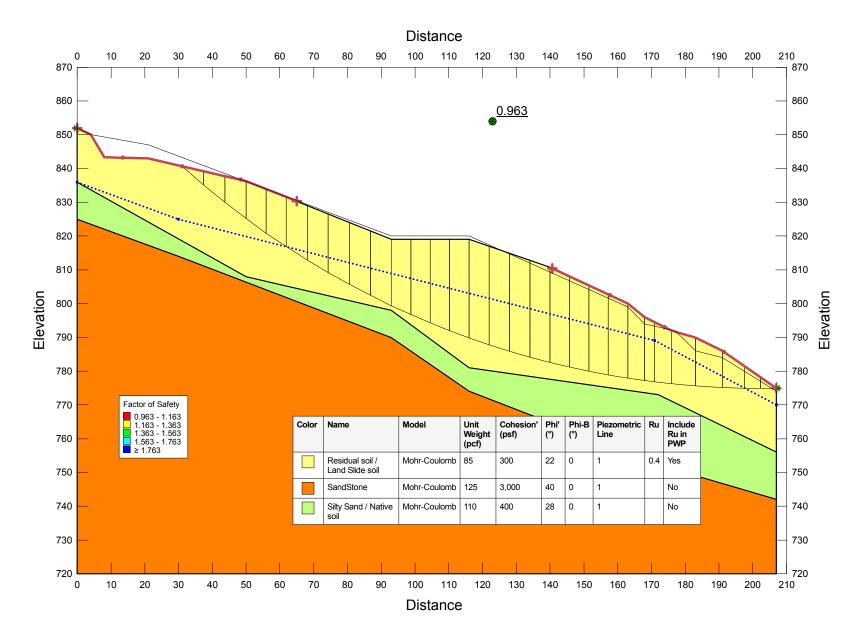
Figure No. 62

### Lyon Tank Slope Stability Safety Factor- Cross Section C3- Current Condition - Static

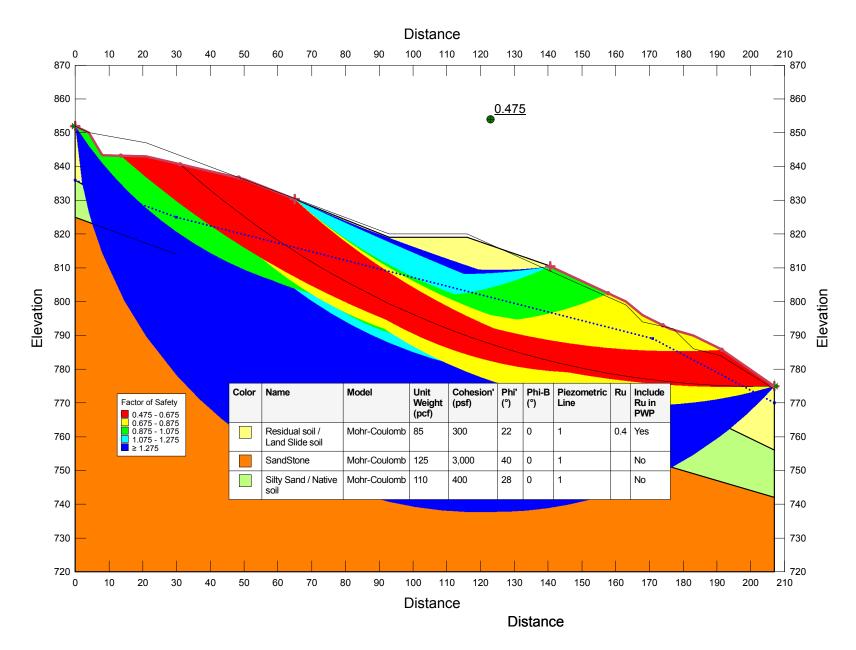
### Lyon Tank Slope Stability Safety Factor- Cross Section C3- Current Condition - Seismic

Note : The border of light blue and dark blue zones shows the thickness of the future probable landslide. (SF less than 1.1 in Figure No. 63 seismic condition are considered as instable slope.
