Olympia Conservation Area
Habitat Management and Monitoring Plan
2021 Annual Report
(TE58263C-0)

San Lorenzo Valley Water District
13060 Highway 9
Boulder Creek, CA 95006

January 2022

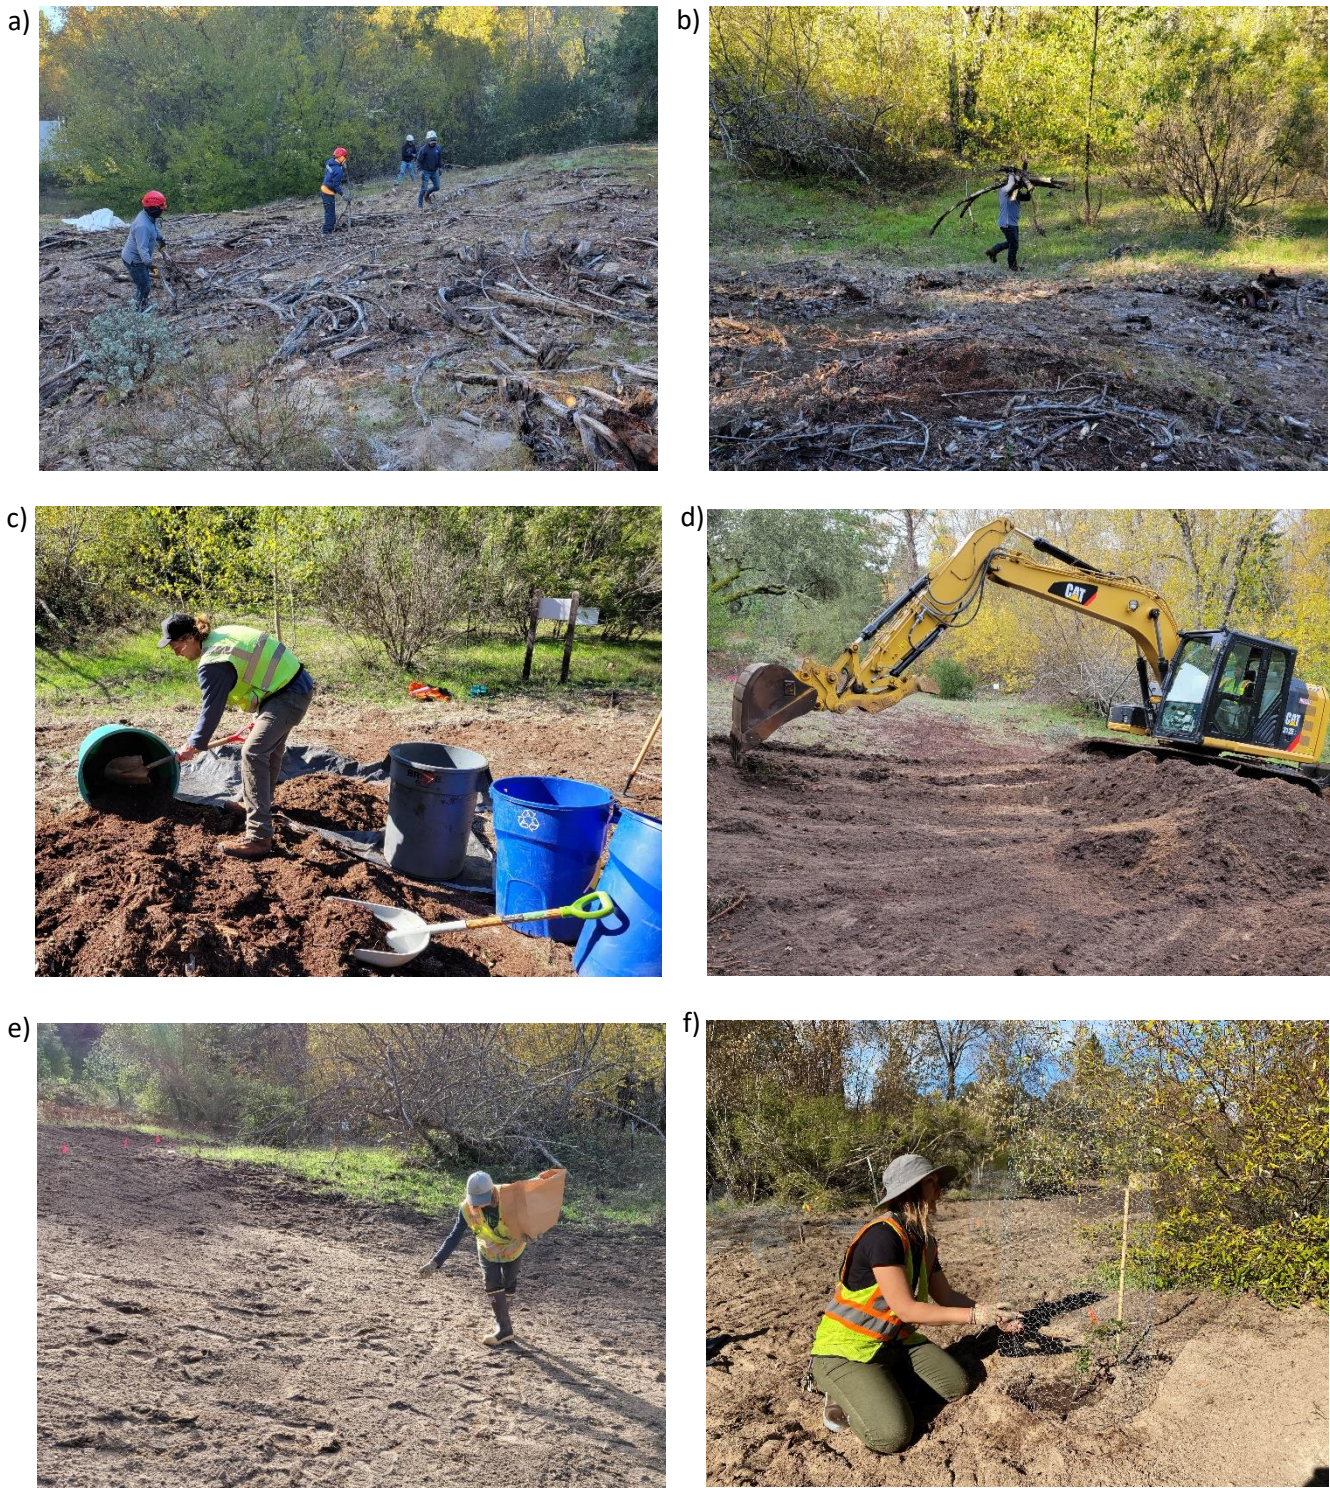
Figure 3: Restoration images, showing: a) and b) contractor removing acacia biomass from the 0.17-acre Restoration Area, c) JMc manually removing acacia debris from the Restoration Area, (d) contractor mechanically removal of remaining acacia biomass from the Restoration Area, e) JMc seeding of the Restoration Area, and (f) JMc planting of the oak trees on the perimeter of the restoration Area. Photographs by Jodi McGraw Consulting.

French broom and Portuguese broom were primarily removed through hand pulling (Figure 3a); a few larger individuals were pulled using weed wrenches. Prickly lettuce, Italian thistle, and velvet grass were grubbed out using a Pulaski. The grass was bagged, as were the flower heads of the thistles. All exotic plant biomass was hauled to the SLVWD yard on site at the Olympia Wellfield (Olympia Watershed Property) and was stacked on pavement.

On 12/21/21, JMc dispersed a total of 851.2 grams of site-collected seed of native plants (Table 2) within the treatment area (Figure 3e). Prior to seeding, the treatment area was raked to gently scarify the soil surface and create approximately 0.5" furrows designed to promote soil-to-seed contact and enhance seed germination. The seed mix was comprised of 20 herbs and subshrubs characteristic of the sand parkland community, which included two of the endangered species: Ben Lomond buckwheat and Ben Lomond spineflower. [Inclusion of Ben Lomond wallflower requires a permit to handle the seed of the state-listed endangered species.]

On December 21, 2021, JMc planted 15 coast live oaks (Figure 3f) to provide food for Mount Hermon June beetle. Though the species is a generalist (polyphagous; Hill and O'Malley 2009), *Polyphylla* larvae observed in areas that support Mount Hermon June beetle (and thus thought to be the endangered species) have been found in association with coast live oaks in Zayante soil (e.g., McGraw and Chrislock 2019, McGraw 2020). In order to maintain open canopy habitat required habitat, the trees were planted around the north/northeastern, western, and southwestern perimeter of the 0.17-acre restoration area along the ecotone with the riparian woodland (Figure 3f).
