**GEOTECHNICAL INVESTIGATION
FOR
LYON TANK ACCESS ROAD LANDSLIDE REPAIR
365 Madrone Drive
Boulder Creek, California**

**Prepared For
SAN LORENZO VALLEY WATER DISTRICT
Boulder Creek, California**

**Prepared By
HARO, KASUNICH AND ASSOCIATES, INC.
Geotechnical & Coastal Engineers
Project No. SC4090.3
August 2019**

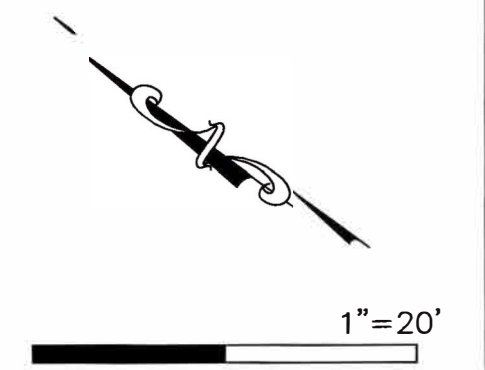
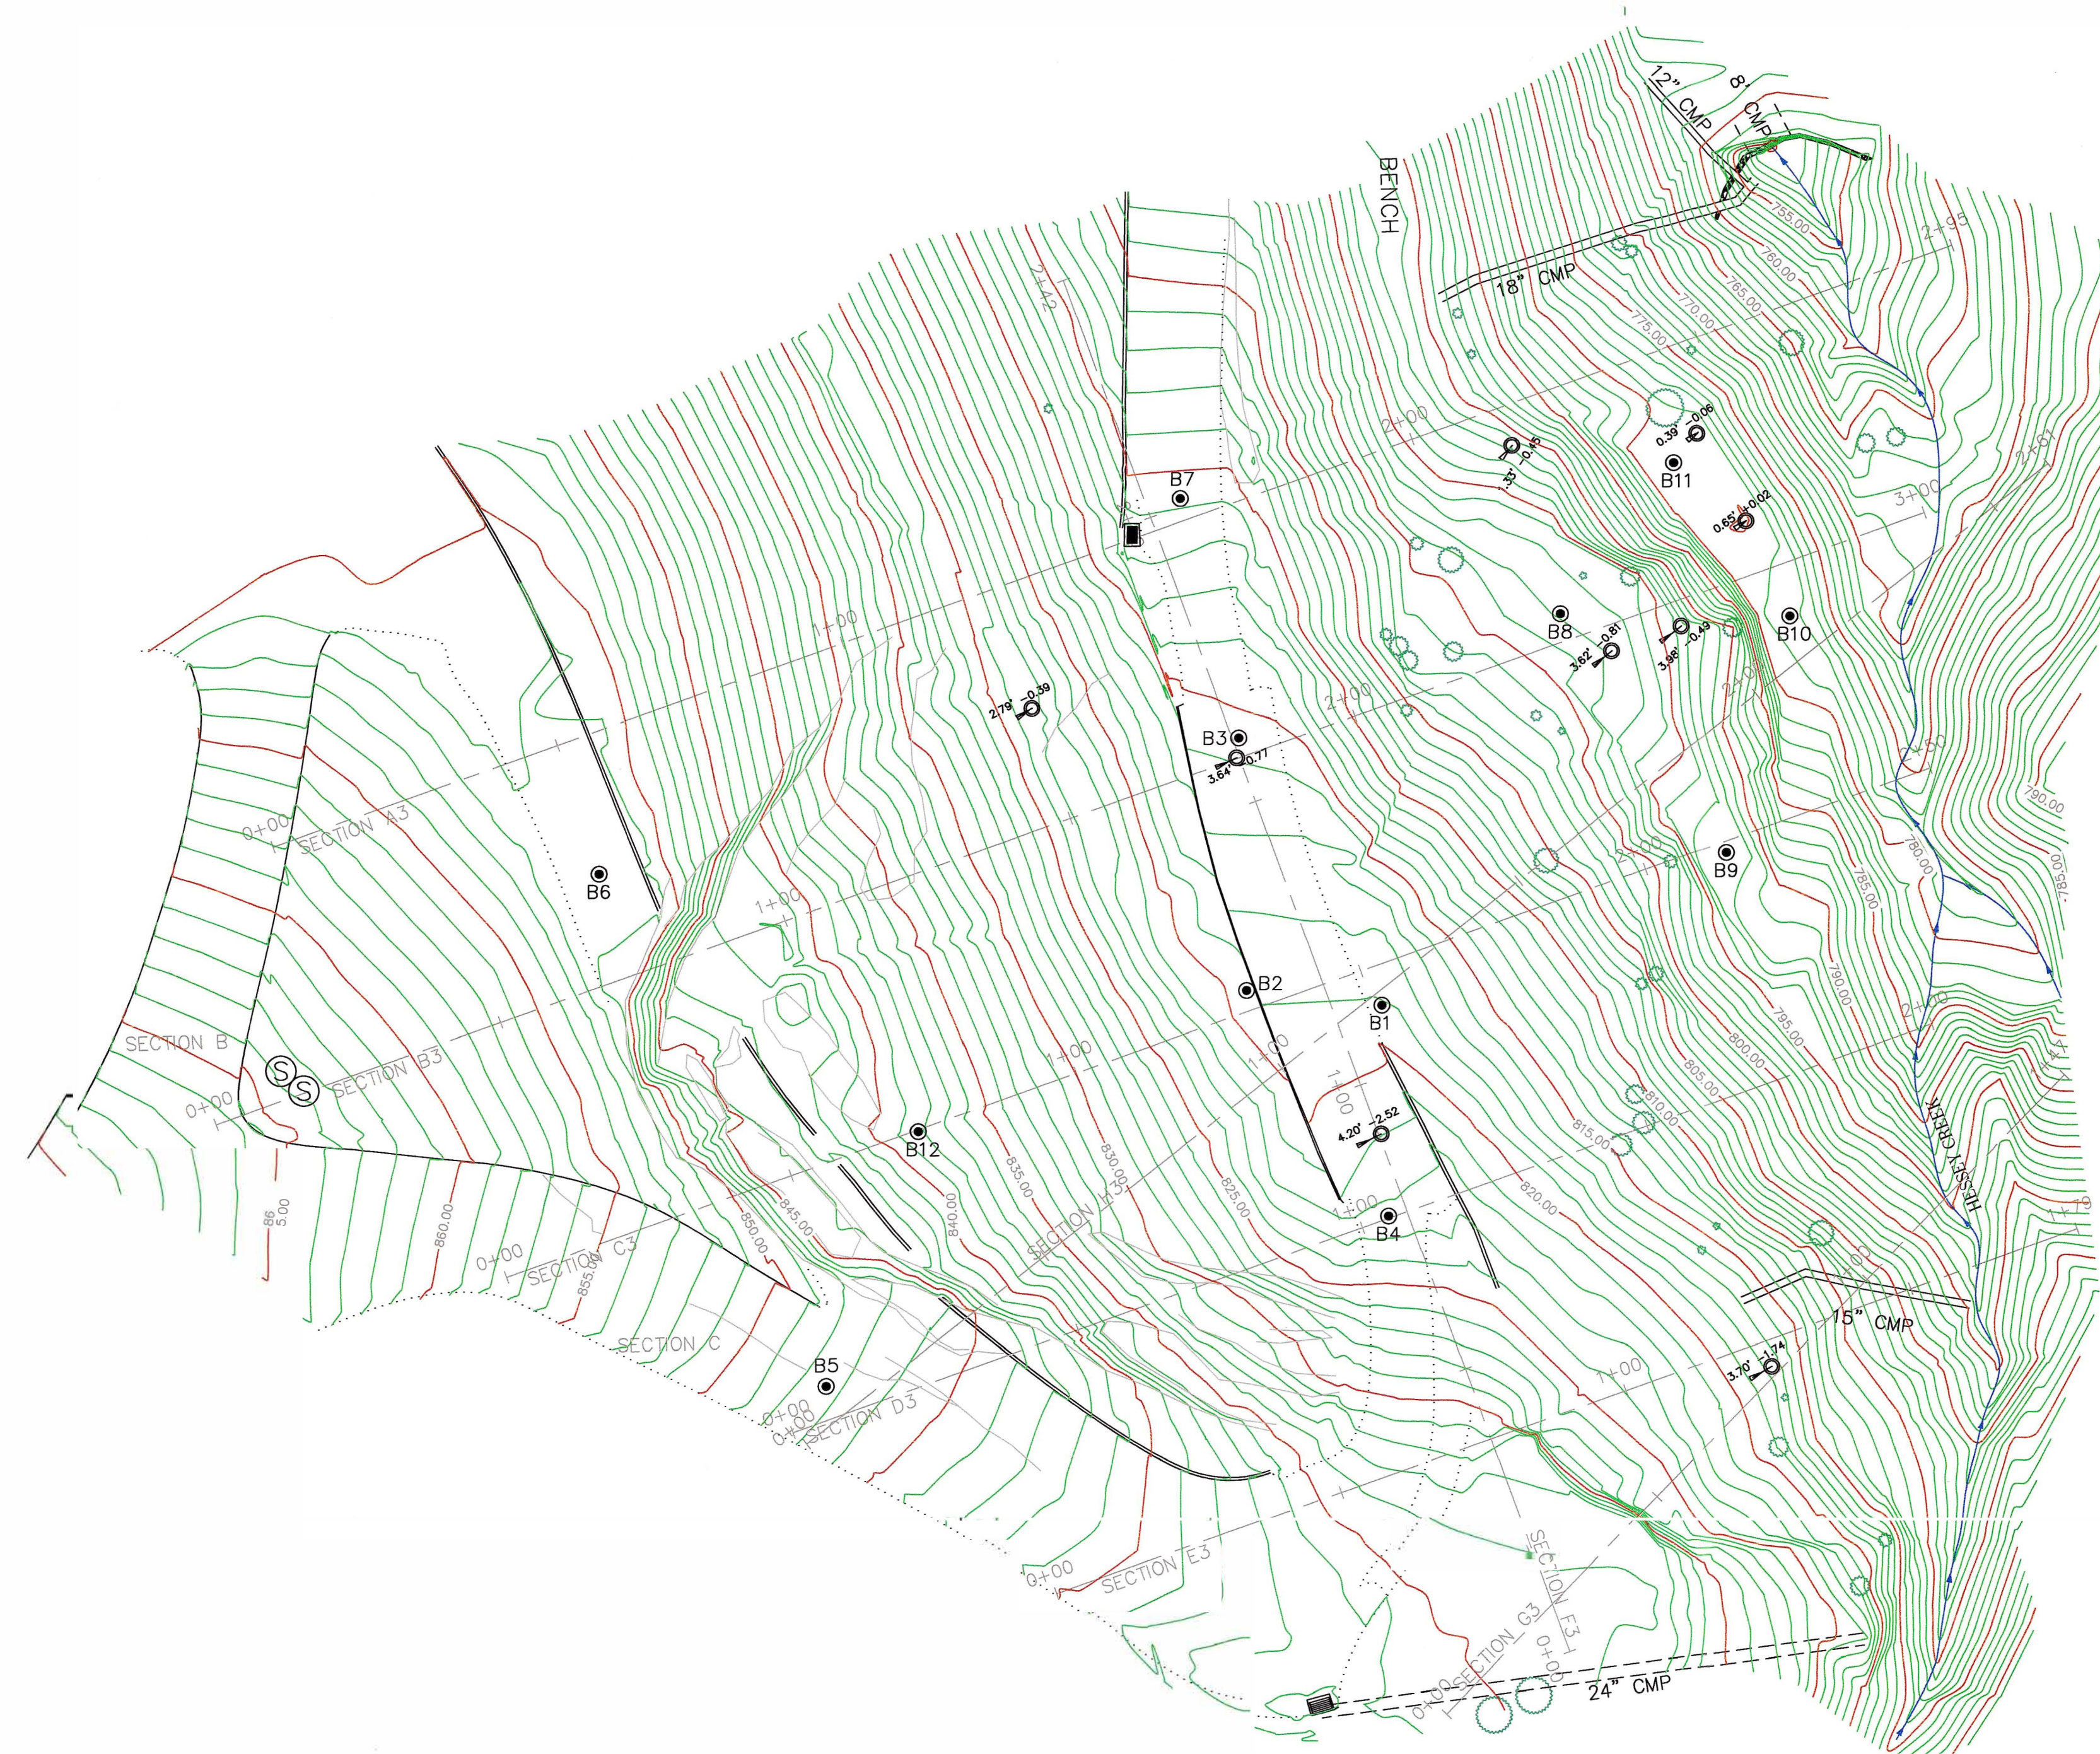
FIGURE NO. 54

- LEGEND:**
- = EXPOSED FISSURE
OCTOBER 17, 2017
 - = EDGE OF PAVEMENT
 - ⊙ = SEPTIC MANHOLE
 - = BORE SITE
 - = MONITORING POINT
 - = MOVEMENT OF MONITORING
POINT SINCE FEBRUARY 25, 2017

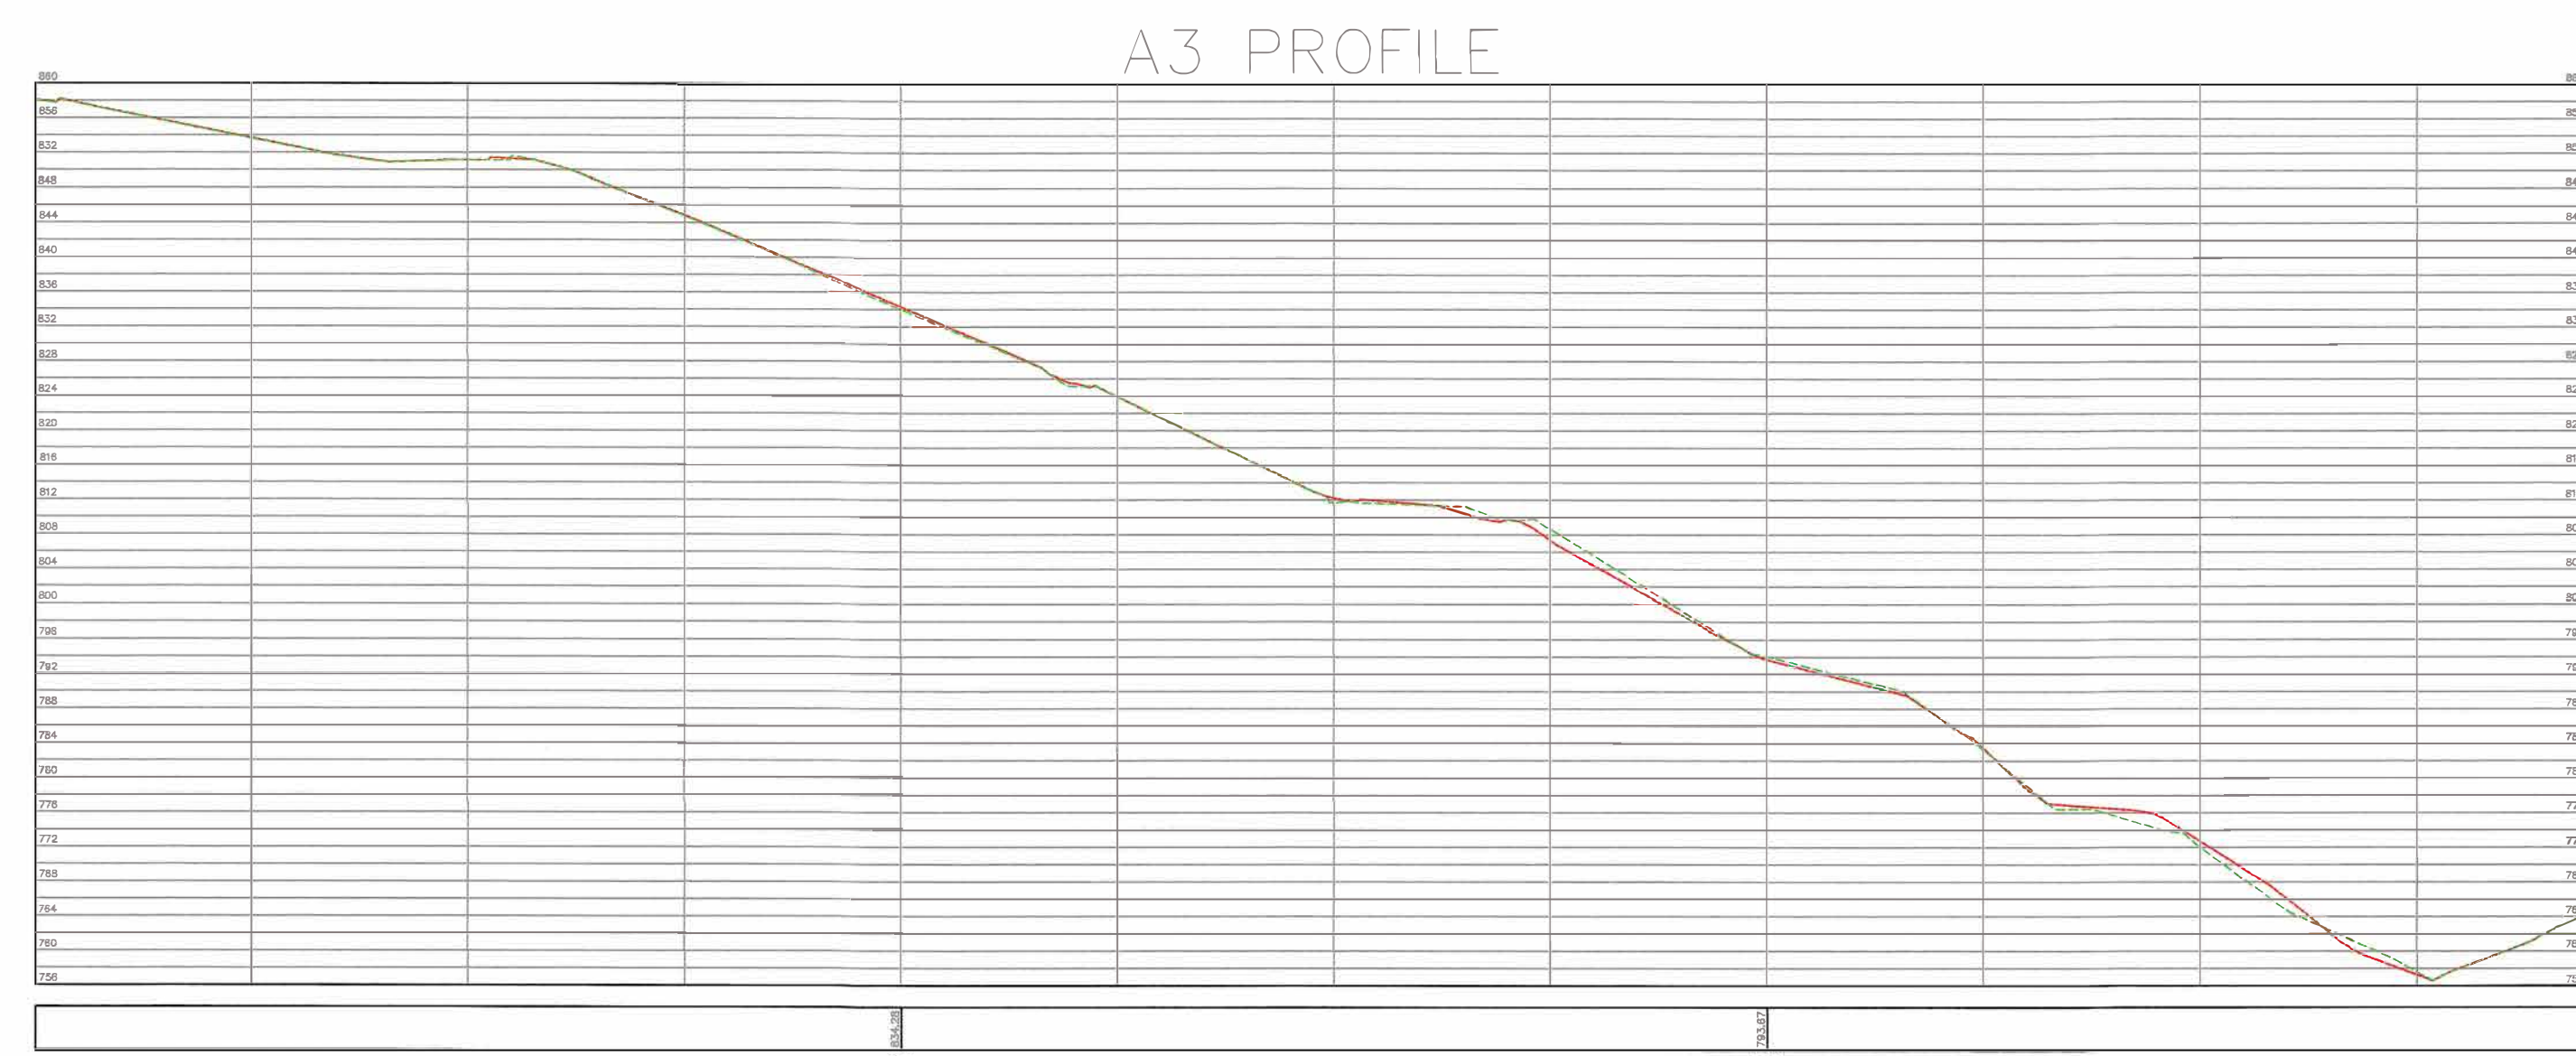
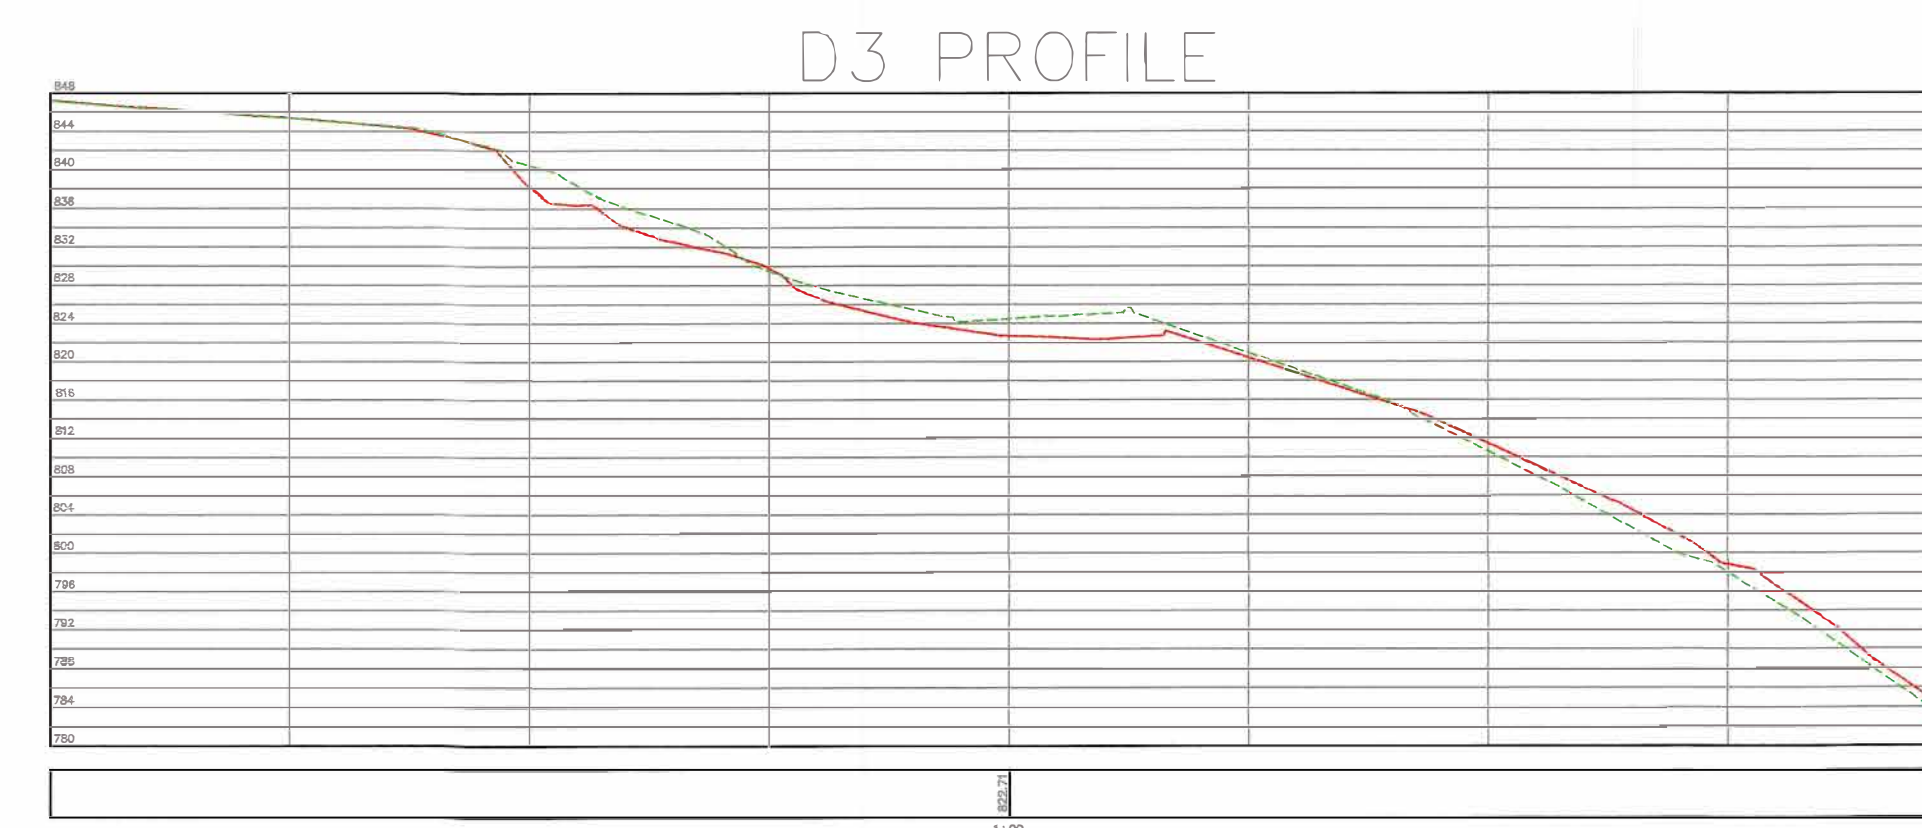
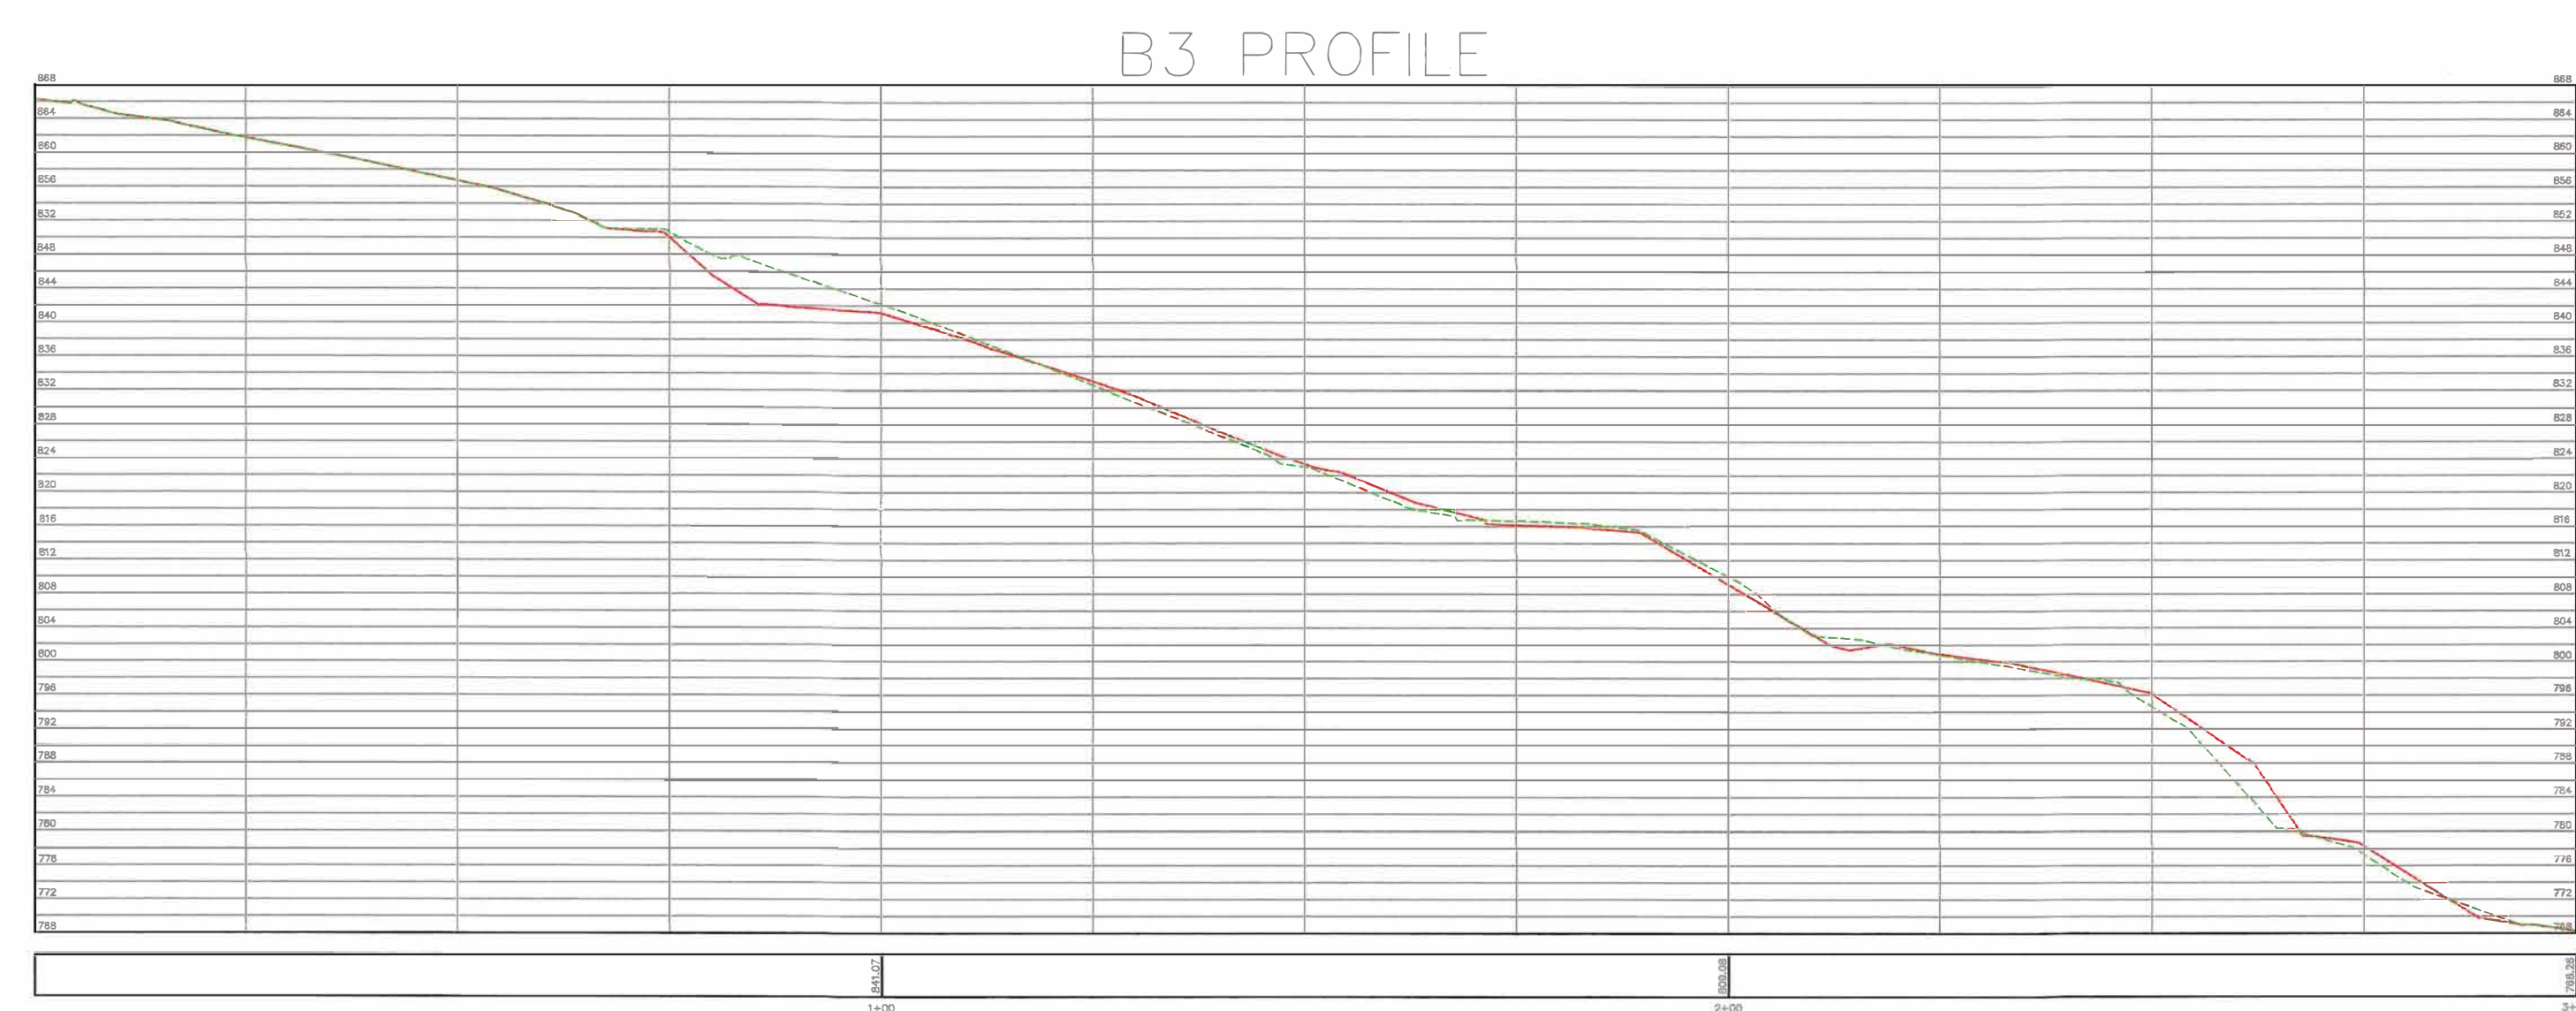
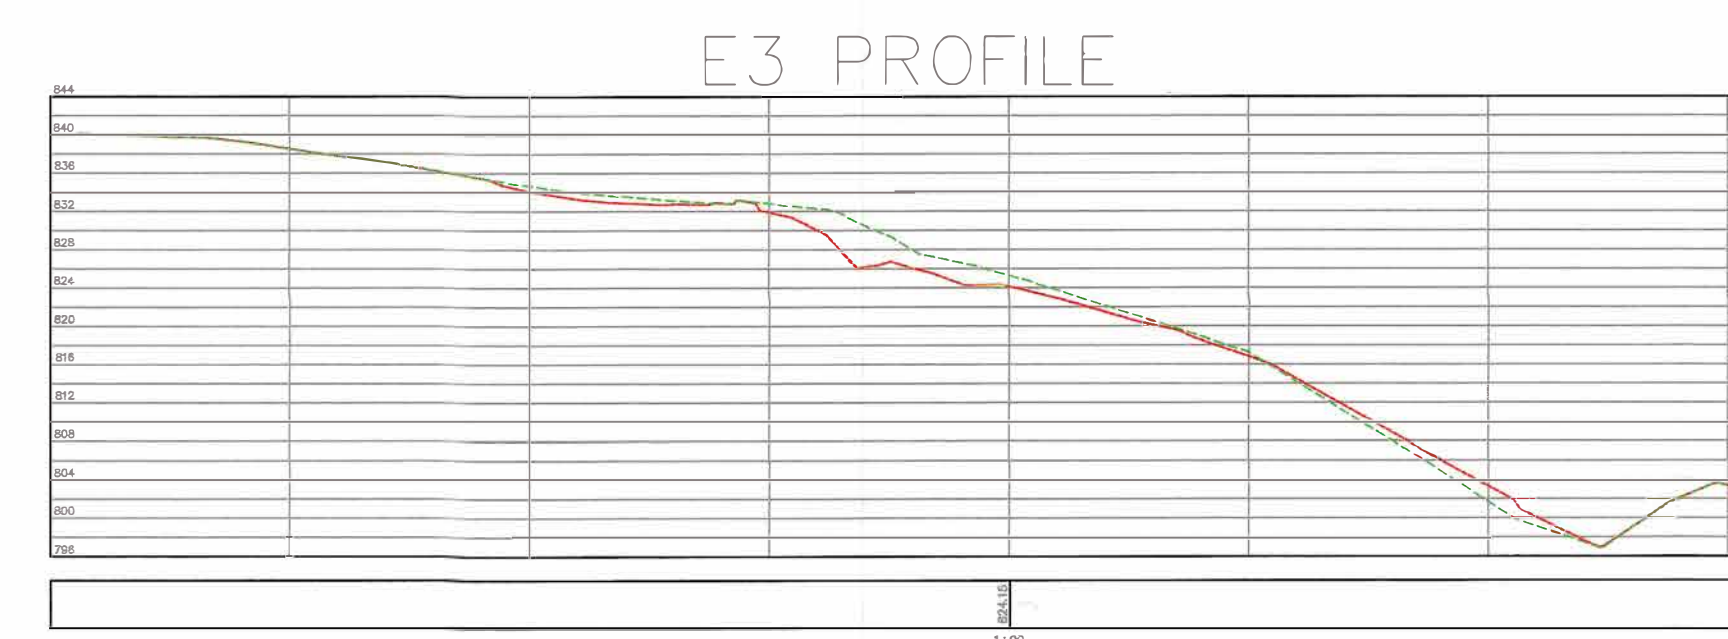
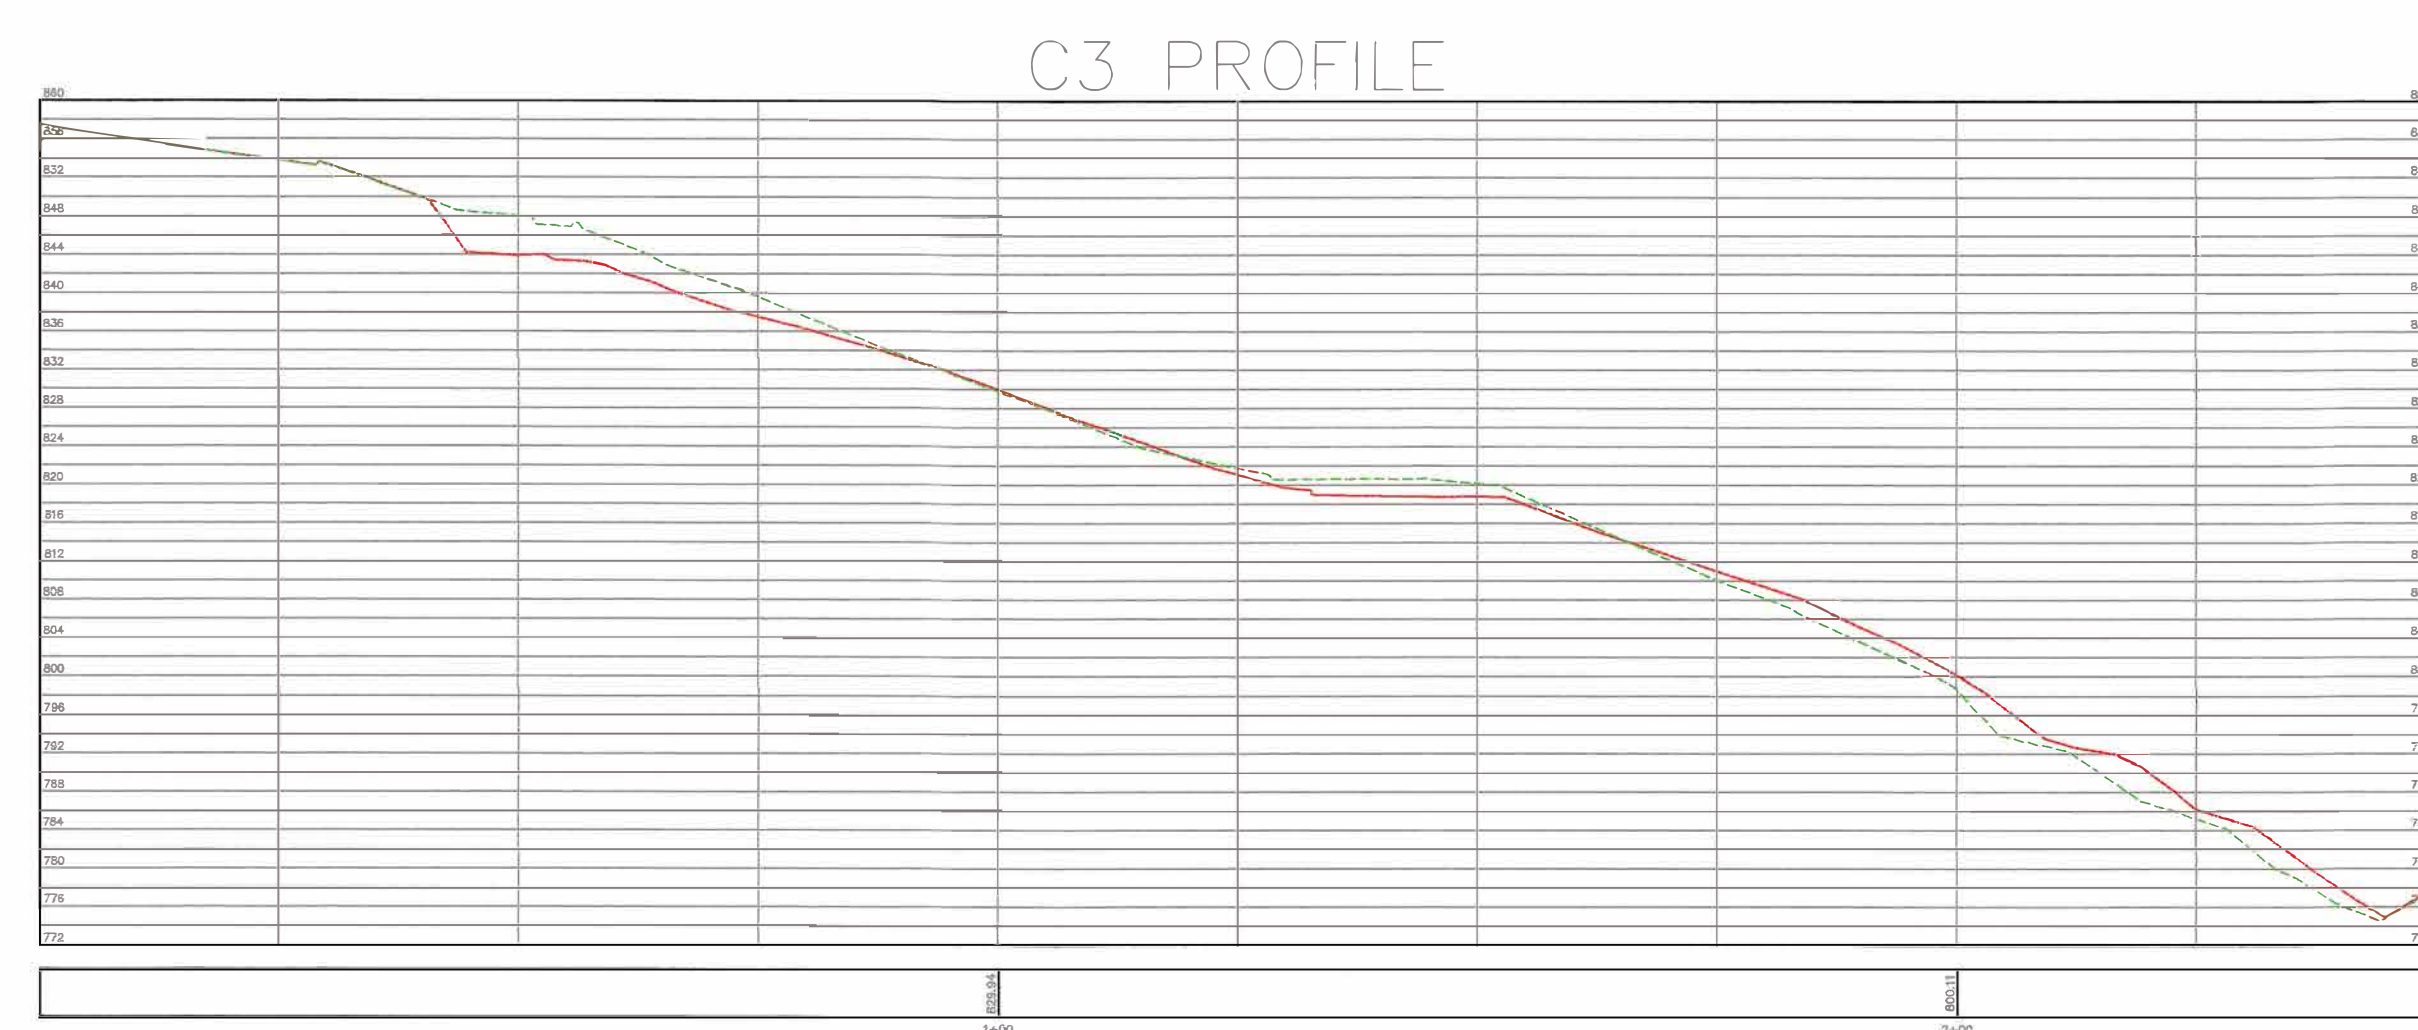
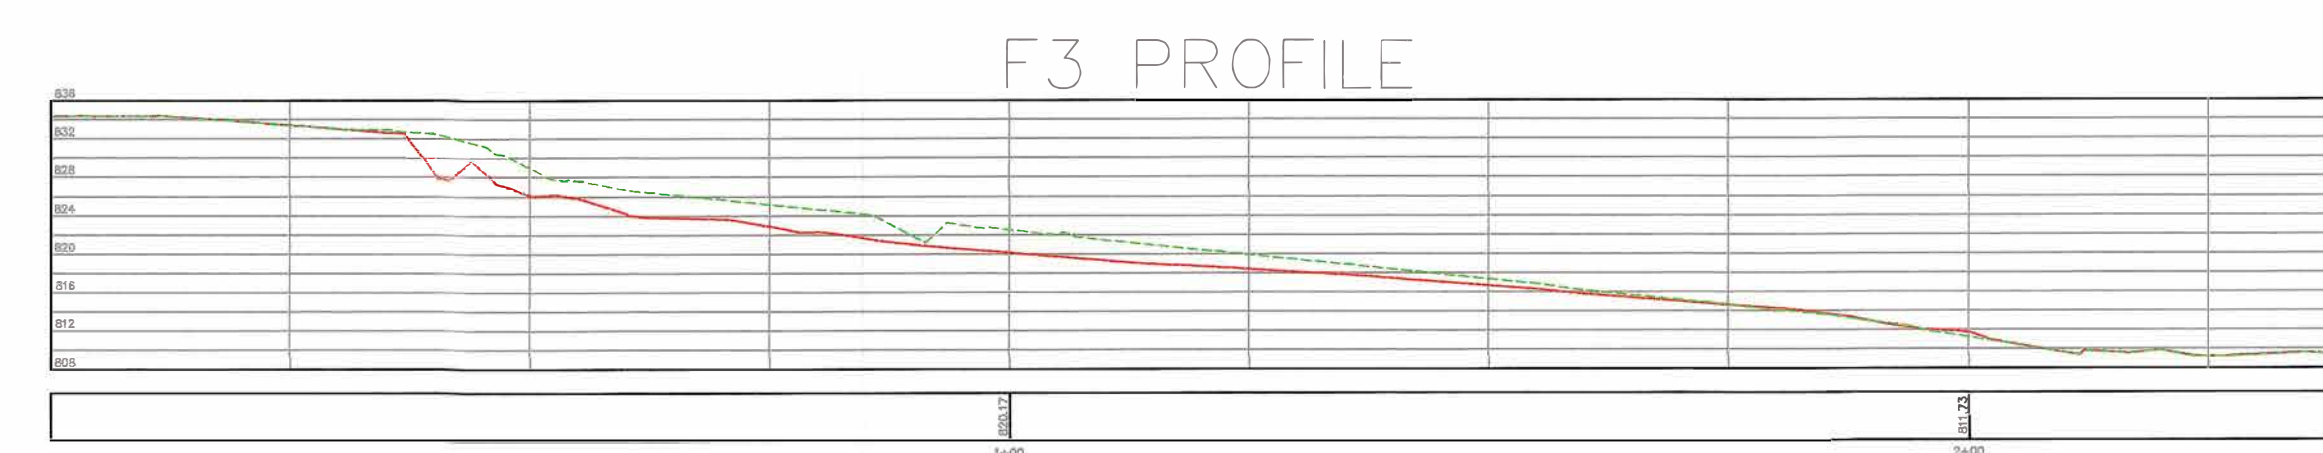
FIGURE NO. 59

----- = CROSS SECTION PER FEBRUARY 25, 2017 SURVEY
————— = CROSS SECTION PER JUNE 03, 2017 SURVEY
