Watershed Emergency Response Team Evaluation

CZU LIGHTNING COMPLEX

CA-CZU-005205

October 1, 2020

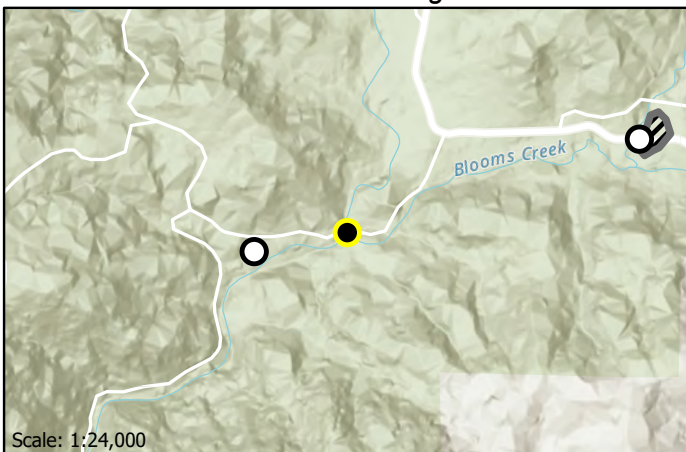
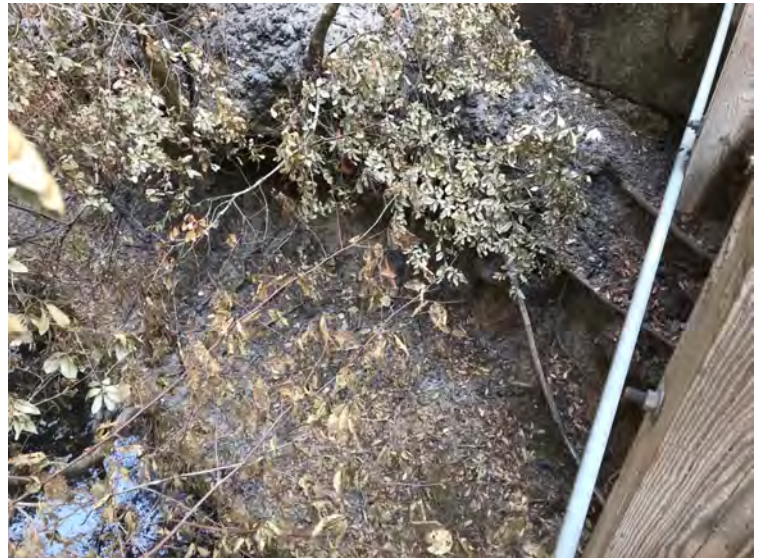
Field Observation Scour along eastern abutment. Landslides visible on hillshade along upstream
or Potential Hazard: slopes.

Potential Hazard to Life: **low**

Potential Hazard to Property: **low**

Description: NA

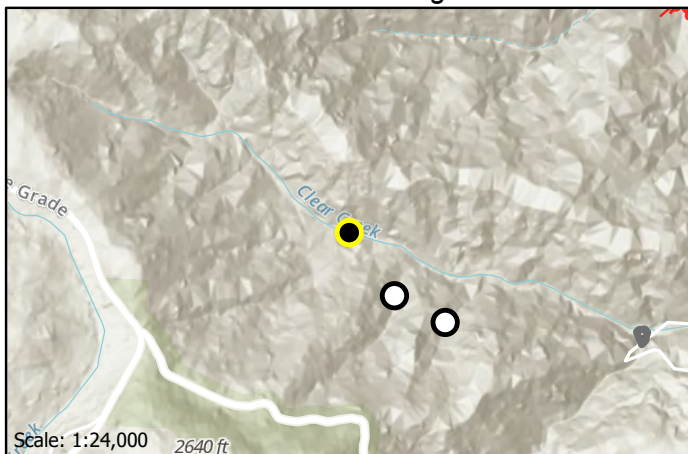
Field Observation impacts to San Lorenzo Valley water intake
or Potential Hazard:

Potential Hazard to Life: **low**

Potential Hazard to Property: **high**

Description: prepare for increased dissolved organics

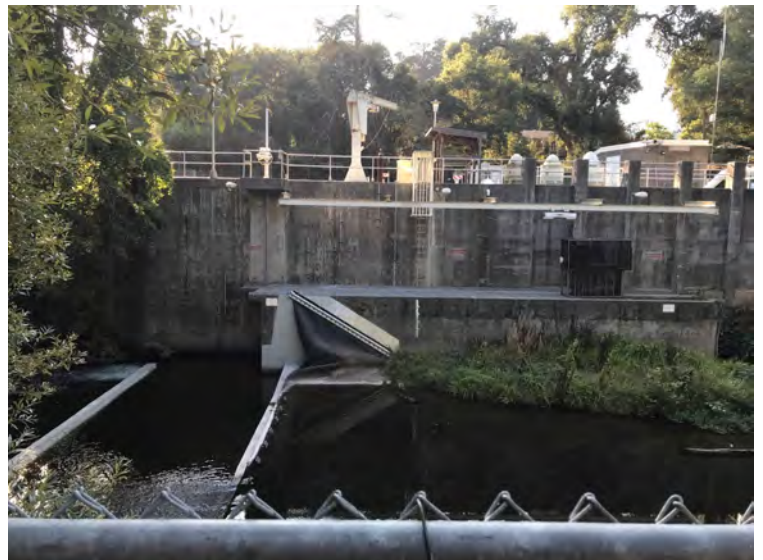
Field Observation Post-fire runoff could result in excessive organic that would impair water or Potential Hazard: treatment.

Potential Hazard to Life: **low**

Potential Hazard to Property: **moderate**

Description: Prepare for increased organics

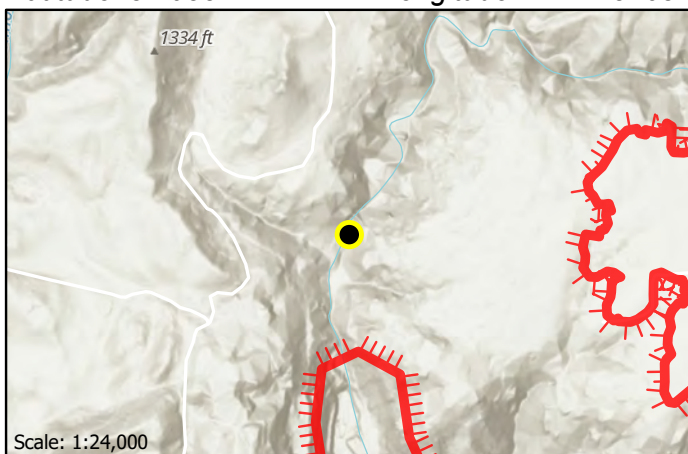
Field Observation or Potential Hazard: Potential for sedimentation, possible impacts to water quality

Potential Hazard to Life: low

Potential Hazard to Property: low

Description: Prepare for increased organics

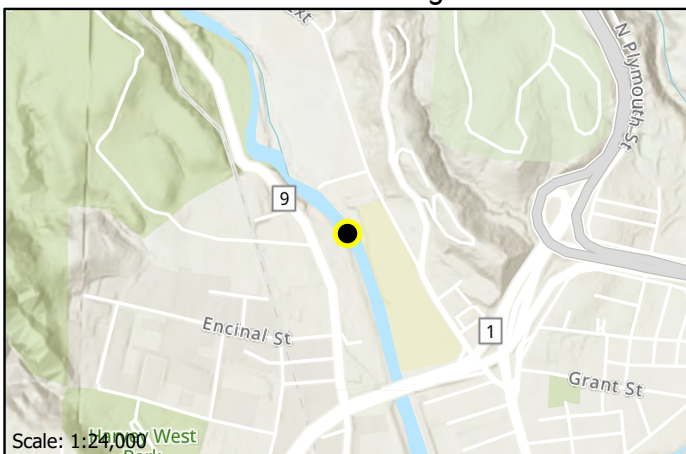
Field Observation Post-fire runoff could result in excessive organic that would impair water or Potential Hazard: treatment.

Potential Hazard to Life: **low**

Potential Hazard to Property: **moderate**

Description: Prepare for increased organics

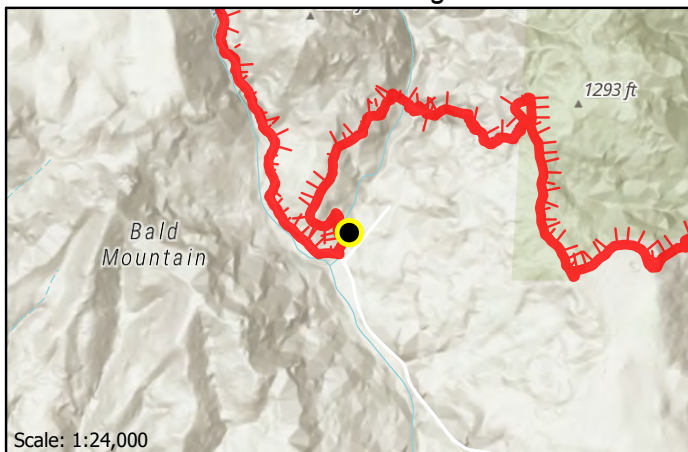
Field Observation Impacts to water quality at City of Santa Cruz water intake
or Potential Hazard:

Potential Hazard to Life: moderate

Potential Hazard to Property: low

Description: Prepare for increased organics

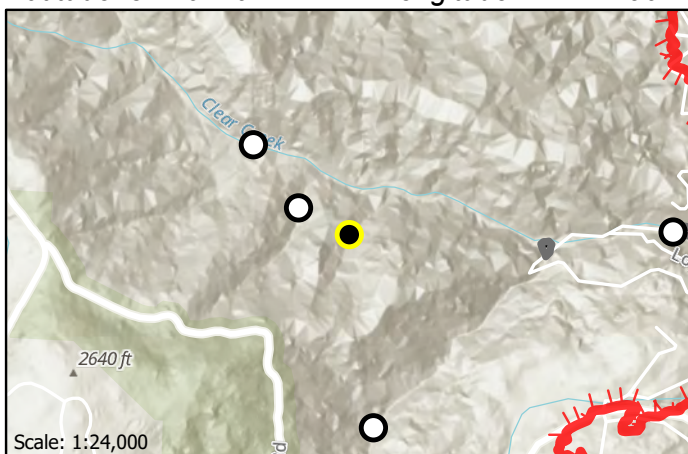
Field Observation Imapcts to San Lorenzo Valley water intake
or Potential Hazard:

Potential Hazard to Life: **low**

Potential Hazard to Property: **high**

Description: prepare for increased dissolve organics

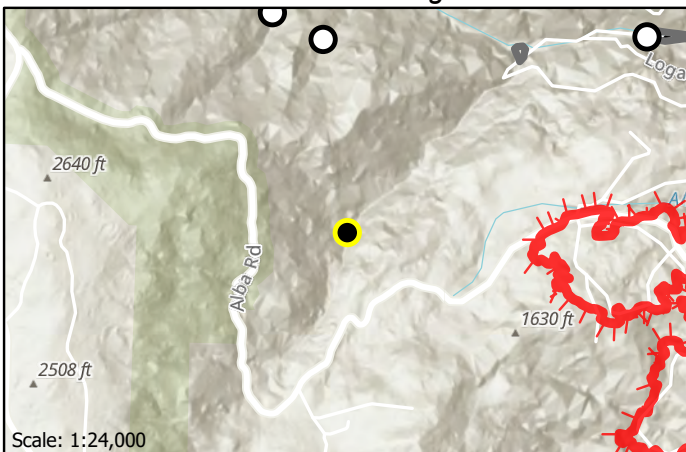
Field Observation impacts to San Lorenzo Valley water intake
or Potential Hazard:

Potential Hazard to Life: **low**

Potential Hazard to Property: **high**

Description: Prepare for increased dissolved organics

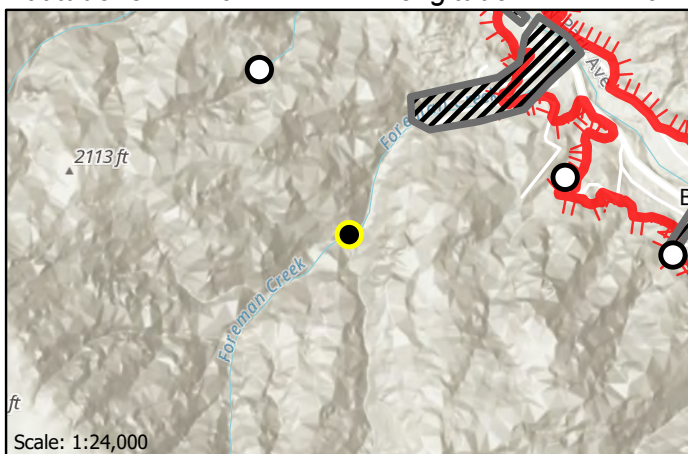
Field Observation impacts to San Lorenzo Valley water intake
or Potential Hazard:

Potential Hazard to Life: **low**

Potential Hazard to Property: **high**

Description: prepare for increased dissolved organics

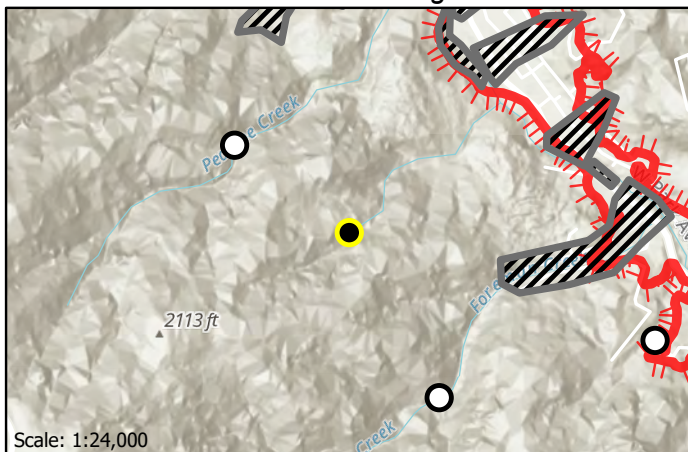
Field Observation impacts to San Lorenzo Valley water intake
or Potential Hazard:

Potential Hazard to Life: **low**

Potential Hazard to Property: **high**

Description: prepare for increased dissolved organics

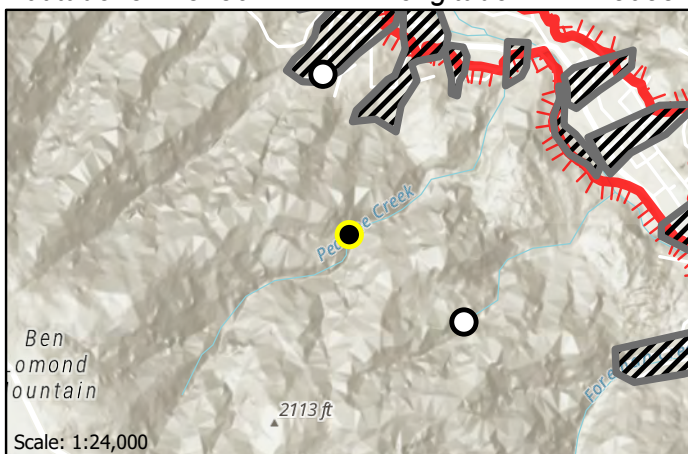
Field Observation impacts to San Lorenzo Valley water intake
or Potential Hazard:

Potential Hazard to Life: **low**

Potential Hazard to Property: **high**

Description: prepare for increased dissolved organics

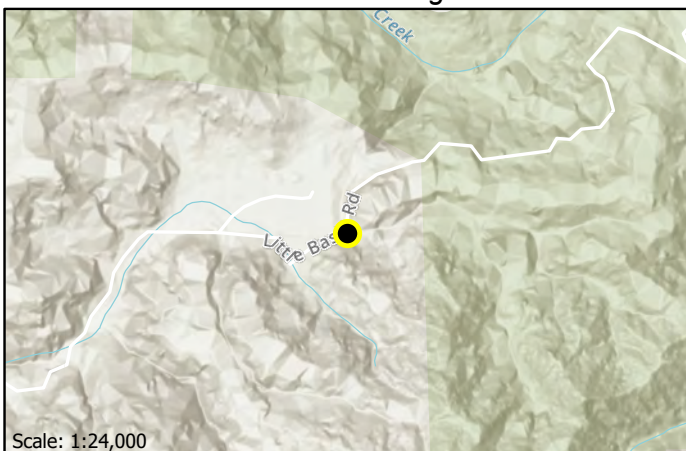
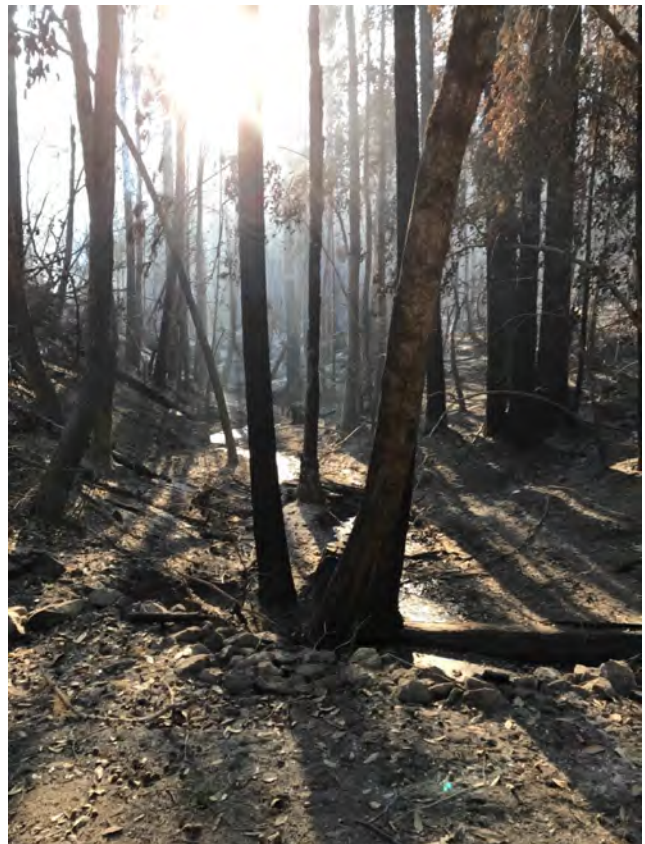
Field Observation or Potential Hazard: Culvert along Little Basin Road has potential plug and washout. Drainage contains moderate to steep slopes, with a moderate to high debris flow potential. Rockfall also observed along the road in the vicinity of the crossing.

Potential Hazard to Life: high

Potential Hazard to Property: low

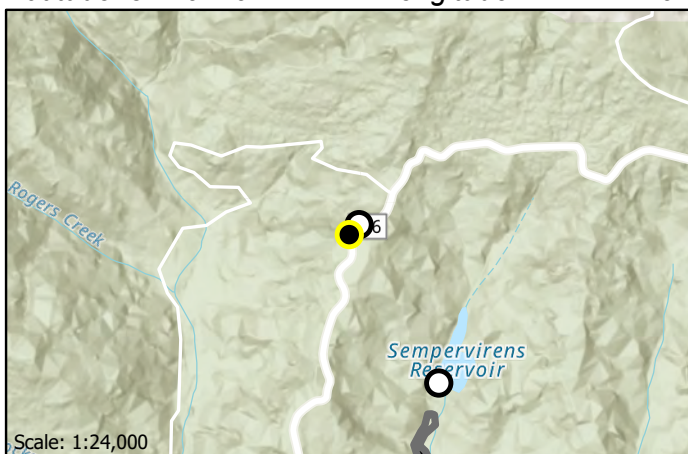
Field Observation Approximately 150 feet of retaining wall is damaged
or Potential Hazard:

Potential Hazard to Life: **low**

Potential Hazard to Property: **moderate**

Description: Further evaluation should be made by a PE or PG

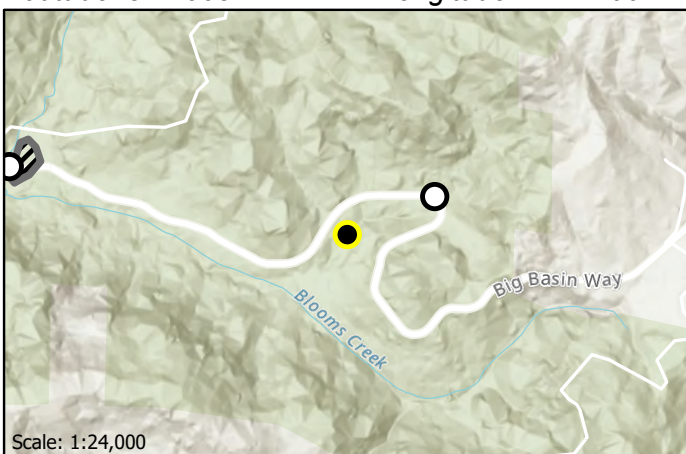
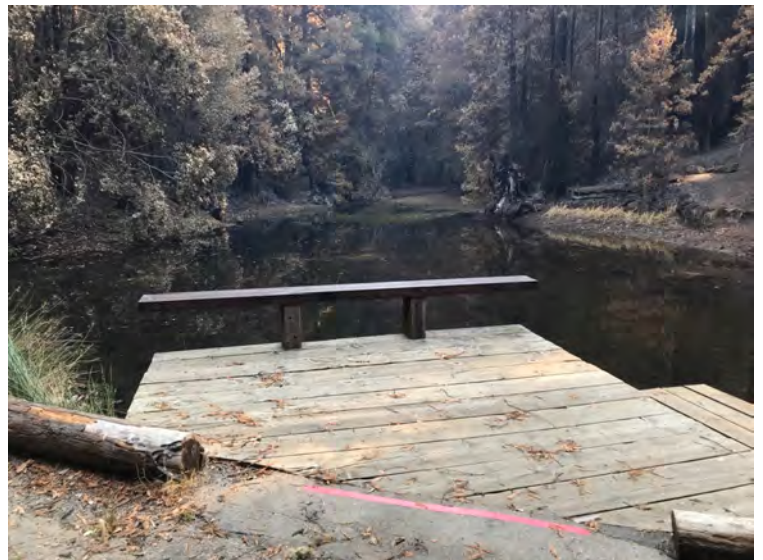
Field Observation or Potential Hazard: Retention pond along paved access road has potential to overtop and divert towards residence. Moderate to steep slopes upstream, with a moderate to high potential for debris flows.

Potential Hazard to Life: **moderate**

Potential Hazard to Property: **moderate**

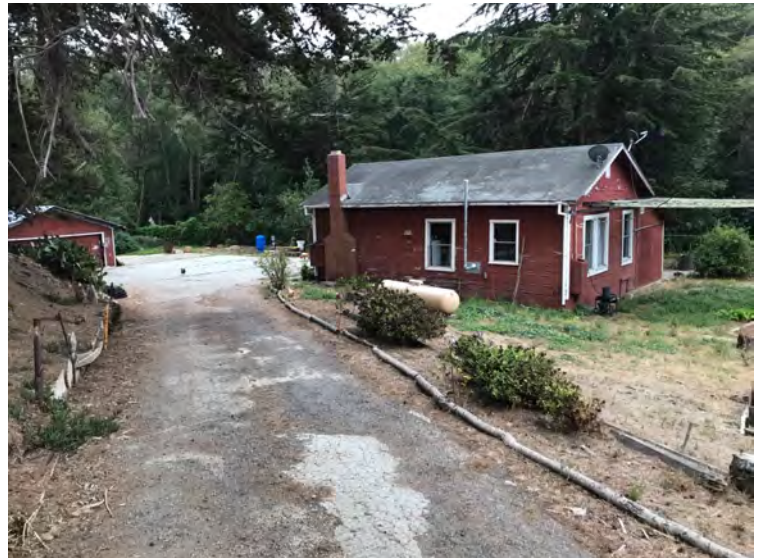
Field Observation House within floodplain, large portion of upstream watershed located within burn or Potential Hazard: area.

Potential Hazard to Life: **moderate**

Potential Hazard to Property: **moderate**

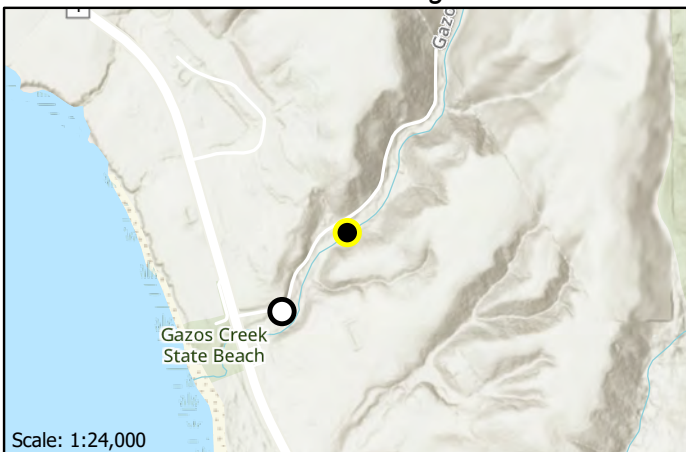
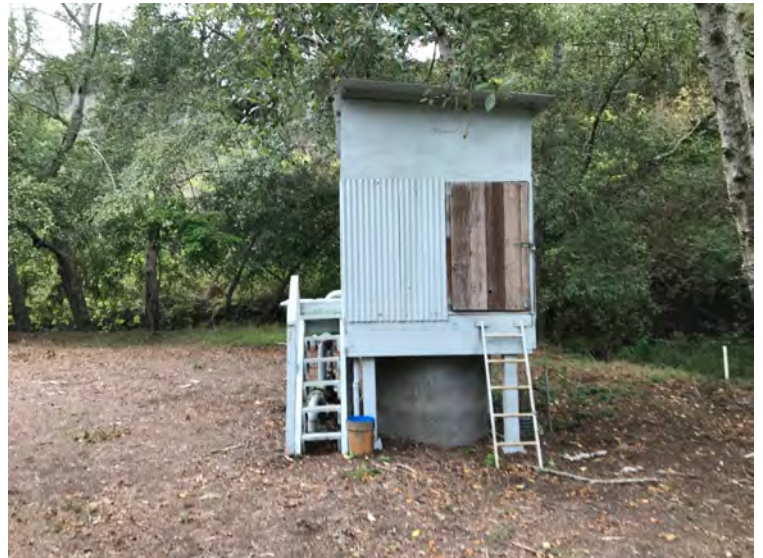
Field Observation Well house and associated equipment within floodplain. Large portion of
or Potential Hazard: upstream watershed located in burn area.

Potential Hazard to Life: **low**

Potential Hazard to Property: **moderate**

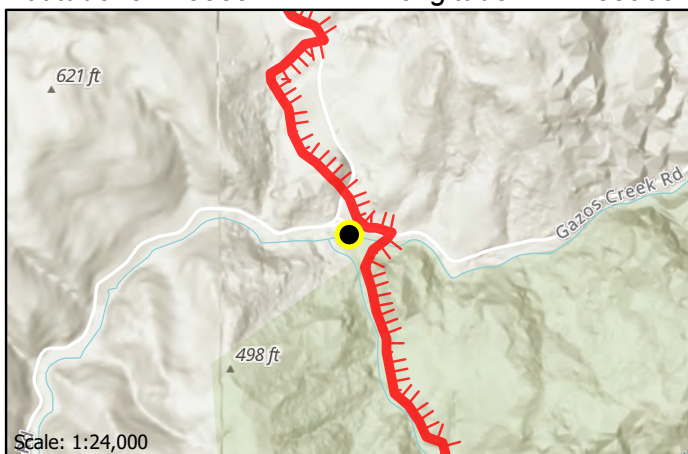
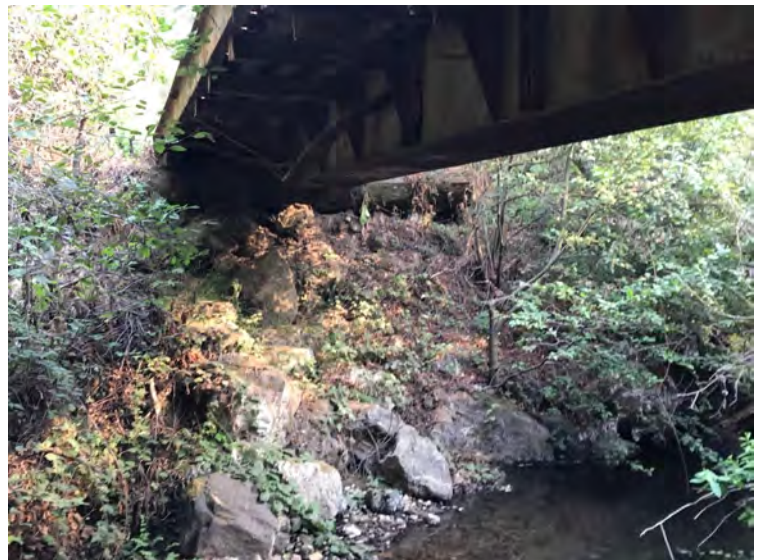
Field Observation Flooding/debris jam has potential to overtop bridge. Bridge founded on sill logs
or Potential Hazard: located immediately above channel slope along northern abutment.

Potential Hazard to Life: **low**

Potential Hazard to Property: **moderate**

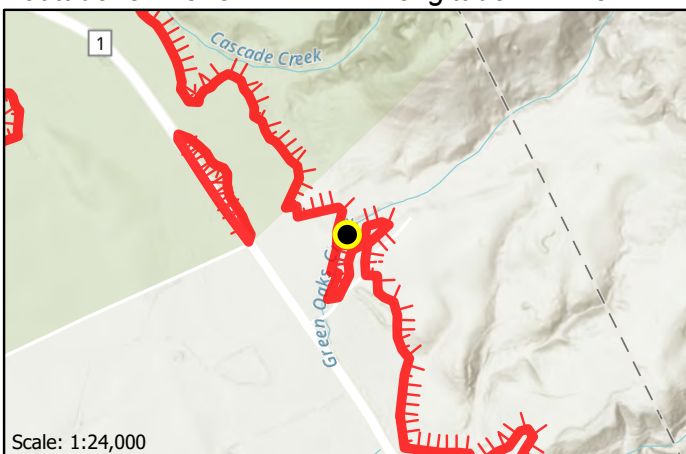
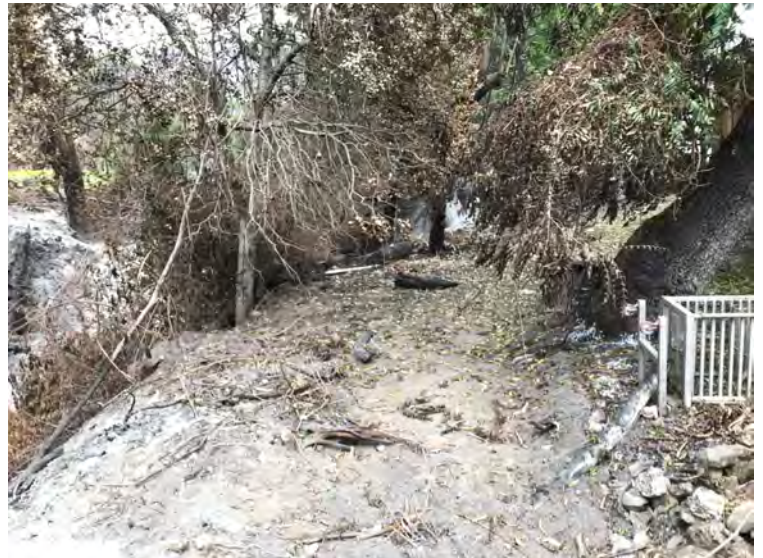
Field Observation Upstream watercourse mapped as a moderate to high potential for debris flows.
or Potential Hazard: Watercourse contains large amounts of debris. Classroom buildings within lower portion of the property are located adjacent to watercourse.

Potential Hazard to Life: **low**

Potential Hazard to Property: **moderate**

Description: Temporary Closure

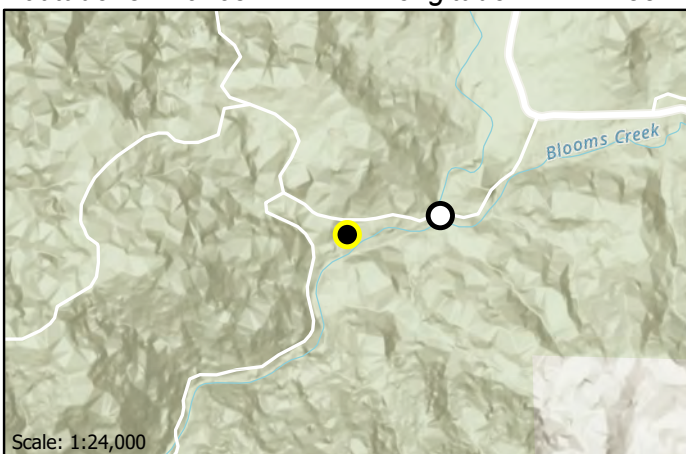
Field Observation Moderate to steep slopes above with moderate burn severity, potential for
or Potential Hazard: shallow debris slides to impact facility

Potential Hazard to Life: **low**

Potential Hazard to Property: **moderate**

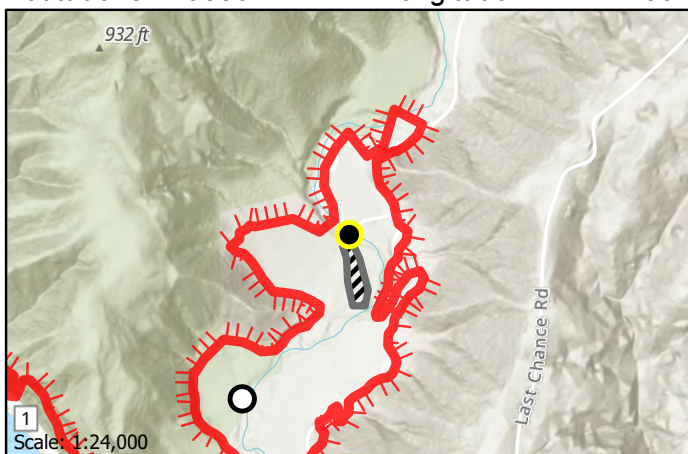
Field Observation Flooding could impact the bridge, large watershed upstream.
or Potential Hazard:

Potential Hazard to Life: **low**

Potential Hazard to Property: **moderate**

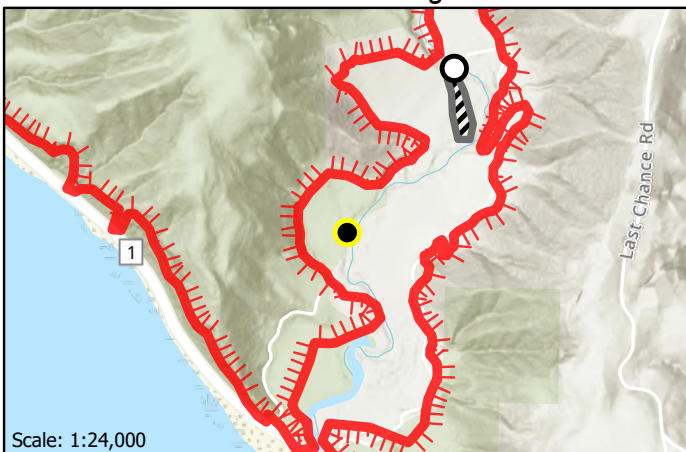
Field Observation or Potential Hazard: Flooding could impact the bridge, large watershed upstream.

Potential Hazard to Life: **low**

Potential Hazard to Property: **moderate**

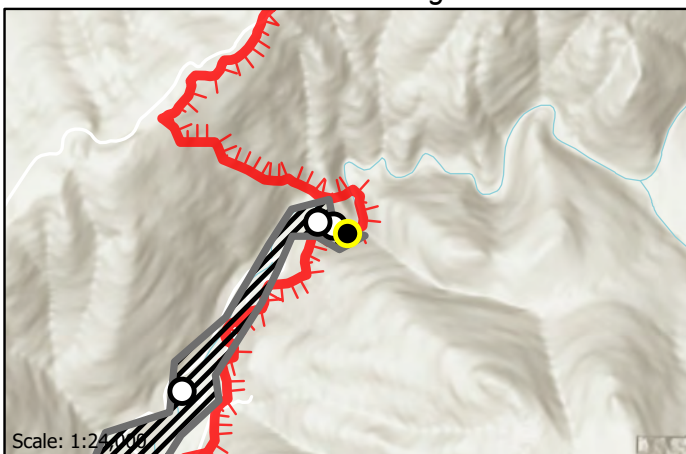
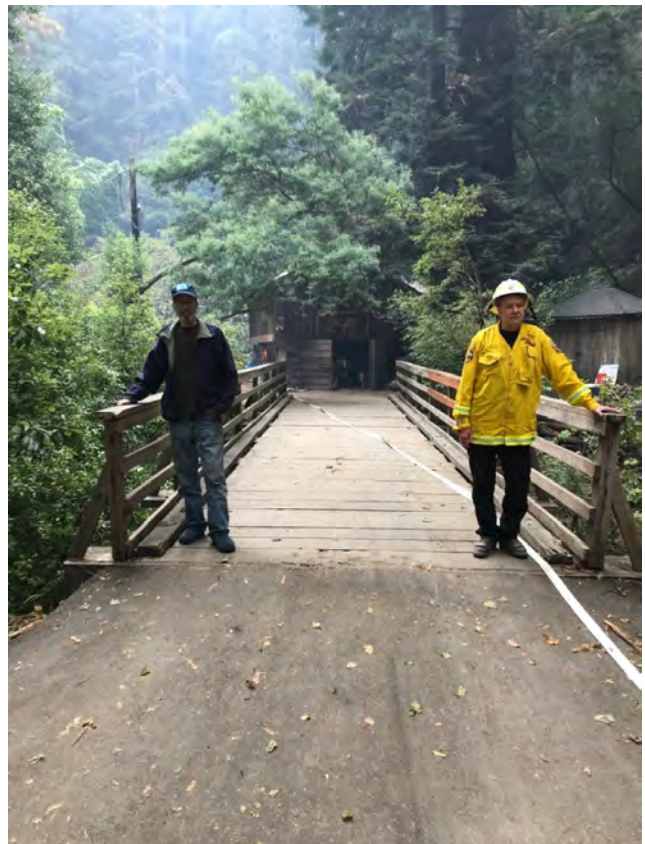
Field Observation Flooding could impact bridge. Large portion of upstream watershed located in
or Potential Hazard: burn area.

Potential Hazard to Life: **low**

Potential Hazard to Property: **moderate**

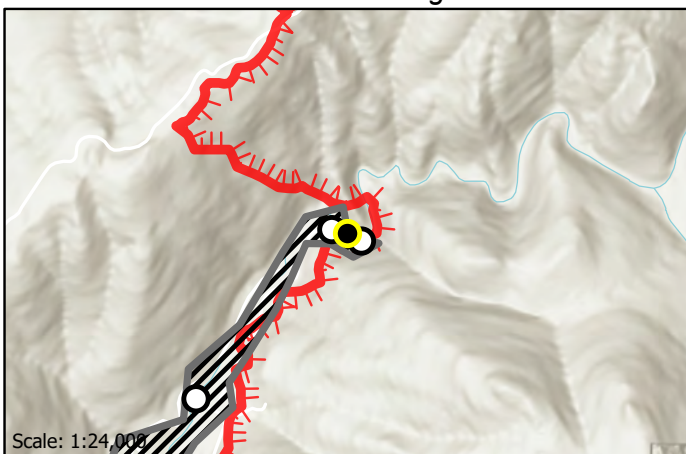
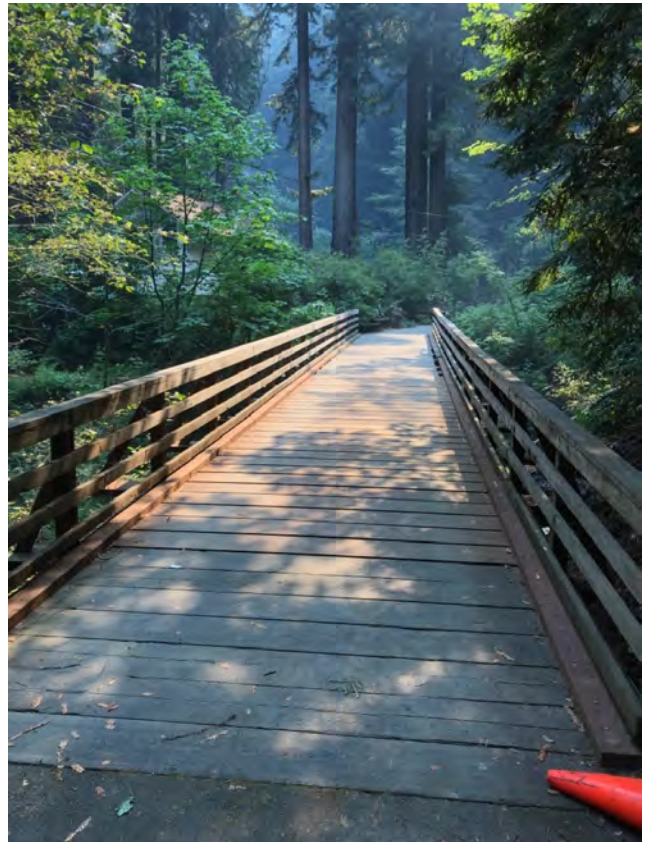
Field Observation Flooding could impact bridge. Large portion of upstream watershed located in
or Potential Hazard: burn area.

Potential Hazard to Life: **low**

Potential Hazard to Property: **moderate**

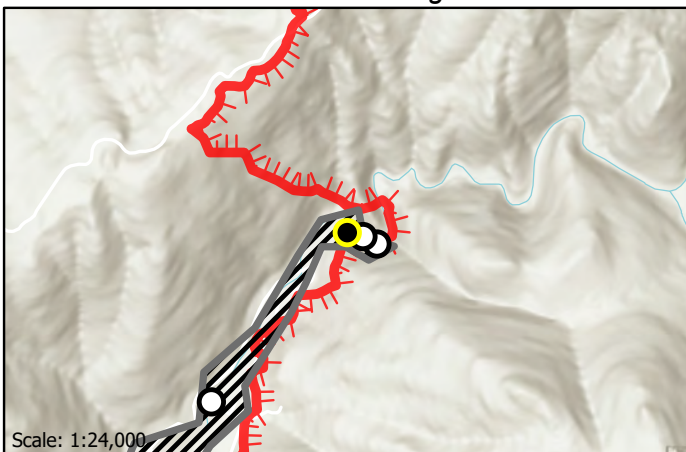
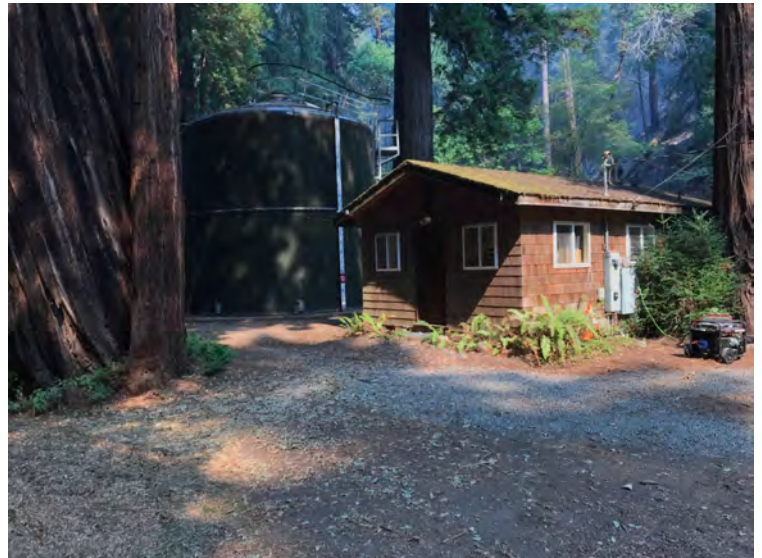
Field Observation Community water tanks, pump house and purification system within floodplain
or Potential Hazard:

Potential Hazard to Life: **low**

Potential Hazard to Property: **moderate**

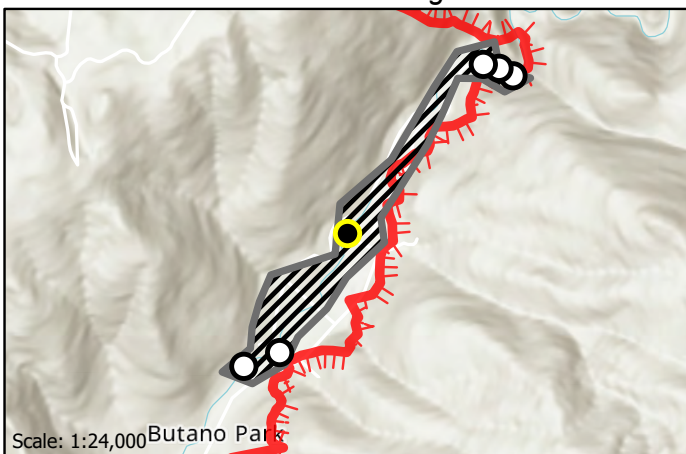
Field Observation or Potential Hazard: Flooding could impact bridge. Scour observed along abutments.

Potential Hazard to Life: **low**

Potential Hazard to Property: **moderate**

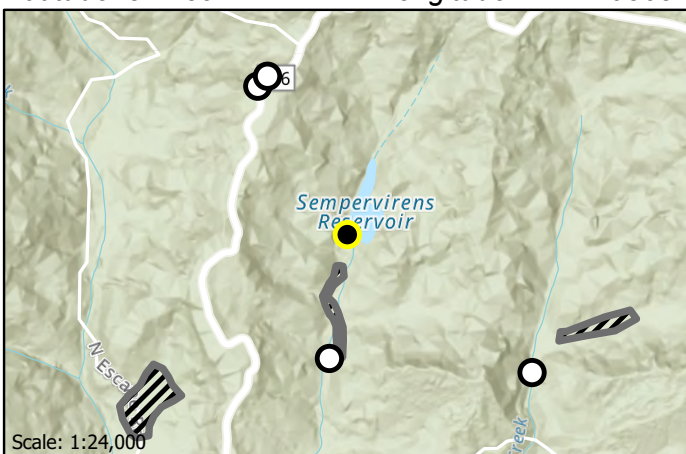
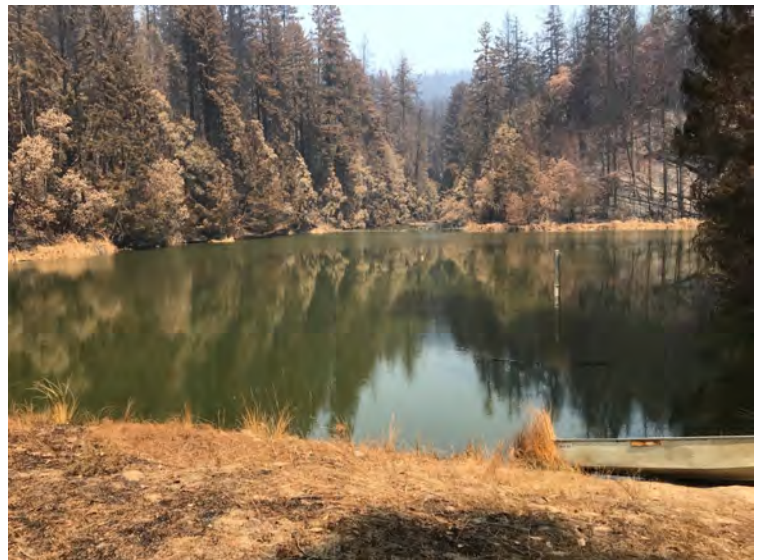
Field Observation Flooding and debris flows could impact dam. Slopes upstream with moderate to high burn severity and visible landslides on hillshade imagery. Existing 12" diameter drainage pipe along east side of embankment is damaged. Spillway outlet prone to plugging.

Potential Hazard to Life: **low**

Potential Hazard to Property: **moderate**

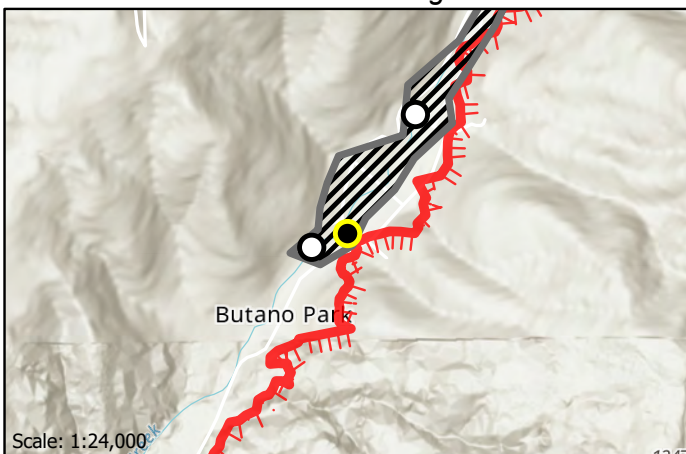
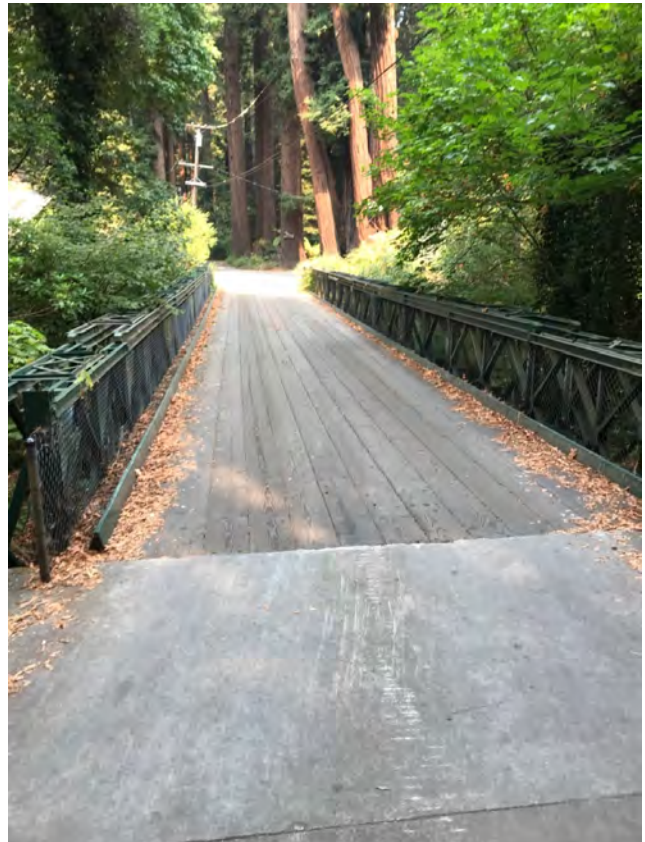
Field Observation Flooding could impact bridge. Large portion of upstream watershed located in
or Potential Hazard: burn area.

Potential Hazard to Life: **low**

Potential Hazard to Property: **moderate**

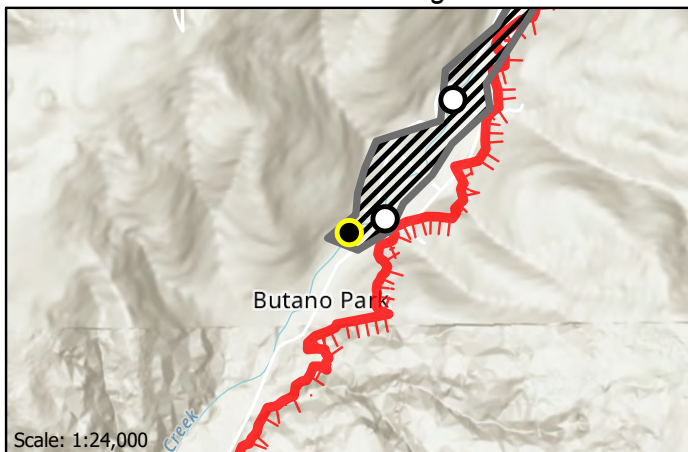
Field Observation Flooding could impact bridge. Vertically stacked log abutments functioning as
or Potential Hazard: retaining wall along eastern abutment.

Potential Hazard to Life: **low**

Potential Hazard to Property: **moderate**

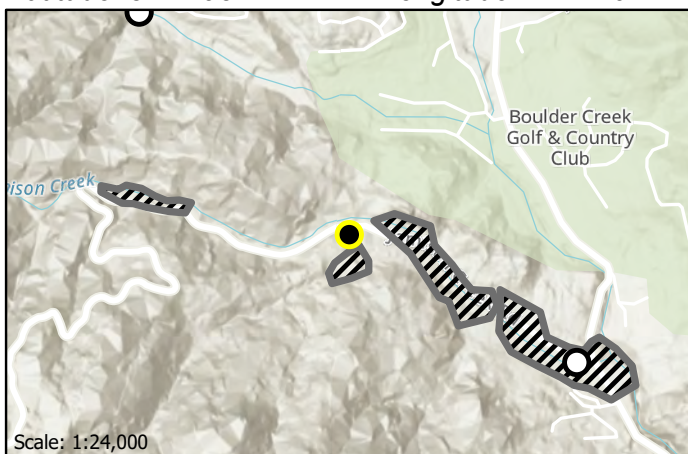
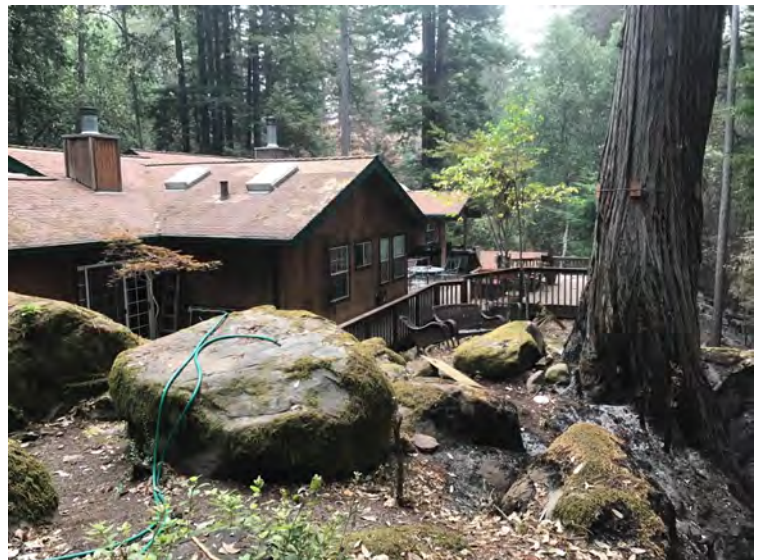
Field Observation House located along tributary to Jamison Creek. Evidence of past debris flow or *Potential Hazard:* activity, including large boulders within channel and adjacent to structure.

Potential Hazard to Life: **high**

Potential Hazard to Property: **high**

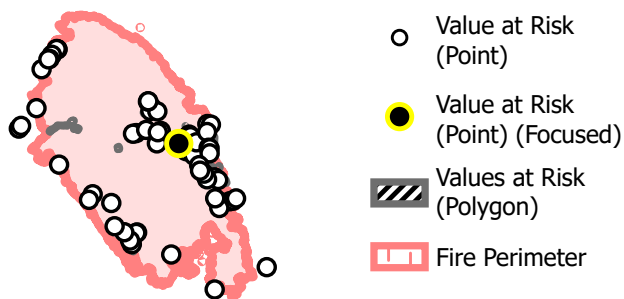
Field Observation House located on fan at base of steep watercourse. Multiple debris slides or *Potential Hazard:* mapped upstream.

Potential Hazard to Life: **moderate**

Potential Hazard to Property: **moderate**

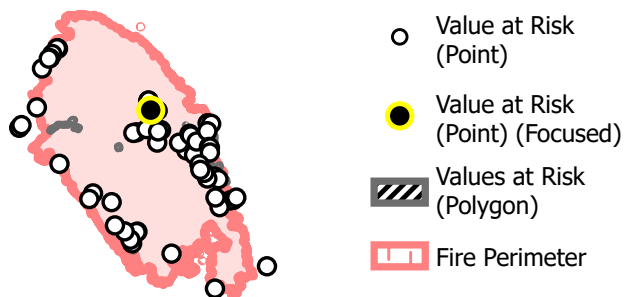
Field Observation 90 degree turn in creek observed approximately 80' upstream of the tank.
or Potential Hazard: Potential for water and debris to leave the main channel and flow towards tank.

Potential Hazard to Life: **low**

Potential Hazard to Property: **moderate**

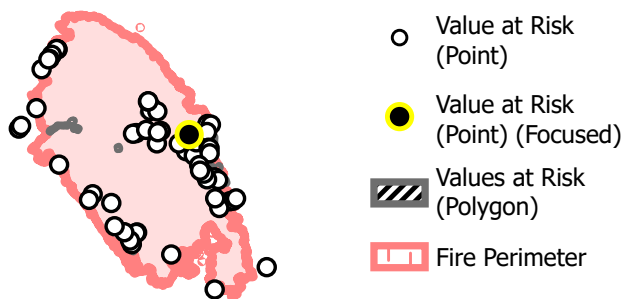
Field Observation House and deck located immediately adjacent to Boulder Creek. Deck post or Potential Hazard: rotated.

Potential Hazard to Life: **low**

Potential Hazard to Property: **moderate**

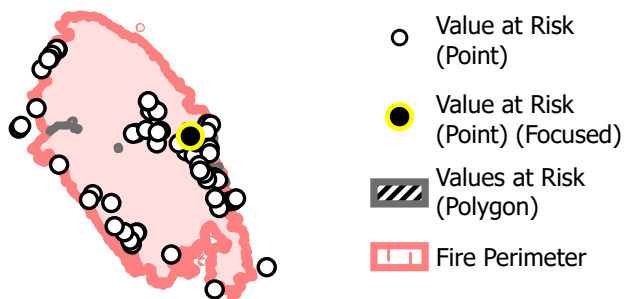
Field Observation or Potential Hazard: Potential for flooding impacts to temporary housing site. Apparent former structure and shipping container located within bank full flood plain of Boulder Creek. Also, rail car bridge.

Potential Hazard to Life: low

Potential Hazard to Property: moderate

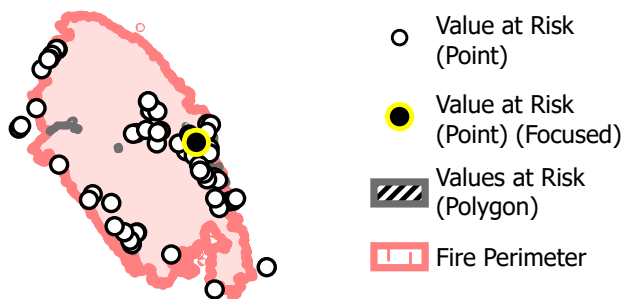
Field Observation or Potential Hazard: House located adjacent to small channel. Channel mapped as low debris flow probability.

Potential Hazard to Life: **low**

Potential Hazard to Property: **moderate**

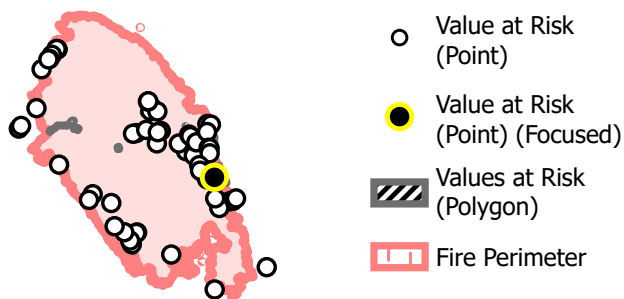
Field Observation Well box located in Creek. Creek identified as low probability debris flow.
or Potential Hazard:

Potential Hazard to Life: **low**

Potential Hazard to Property: **moderate**

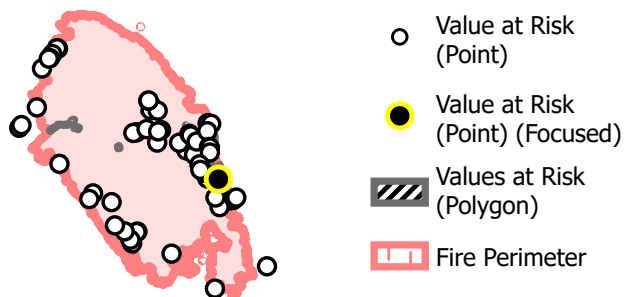
Field Observation or Potential Hazard: House located adjacent to modeled debris flow channel segment. Model shows low potential. Possible small avulsion upstream of house. Homeowner constructed berm to channel flow away from house

Potential Hazard to Life: **low**

Potential Hazard to Property: **moderate**

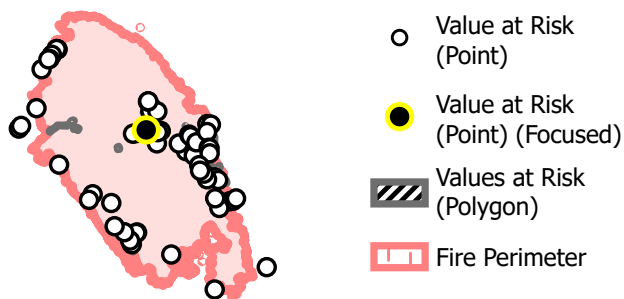
Field Observation Choke point, 10-foot diameter arched culvert appears to be chokepoint for
or Potential Hazard: upstream watershed. Potential to plug with woody debris, overtop and washout road prism.

Potential Hazard to Life: **low**

Potential Hazard to Property: **moderate**

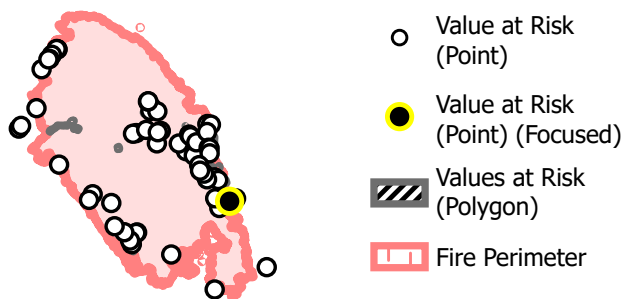
Field Observation Existing house and driveway bridge
or Potential Hazard:

Potential Hazard to Life: high

Potential Hazard to Property: high

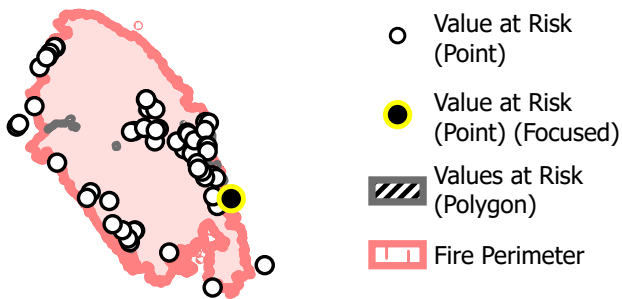
Field Observation Existing house
or Potential Hazard:

Potential Hazard to Life: **high**

Potential Hazard to Property: **high**

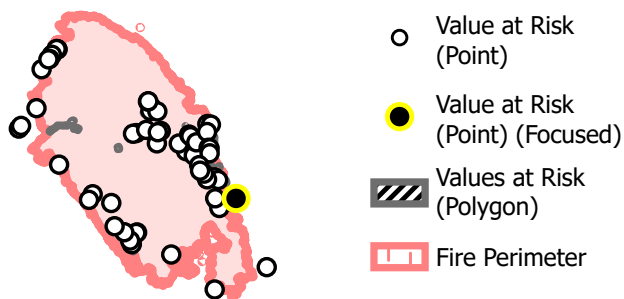
Field Observation or Potential Hazard: Highway 9 bridge

Potential Hazard to Life: **low**

Potential Hazard to Property: **moderate**

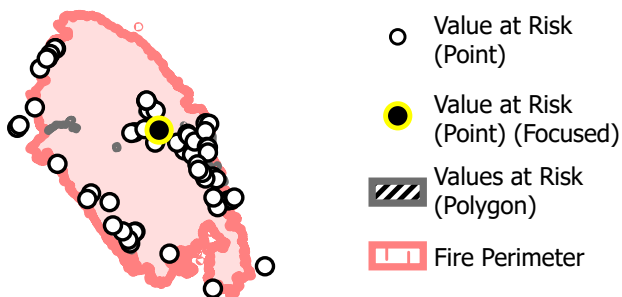
Field Observation 36-inch concrete box culvert has potential to overtop and washout road prism.
or Potential Hazard: Crossing located downstream of steep slopes with high potential for debris flows. Watercourse contains large amount of woody debris.

Potential Hazard to Life: **low**

Potential Hazard to Property: **moderate**

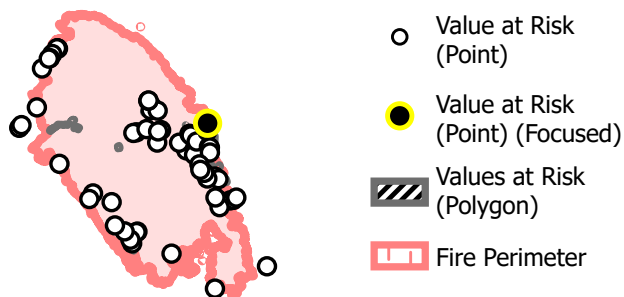
Field Observation House located adjacent to watercourse. Stream is channelized through
or Potential Hazard: property. Potential for clogging and flooding.

Potential Hazard to Life: low

Potential Hazard to Property: moderate

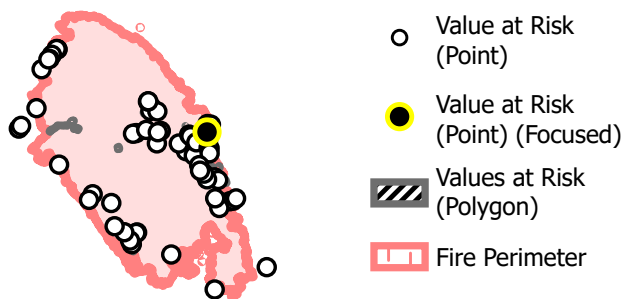
Field Observation or Potential Hazard: House located at mouth of canyon.

Potential Hazard to Life: **moderate**

Potential Hazard to Property: **moderate**

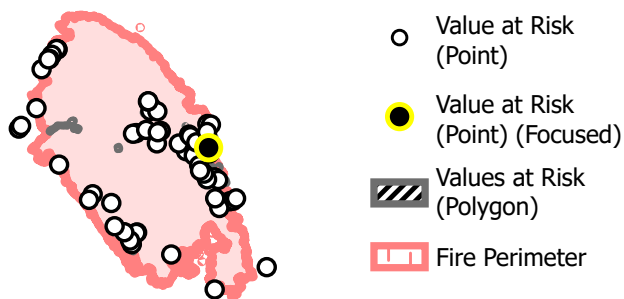
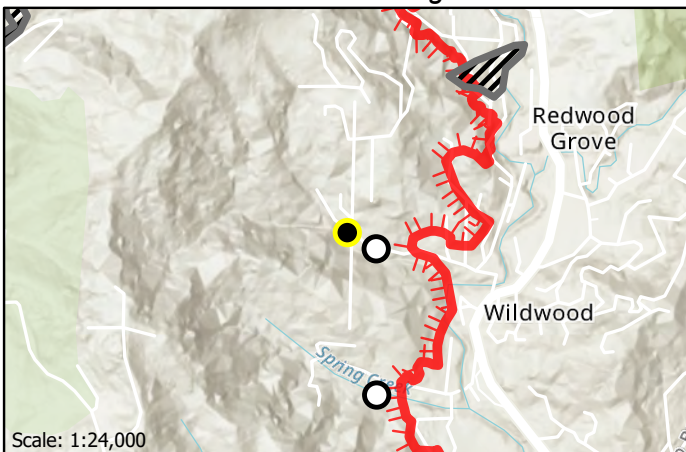
Field Observation or Potential Hazard: Potential for debris flow to impact temporary housing site. Burned house located immediately adjacent to watercourse with a low probability for debris flow.

Potential Hazard to Life: moderate

Potential Hazard to Property: low

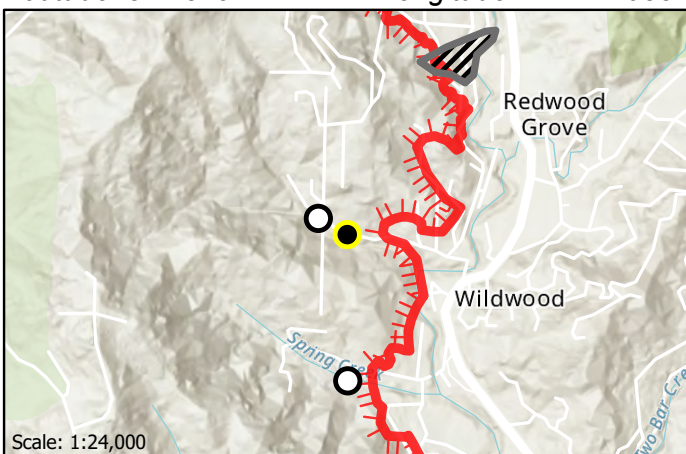
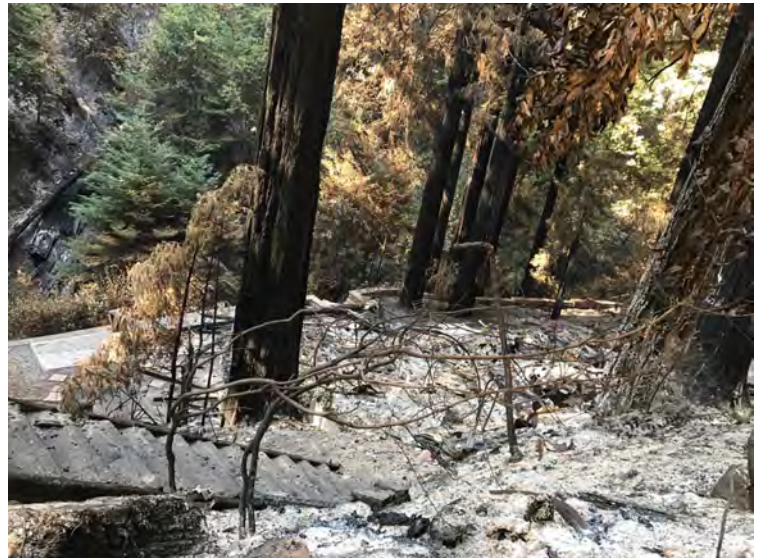
Field Observation Potential for debris flow to impact temporary housing site. Burned house
or Potential Hazard: located immediately adjacent to watercourse with a low probability for debris flow.

Potential Hazard to Life: **moderate**

Potential Hazard to Property: **low**

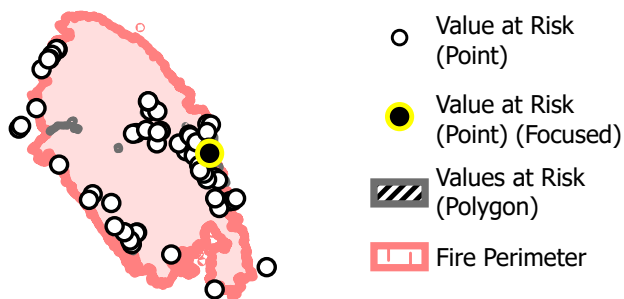
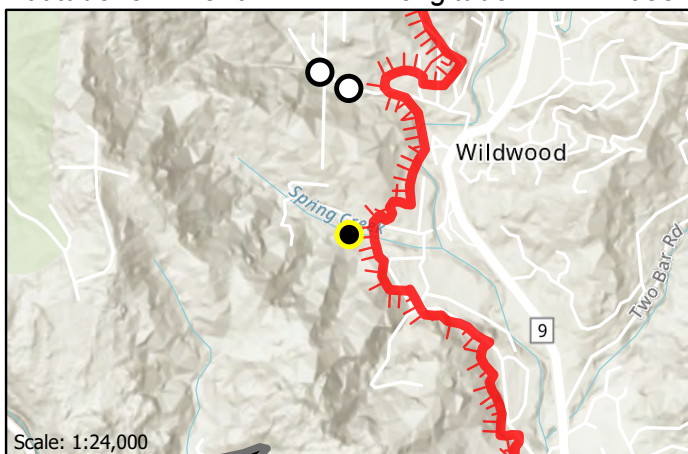
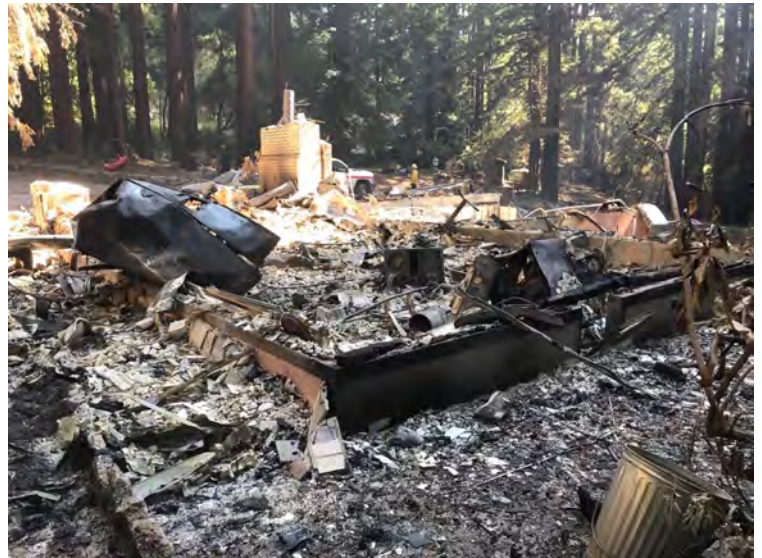
Field Observation Potential for debris flow to impact temporary housing site. Burned house
or Potential Hazard: located immediately adjacent to watercourse with a low probability for debris flow.

Potential Hazard to Life: **moderate**

Potential Hazard to Property: **moderate**
