Watershed Emergency Response Team Evaluation

CZU LIGHTNING COMPLEX

CA-CZU-005205

October 1, 2020

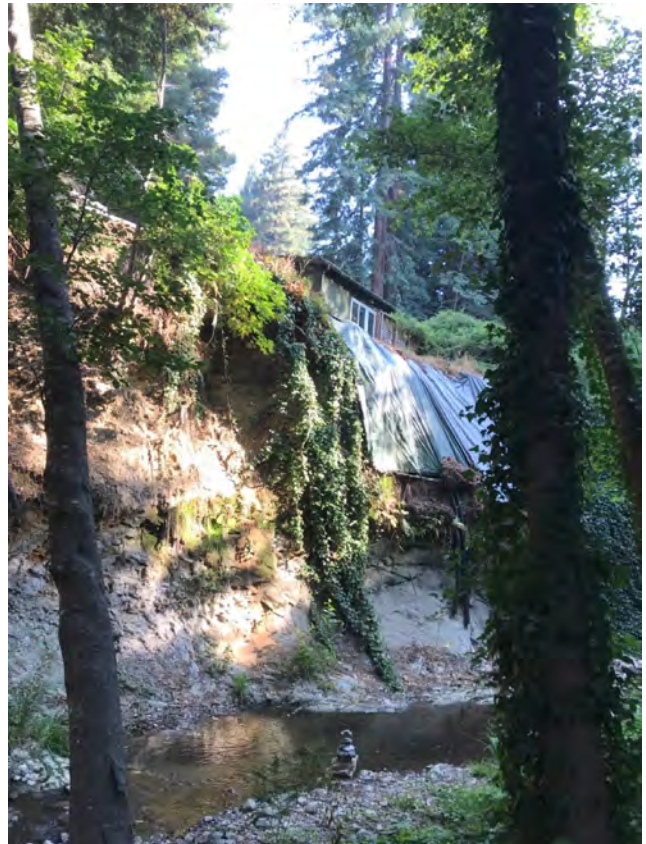
Field Observation or Potential Hazard: House located above bend in San Lorenzo River. Existing channel scour is endangering house.

Potential Hazard to Life: **moderate**

Potential Hazard to Property: **moderate**

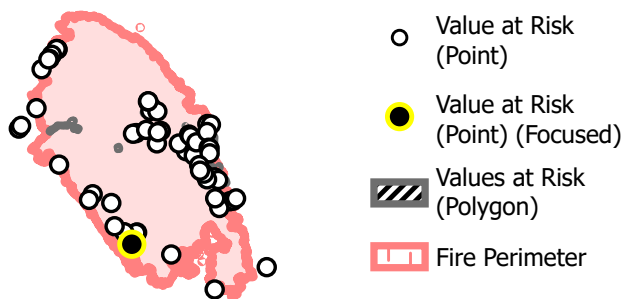
Field Observation Bridge appears to be choke point for debris and sediment. Woody debris could
or Potential Hazard: block bridge

Potential Hazard to Life: **low**

Potential Hazard to Property: **moderate**

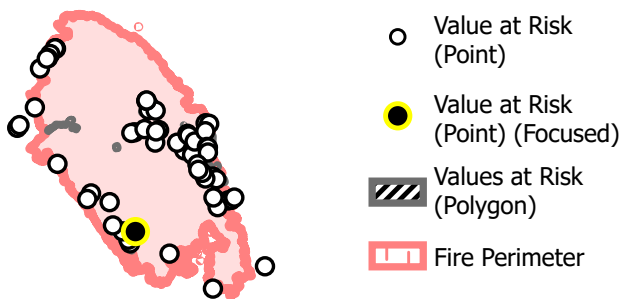
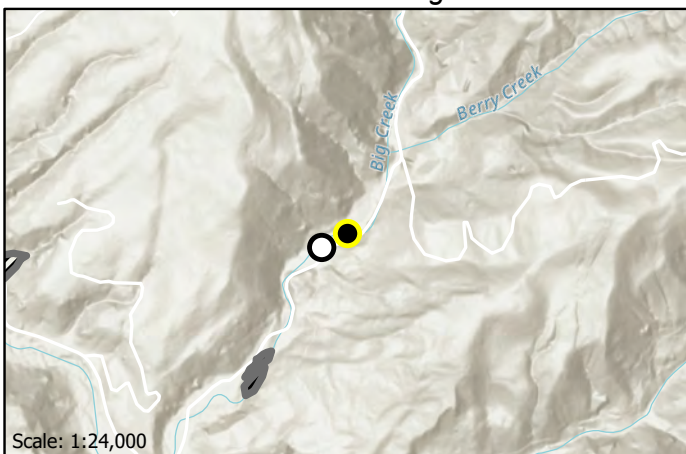
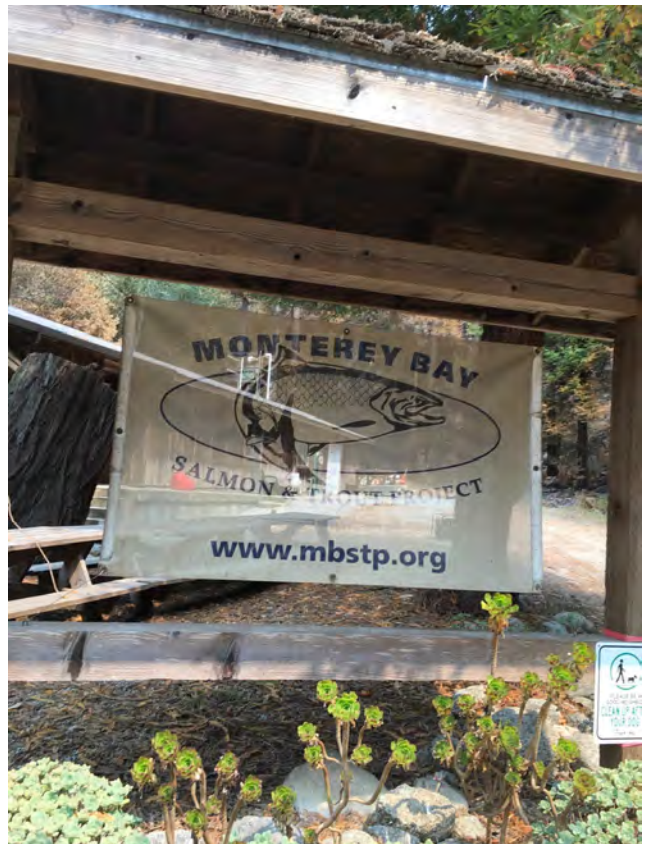
Field Observation or Potential Hazard: Flooding impact to fish hatchery and structures

Potential Hazard to Life: **moderate**

Potential Hazard to Property: **high**

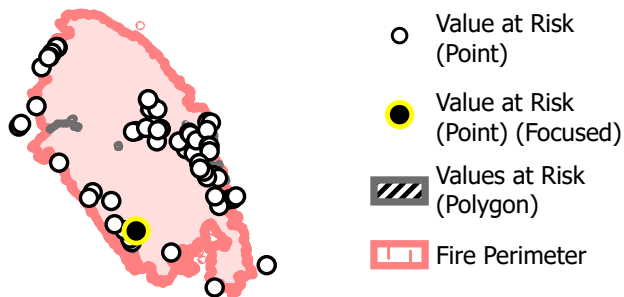
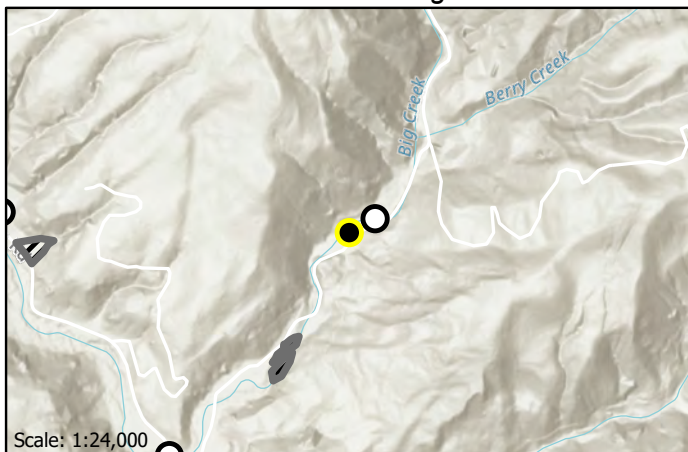
Field Observation Potential for flooding to impact temporary housing site. Existing structures
or Potential Hazard: destroyed.

Potential Hazard to Life: **moderate**

Potential Hazard to Property: **moderate**

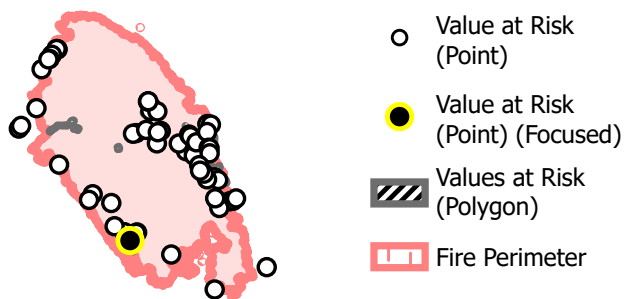
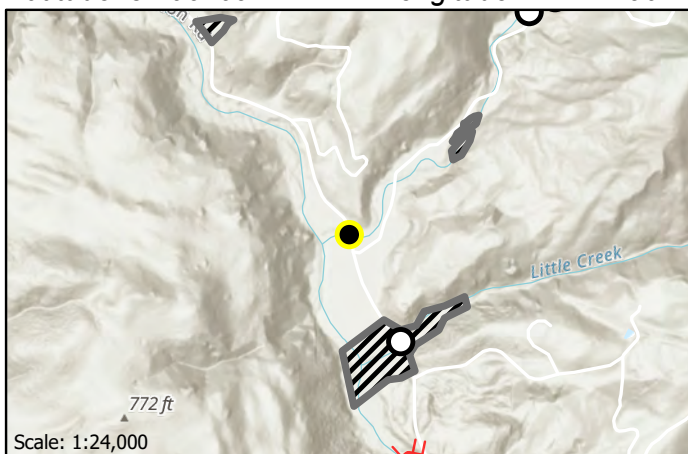
Field Observation Bridge within floodplain. Large watershed upstream with a mapped moderate to
or Potential Hazard: high potential for debris flows. Numerous landslides visible adjacent to
watercourse and tributaries on LiDAR imagery.

Potential Hazard to Life: **low**

Potential Hazard to Property: **moderate**

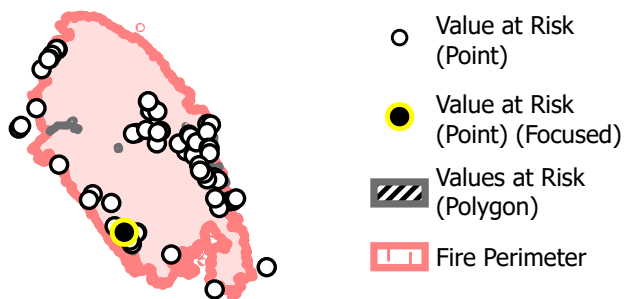
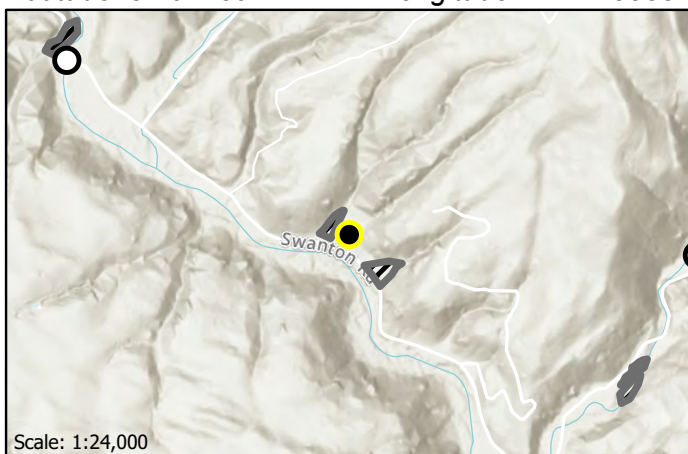
Field Observation House in potential debris flow / flood path.
or Potential Hazard:

Potential Hazard to Life: **high**

Potential Hazard to Property: **high**

Description: K rail

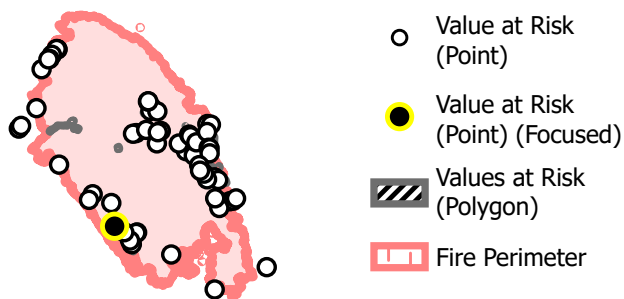
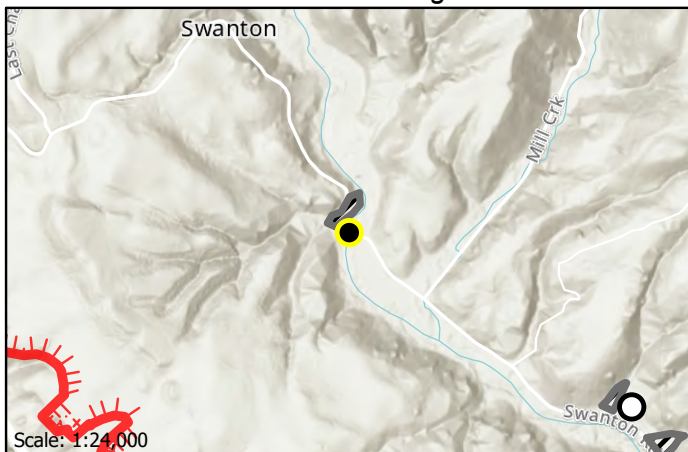
Field Observation Flooding could impact bridge, large watershed upstream.
or Potential Hazard:

Potential Hazard to Life: **low**

Potential Hazard to Property: **moderate**

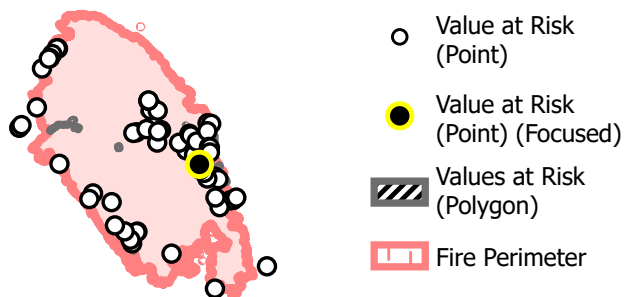
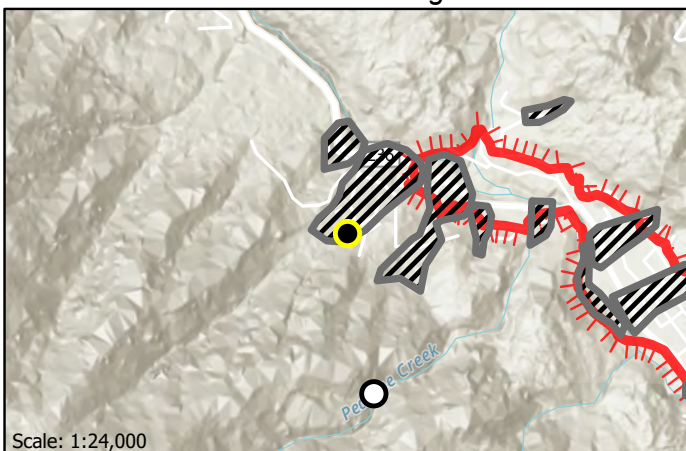
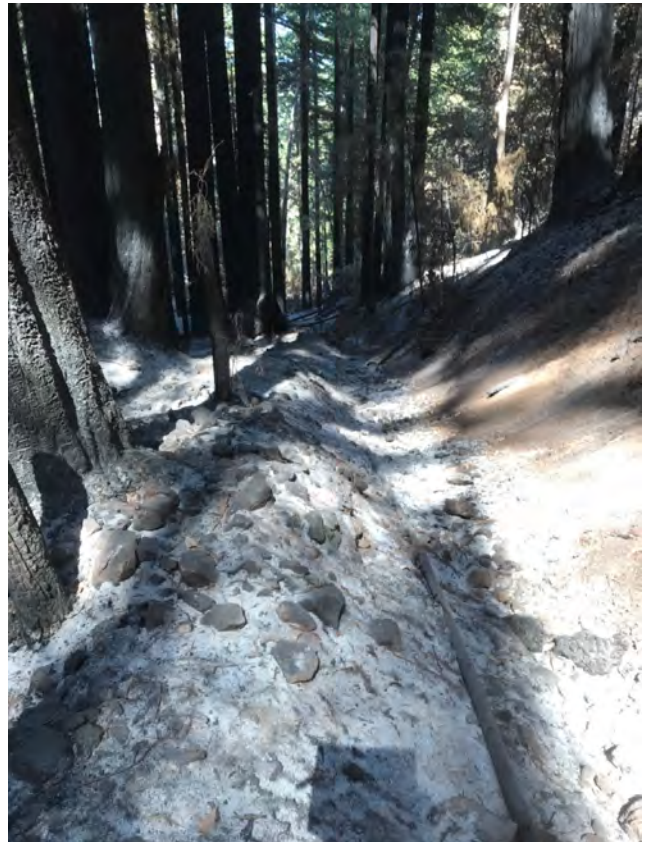
Field Observation or Potential Hazard: Local water district pump house and intake lines. Intake pipe observed extending upstream. Pipe located within active debris flow channel.

Potential Hazard to Life: low

Potential Hazard to Property: high

Description: Prepare for increased organics

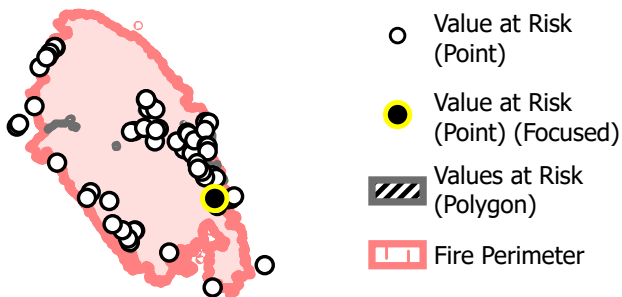
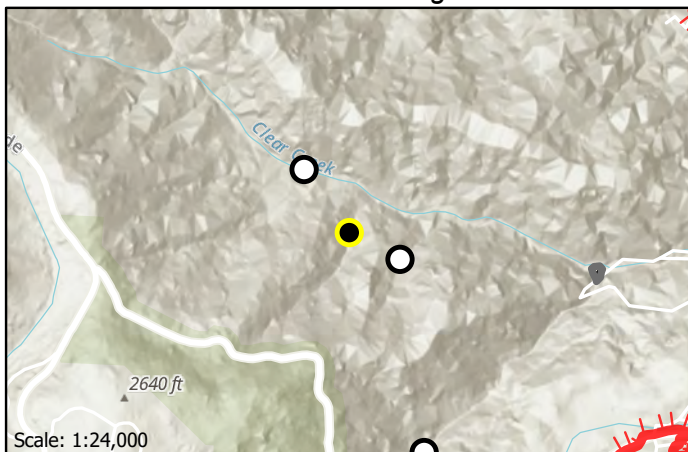
Field Observation or Potential Hazard: Impacts to intake, water quality

Potential Hazard to Life: **low**

Potential Hazard to Property: **high**

Description: Prepare for increased organics

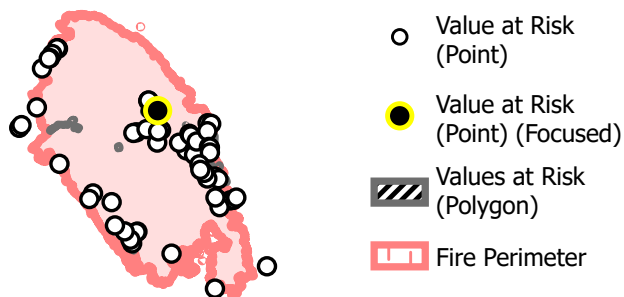
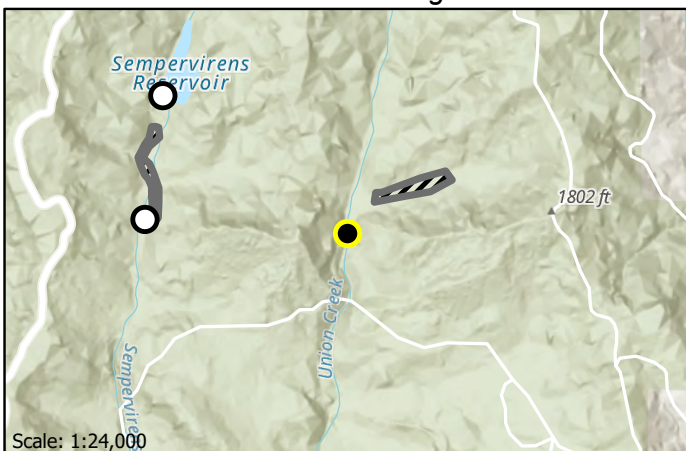
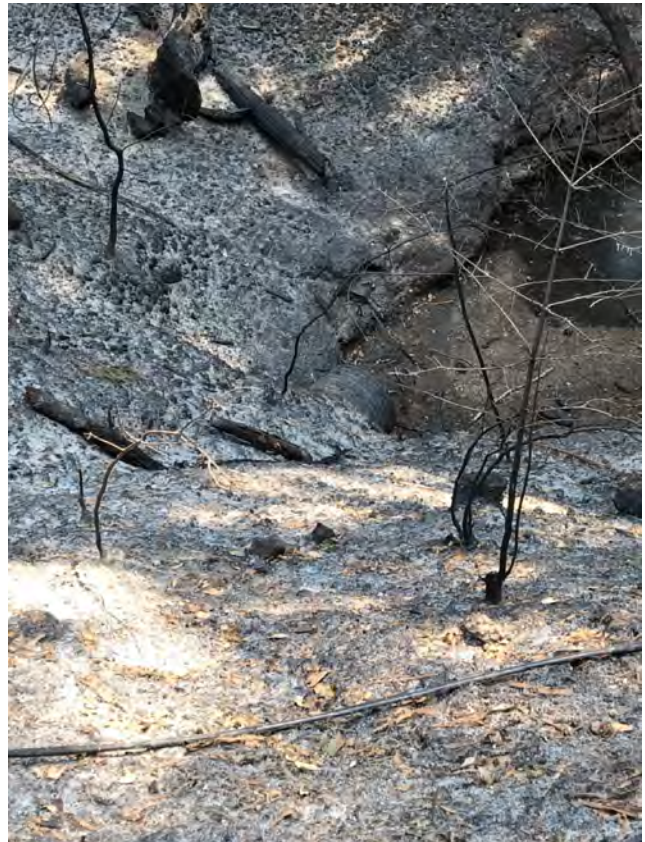
Field Observation or Potential Hazard: Flooding/Debris Flow could impact the crossing. Culvert undersized, large amount of fill (>20 feet). Inlet is highly corroded. Landslides visible on LiDAR images along upstream slopes. Recommend culvert be replaced and sized appropriately.

Potential Hazard to Life: **low**

Potential Hazard to Property: **moderate**

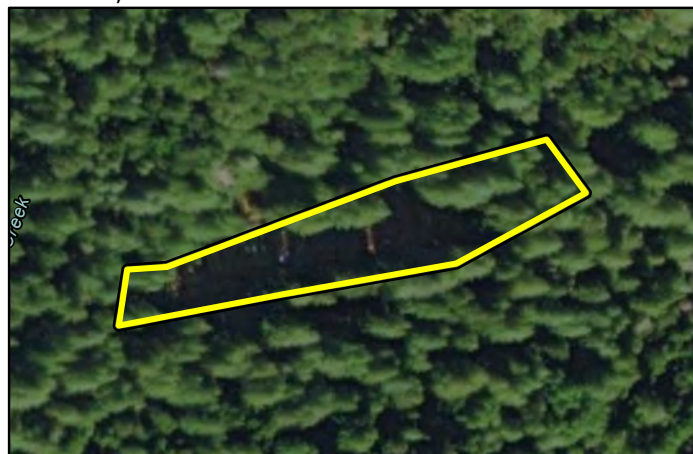
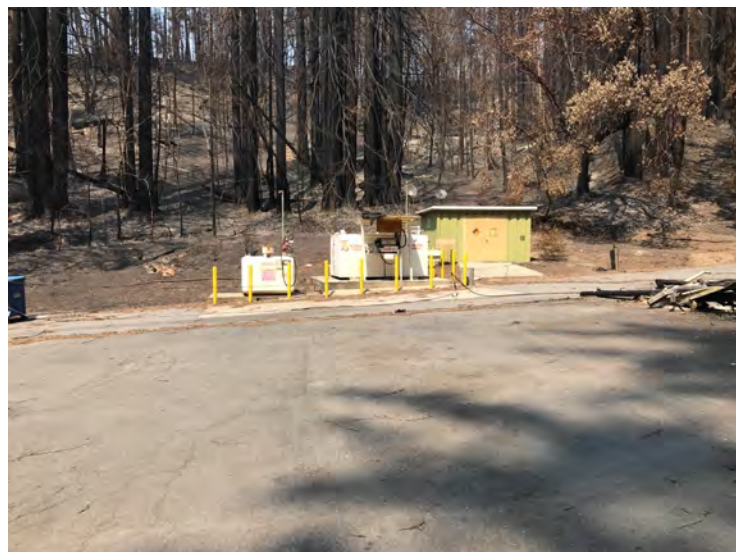
Field Observation Debris flow, structures built on alluvial fan deposits. Fuel tanks and 55-gallon or *Potential Hazard:* drums have potential to spill into watercourse.

Potential Hazard to Life: **low**

Potential Hazard to Property: **high**

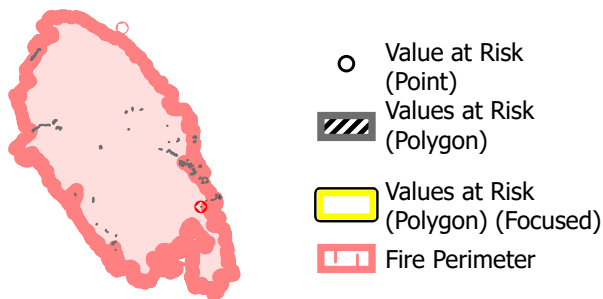
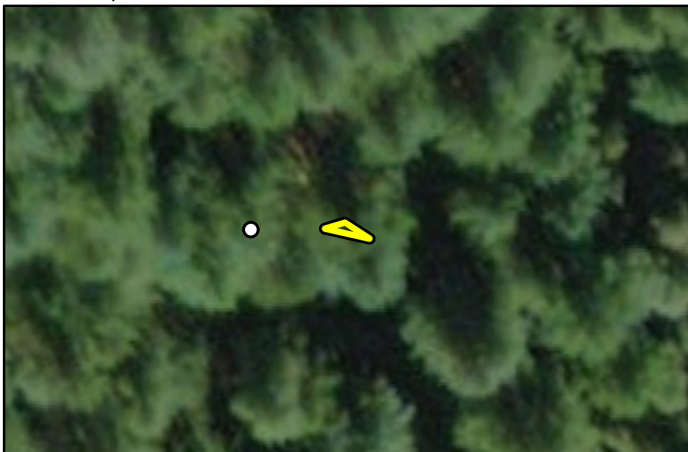
Field Observation Impacts to intake, water quality
or Potential Hazard:

Potential Hazard to Life: **low**

Potential Hazard to Property: **high**

Description: Prepare for increased organics

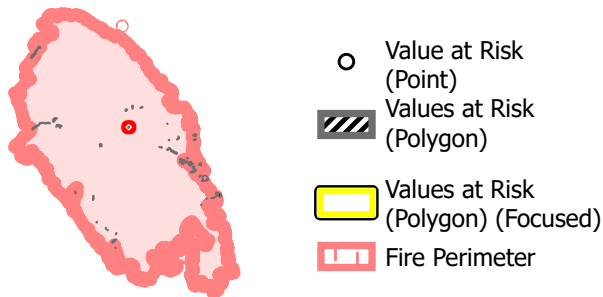
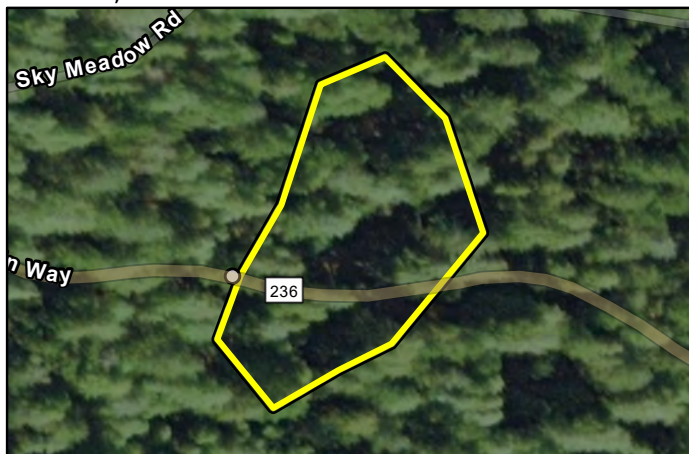
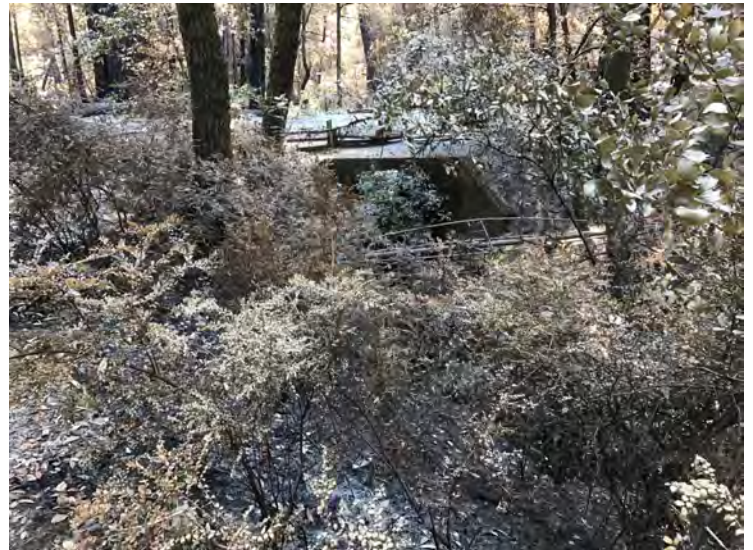
Field Observation Campground located on floodplain upstream of choke point along highway 236
or Potential Hazard:

Potential Hazard to Life: **moderate**

Potential Hazard to Property: **low**

Description: Temporary Closure

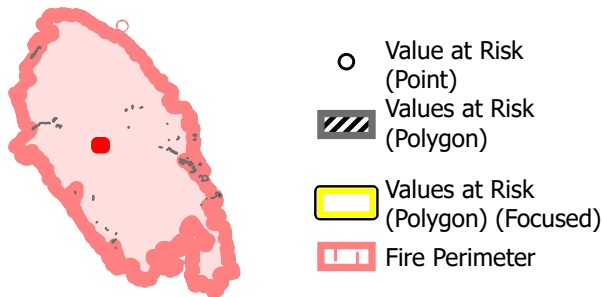
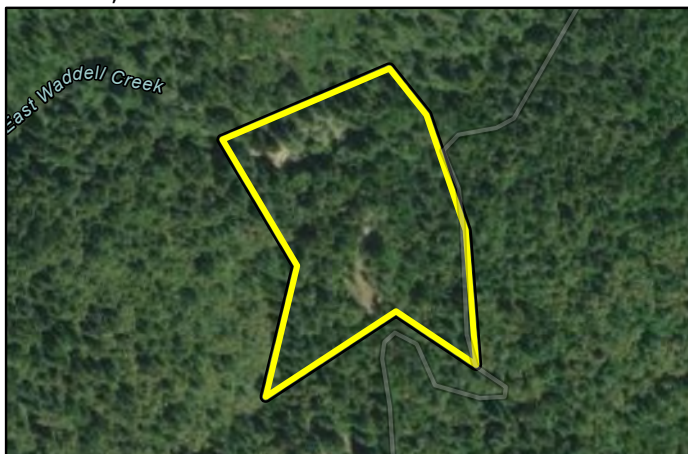
Field Observation Unable to access property. Homes located at the bottom of two drainages with
or Potential Hazard: a high potential for debris flows. Addition determinations and observations should be made by a PG or PE.

Potential Hazard to Life: **moderate**

Potential Hazard to Property: **moderate**

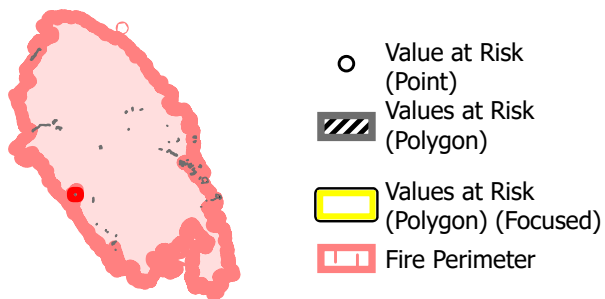
Field Observation Flooding could impact several homes within floodplain.
or Potential Hazard:

Potential Hazard to Life: **low**

Potential Hazard to Property: **moderate**

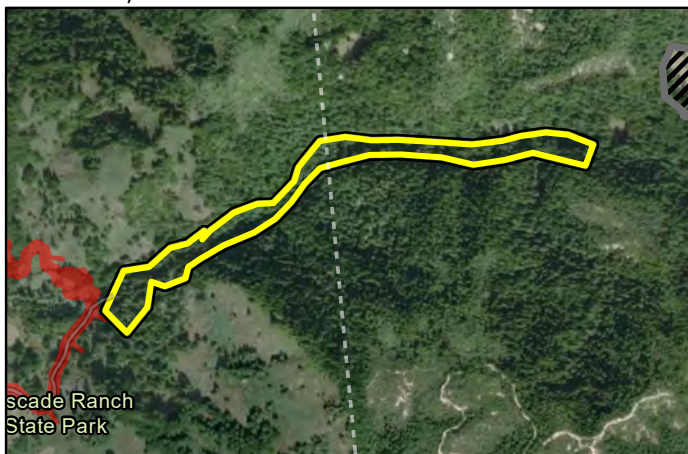
Field Observation Adjacent slopes are steep and appear prone to debris slides/flows. Rockfall or Potential Hazard: hazard also present.

Potential Hazard to Life: **high**

Potential Hazard to Property: **moderate**

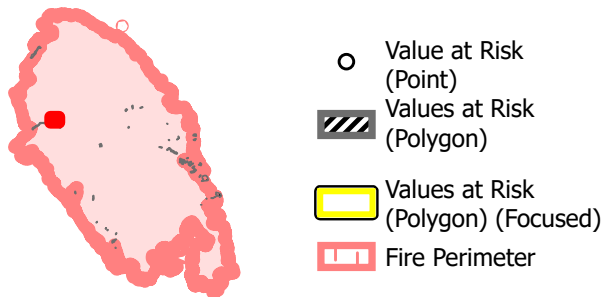
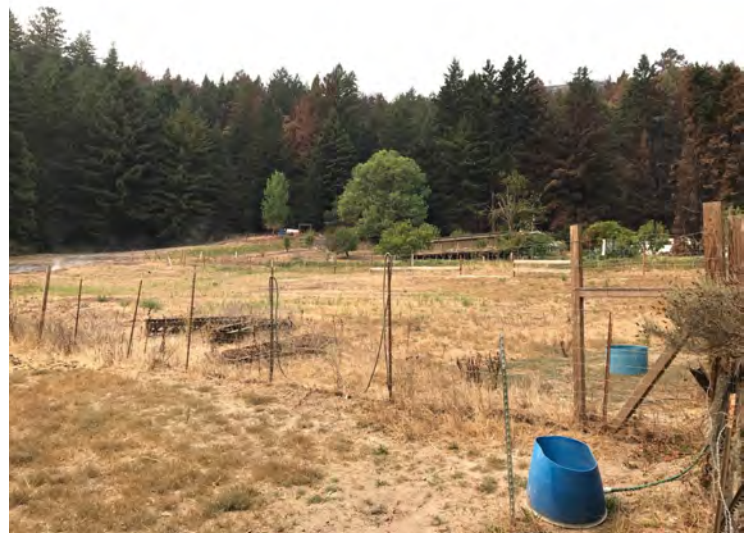
Field Observation Debris flow, homes located on alluvial fan deposits visible on hillshade imagery.
or Potential Hazard: Additional determination and observations should be made by a PG or PE.

Potential Hazard to Life: **moderate**

Potential Hazard to Property: **moderate**

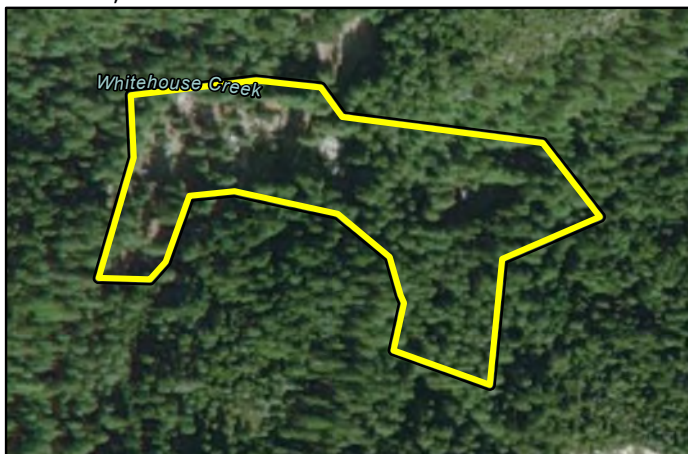
Field Observation Debris flow, homes located on alluvial fan deposits visible on hillshade imagery.
or Potential Hazard: Additional determination and observations should be made by a PG or PE.

Potential Hazard to Life: **moderate**

Potential Hazard to Property: **moderate**

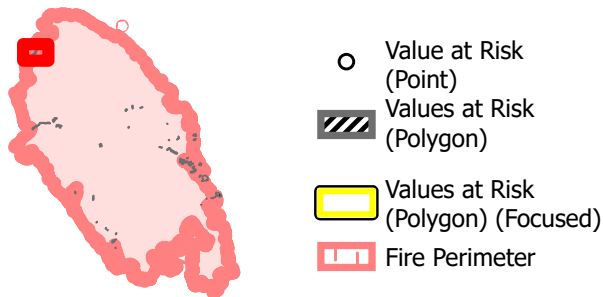
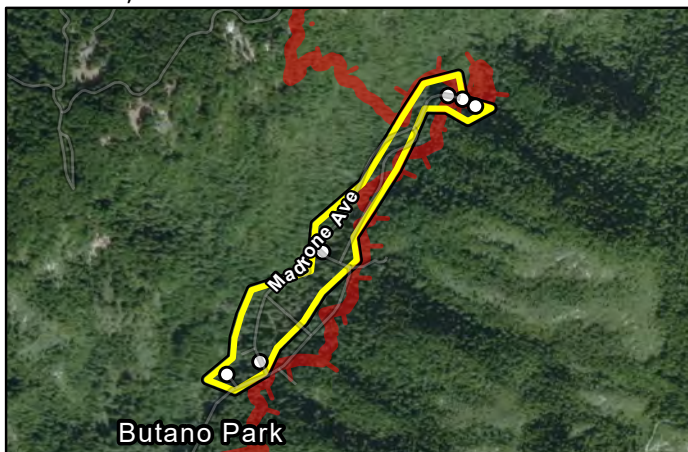
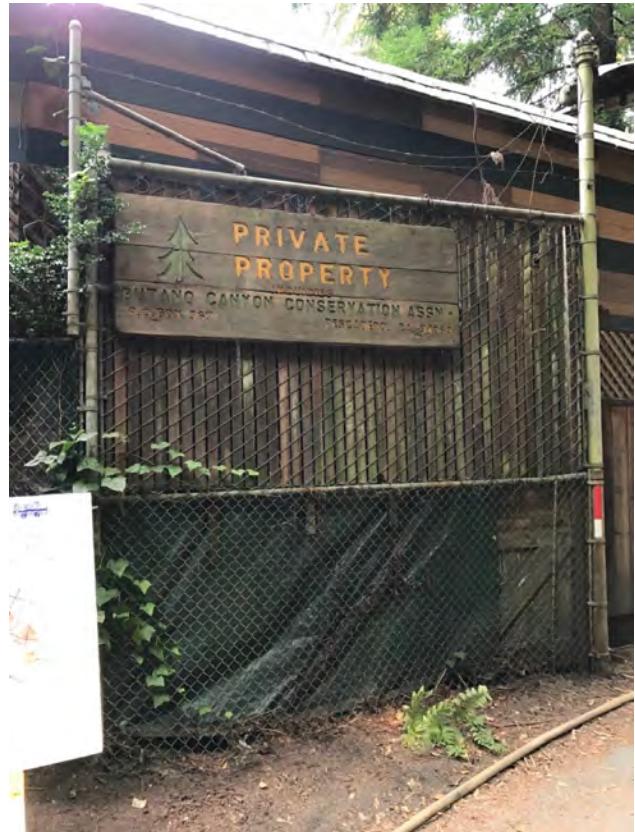
Potential Hazard to Life: **moderate**

Potential Hazard to Property: **high**

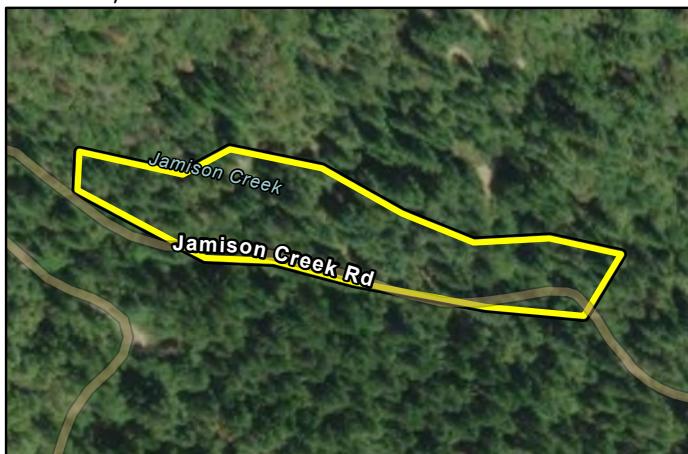
Field Observation Multiple residential properties along Jamison Creek. High potential for debris or **Potential Hazard:** flow. About 2 sq km drainage above, addition determinations and observations should be made by a PG or PE.

Potential Hazard to Life: high

Potential Hazard to Property: high

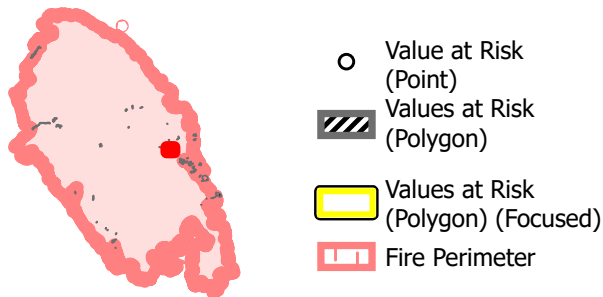
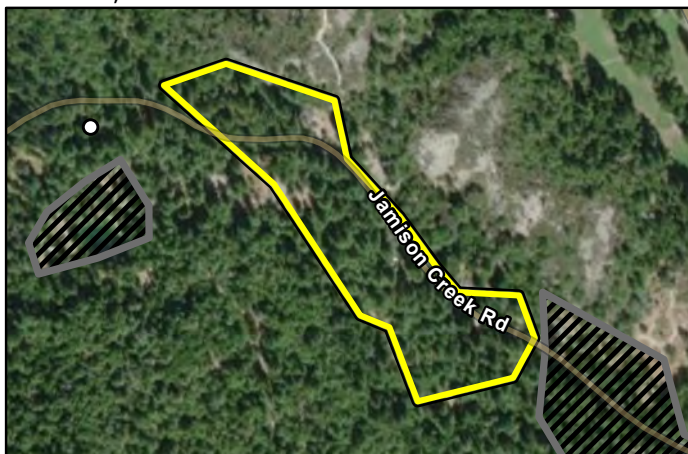
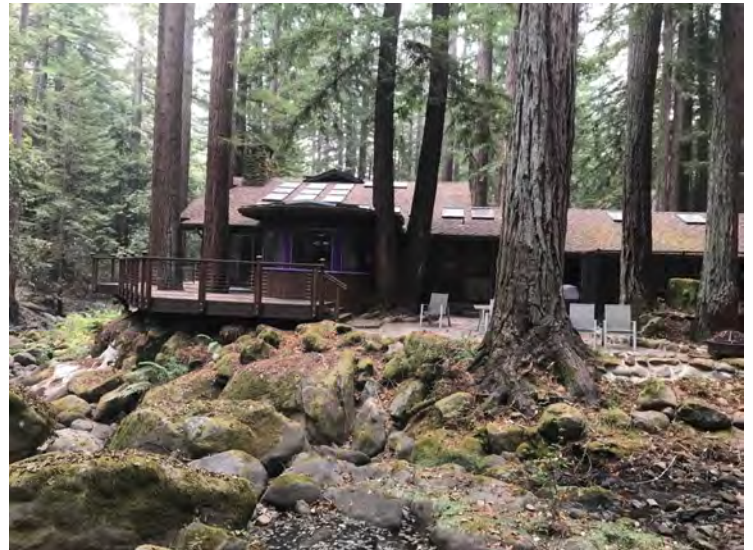
Field Observation Multiple residential properties along Jamison Creek. High potential for debris or *Potential Hazard*: flow. About 4 sq km drainage above, addition determinations and observations should be made by a PG or PE.

Potential Hazard to Life: **high**

Potential Hazard to Property: **high**

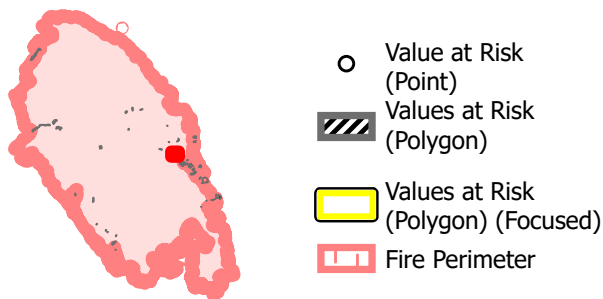
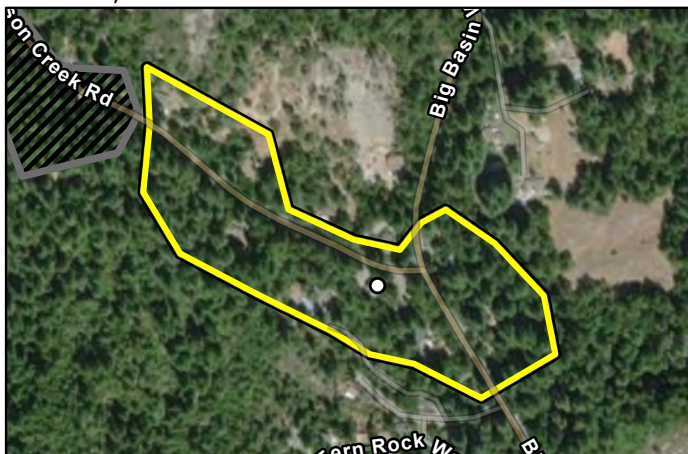
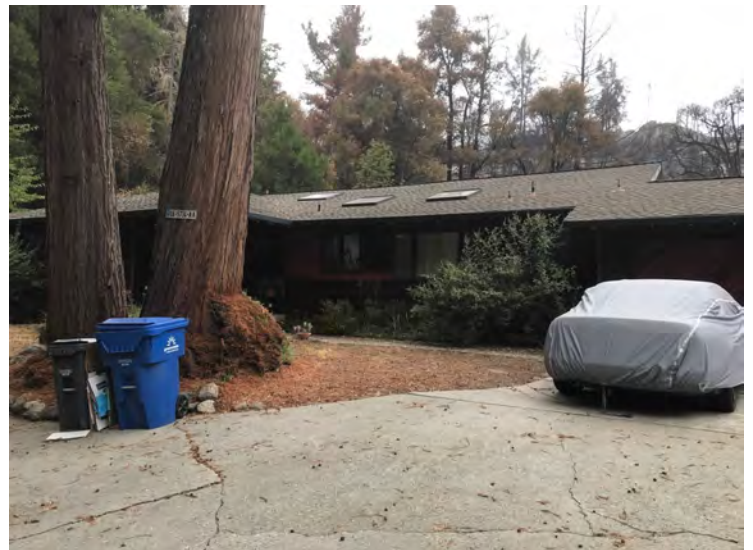
Field Observation Multiple residential properties alluvial fan at bottom Jamison Creek. About 4 sq
or Potential Hazard: km drainage above, addition determinations and observations should be made
 by a PG or PE.

Potential Hazard to Life: **moderate**

Potential Hazard to Property: **moderate**

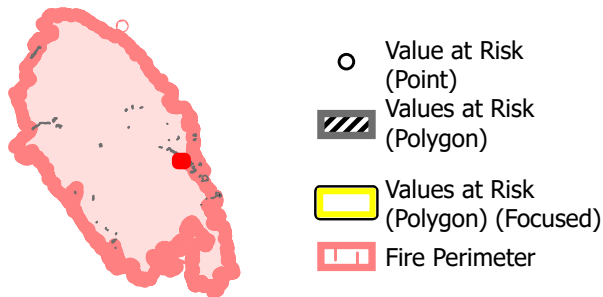
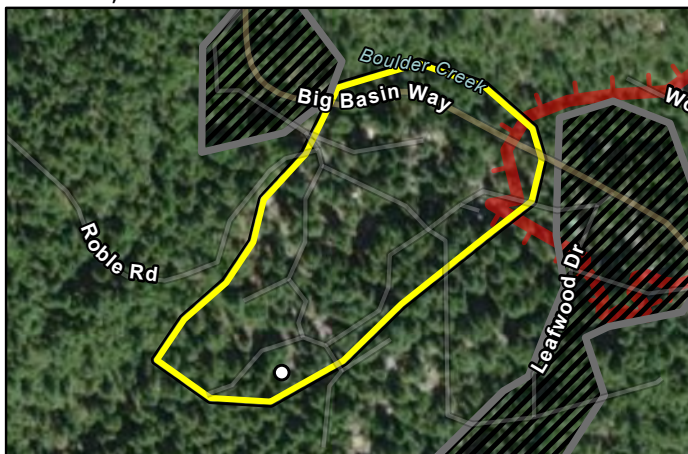
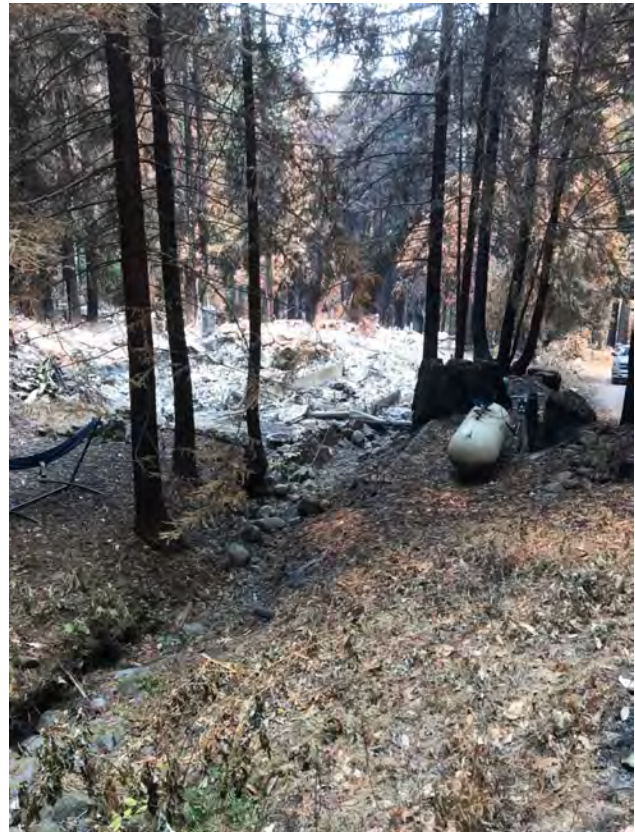
Field Observation Neighborhood constructed on alluvial fan. Avulsion point observed at top of
or Potential Hazard: development. Several foundations constructed over and/or immediately adjacent to watercourse channel. Also impacts to State Highway 236. Evidence of historic debris flow activity

Potential Hazard to Life: **high**

Potential Hazard to Property: **high**

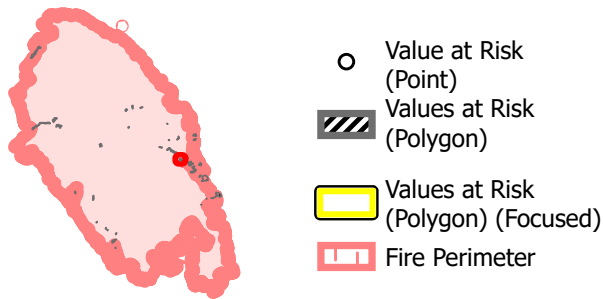
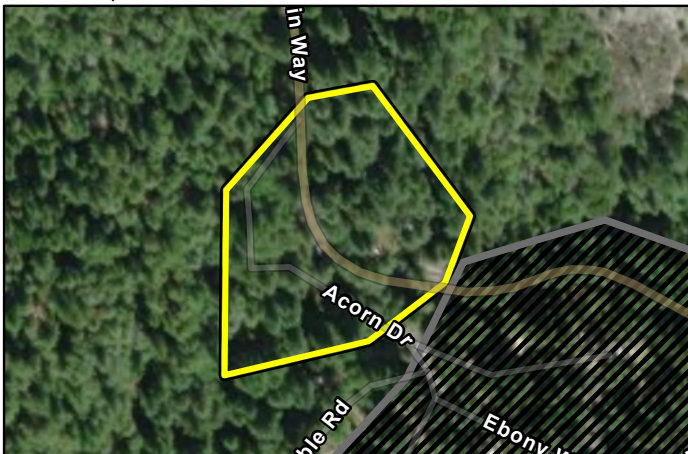
Field Observation Three houses east of SR236 located at mouth of fan deposit. Undersized or Potential Hazard: culvert crosses highway and proceeds under house.

Potential Hazard to Life: **low**

Potential Hazard to Property: **moderate**

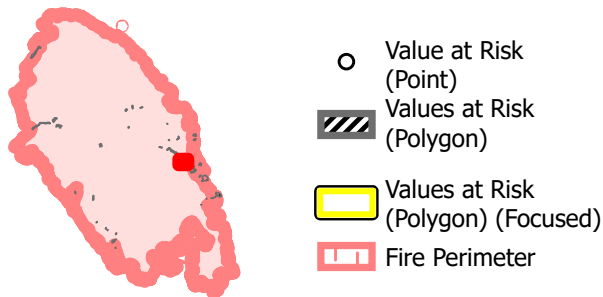
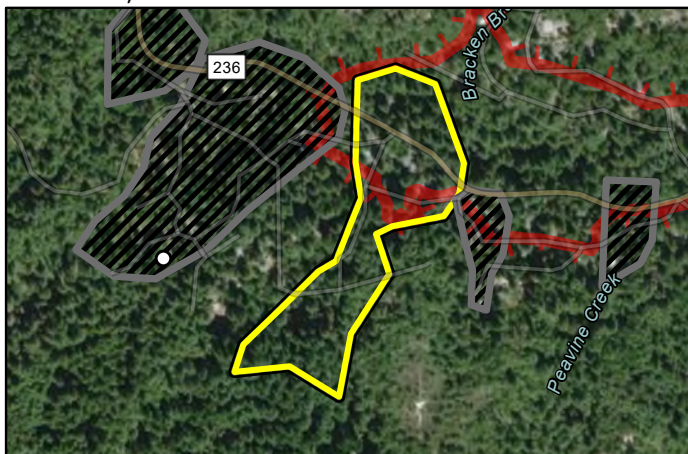
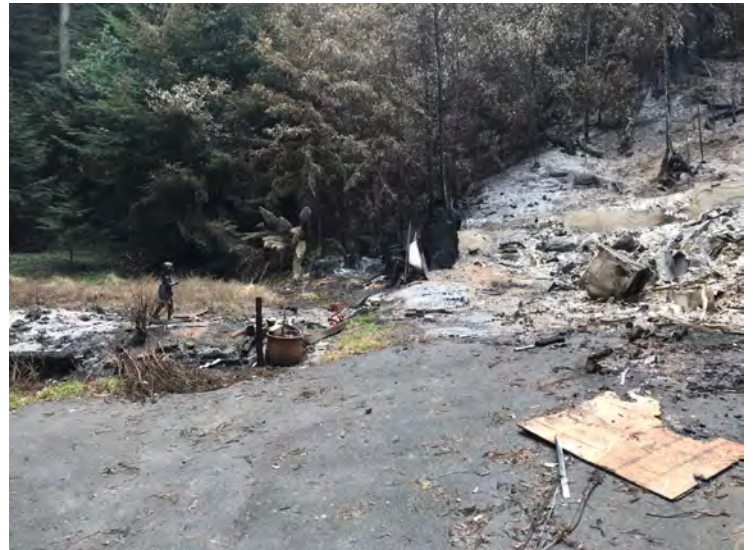
Field Observation Neighborhood constructed on alluvial fan. Several foundations constructed over and/or immediately adjacent to watercourse channel. No obvious channel observed within the deposit fan. Also impacts to State Highway 236.

Potential Hazard to Life: **moderate**

Potential Hazard to Property: **high**

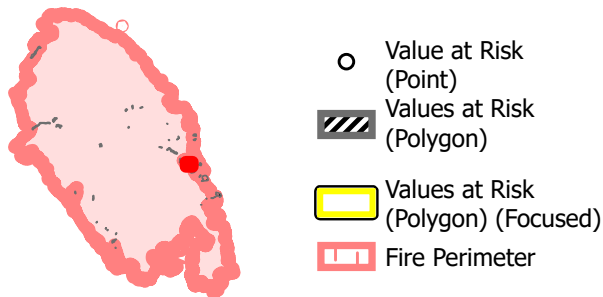
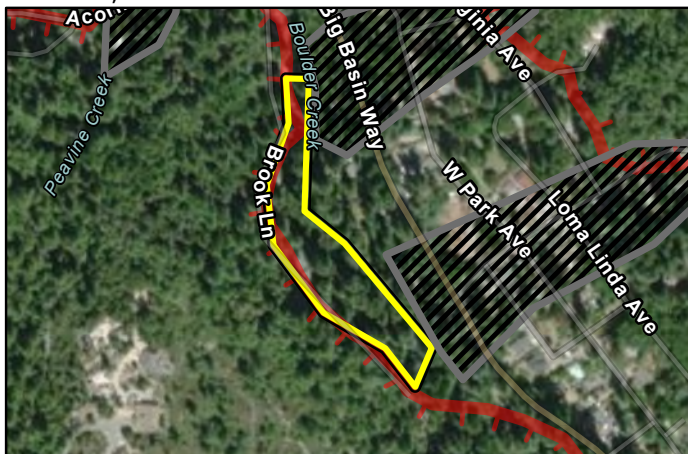
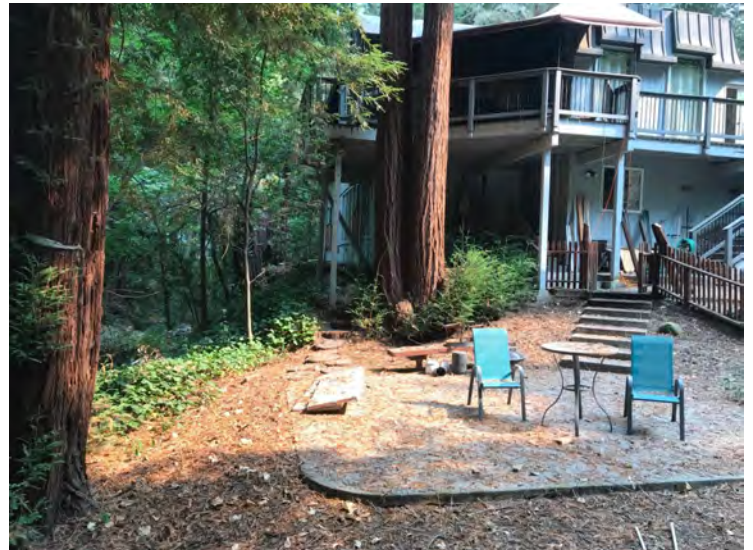
Field Observation Houses located along Boulder Creek in flood plain. Also immediately or Potential Hazard: downslope of debris slide slopes.

Potential Hazard to Life: **low**

Potential Hazard to Property: **moderate**

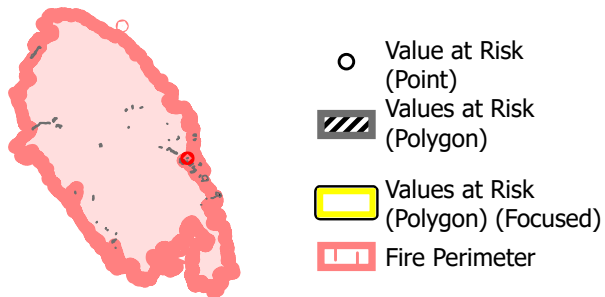
Field Observation Three burned PVC water tanks, one redwood water tank, 1 burned house, and
or Potential Hazard: one unburned house located within debris flow channel

Potential Hazard to Life: **moderate**

Potential Hazard to Property: **moderate**

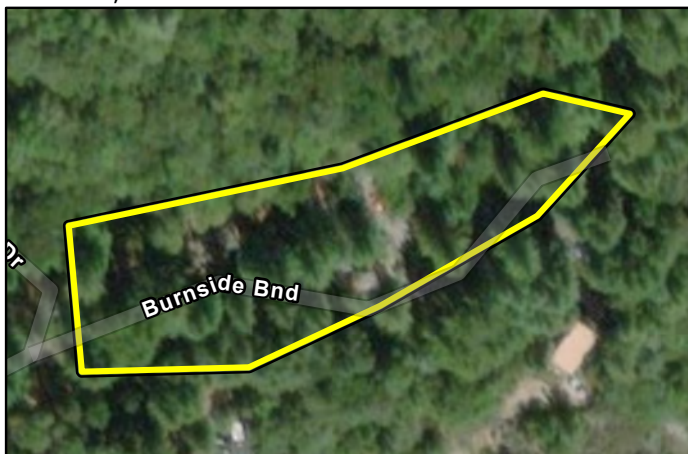
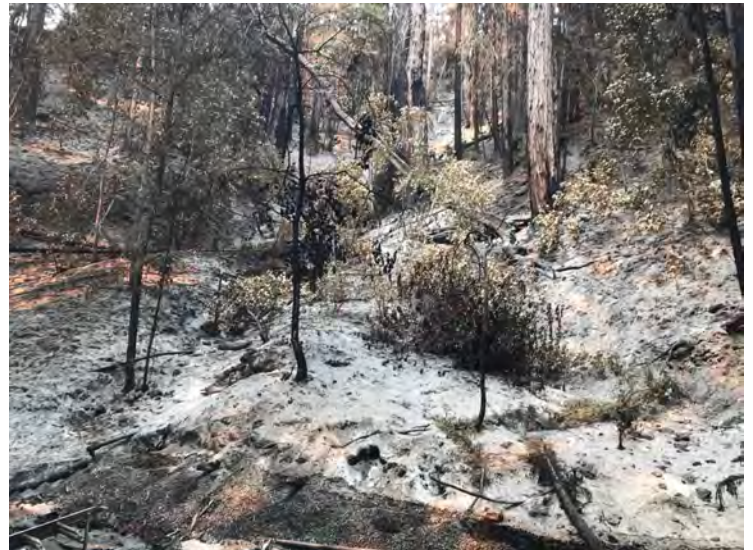
Field Observation Three burned house plus one house adjacent to channel. About a dozen
or Potential Hazard: houses further downslope on apparent fan deposit. No drainage facilities were
 observed downstream of swale. Upstream drainage area below debris model
 threshold.

Potential Hazard to Life: **moderate**

Potential Hazard to Property: **moderate**

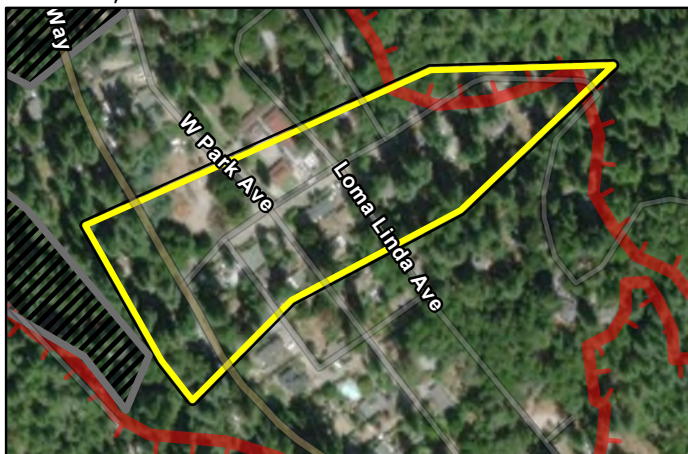
Field Observation One house adjacent debris flow channel. About 18 houses further downslope
or Potential Hazard: on apparent fan deposit. Park Road appears to be preferential pathway.
 Upstream drainage area below debris model threshold.

Potential Hazard to Life: **moderate**

Potential Hazard to Property: **moderate**

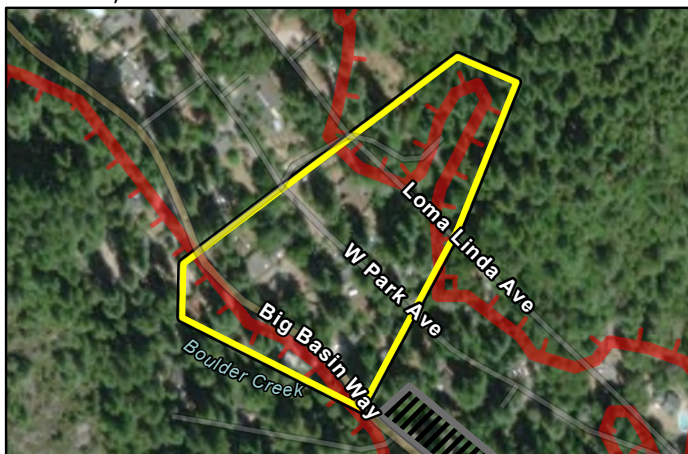
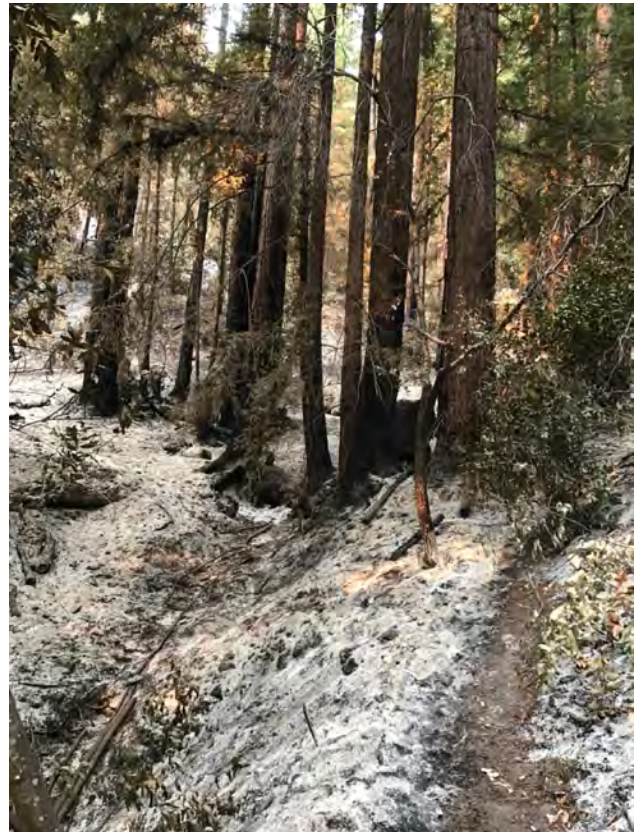
Field Observation Residential homes adjacent and in Foreman Creek. High potential for debris flow. Debris flow deposits and boulders in channel. Debris flow levee observed within channel. About 2 sq km drainage above, addition determinations should be made by PG or PE

Potential Hazard to Life: **high**

Potential Hazard to Property: **high**

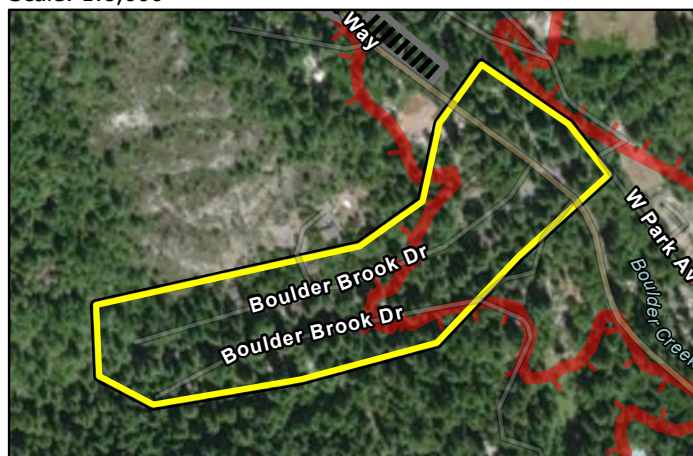
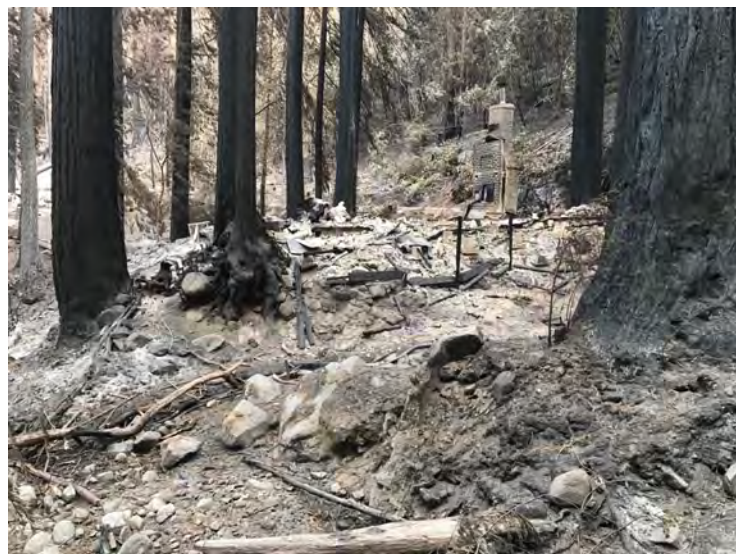
Field Observation Two Houses located along watch stream/ debris flow segment. Existing
or Potential Hazard: concrete retaining walls at base of house along creek to protect house foundations.

Potential Hazard to Life: **low**

Potential Hazard to Property: **moderate**

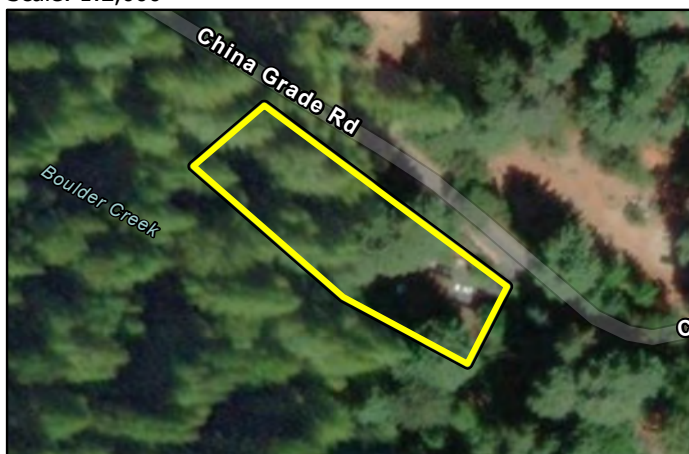
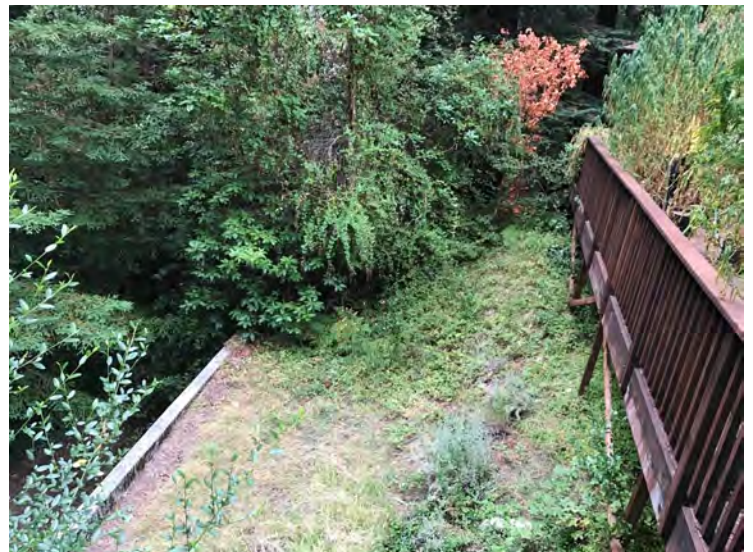
Field Observation Several houses located on fan deposits
or Potential Hazard:

Potential Hazard to Life: **moderate**

Potential Hazard to Property: **moderate**
