Watershed Emergency Response Team Evaluation

CZU LIGHTNING COMPLEX

CA-CZU-005205

October 1, 2020

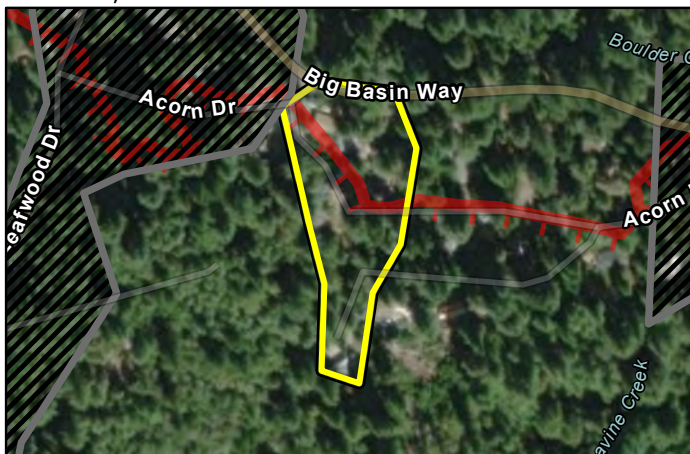
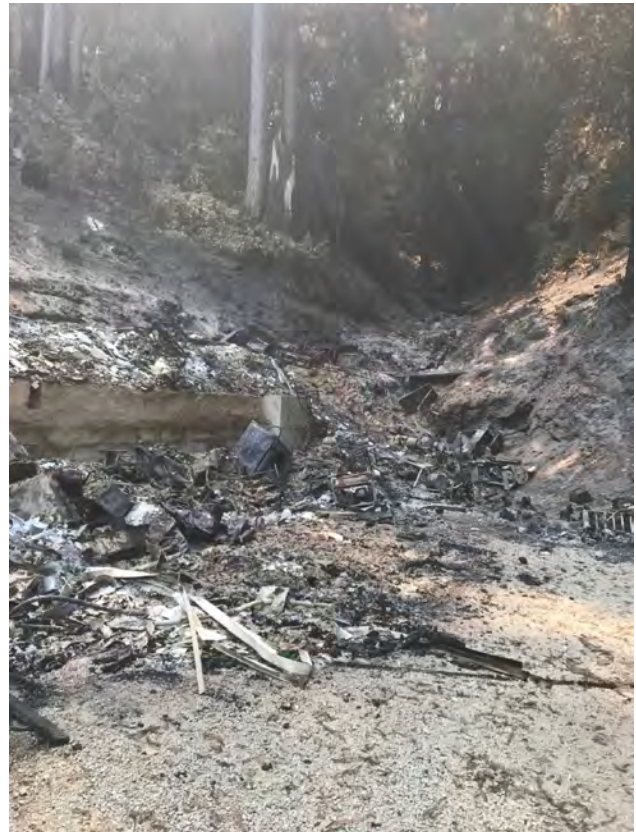
Field Observation At bend in Peavine Creek. Model indicates moderate to high potential or Potential Hazard: upstream. Watershed extends to top of Ben Lomand Mountain.

Potential Hazard to Life: **low**

Potential Hazard to Property: **moderate**

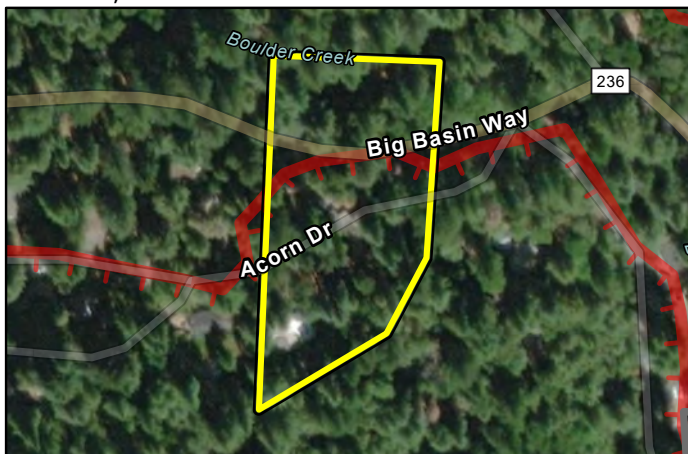
Field Observation Three Houses located along Boulder Creek. Foundation supports within the 1-
or Potential Hazard: year flood plain. Some foundation elements are rotated. Evidence of ongoing
 scour and foundation problems.

Potential Hazard to Life: **moderate**

Potential Hazard to Property: **high**

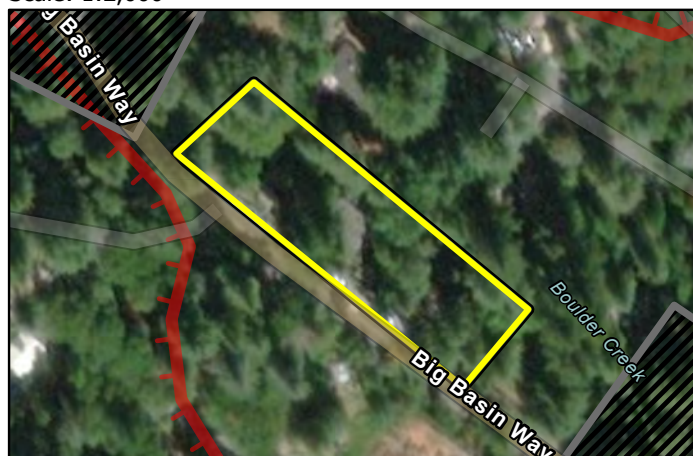
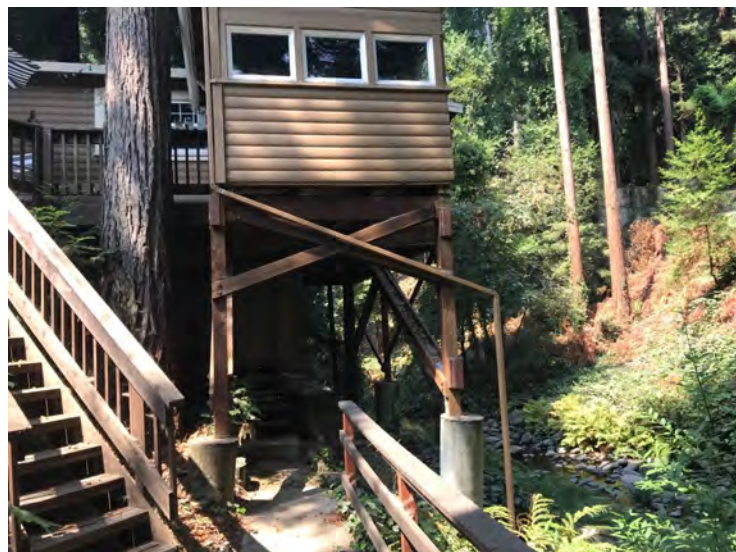
Field Observation Three houses built on watercourse channel. Evidence of creep and foundation or *Potential Hazard:* issues. Existing structural weakness could be exacerbated with increased post-fire sediment and runoff.

Potential Hazard to Life: **low**

Potential Hazard to Property: **moderate**

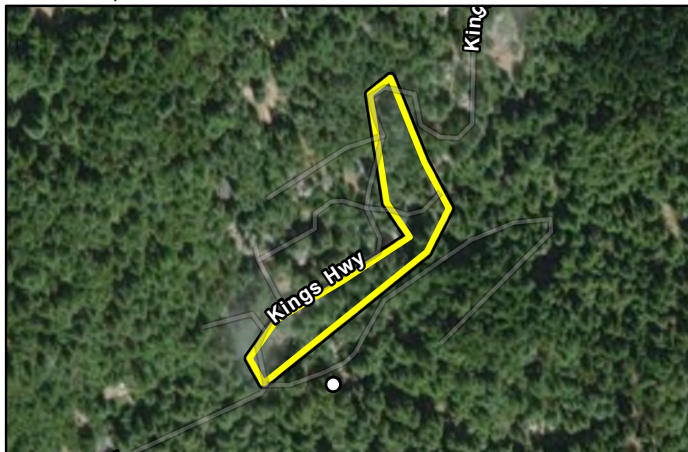
Field Observation Houses on apparent old alluvial fan. Channel mapped as low probability.
or Potential Hazard: Channel is minor about 2 feet wide by 18" depth. Potential for minor avulsion.
 And flood debris impacts.

Potential Hazard to Life: **low**

Potential Hazard to Property: **moderate**

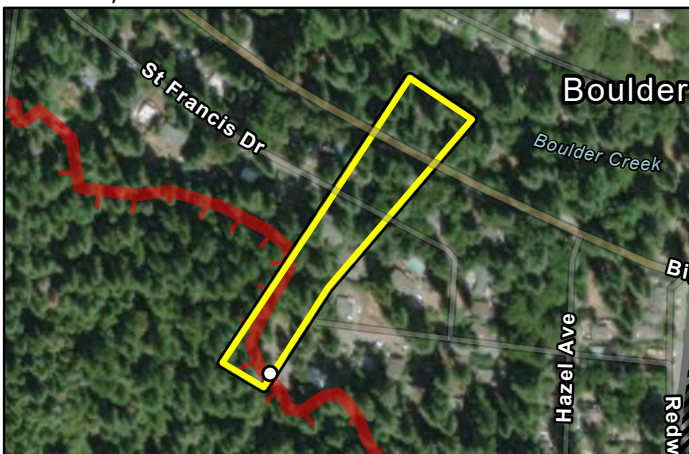
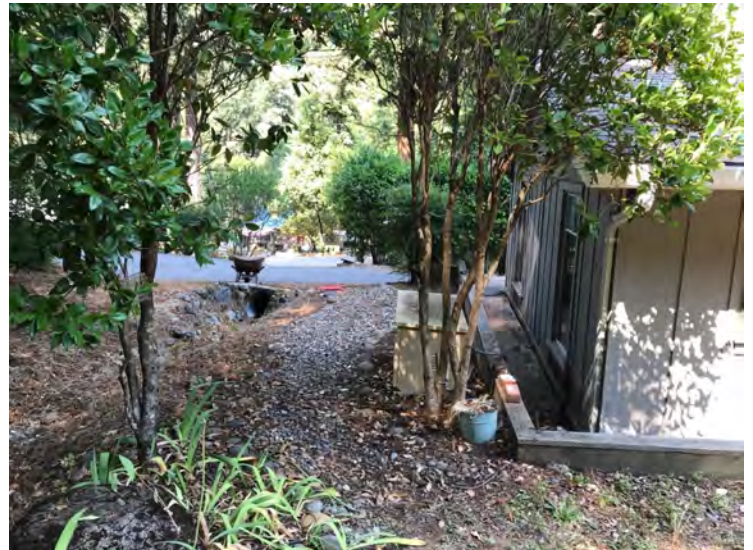
Field Observation or Potential Hazard: Large alluvial fan observed town of Boulder Creek. Elementary school and cemetery at fan apex. Avulsion pathway highly uncertain. Potential avulsion point observed ~500ft SW of cemetery. Addition determinations and observations should be made by a PG/PE

Potential Hazard to Life: moderate

Potential Hazard to Property: moderate

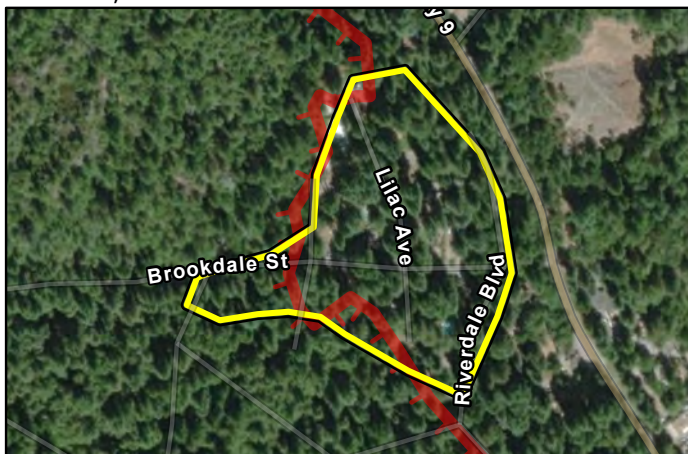
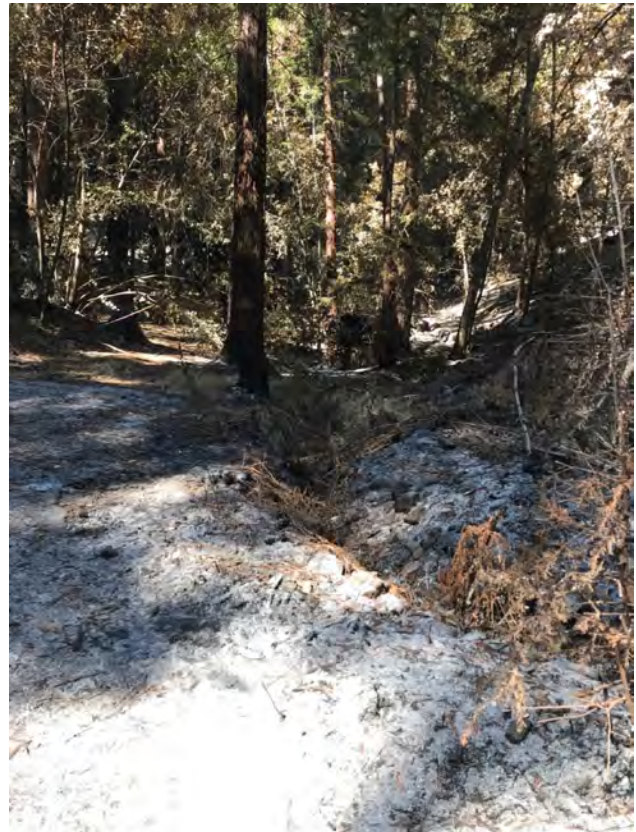
Field Observation Potential for debris flow to impact temporary housing site. Existing structures or Potential Hazard: destroyed.

Potential Hazard to Life: **high**

Potential Hazard to Property: **moderate**

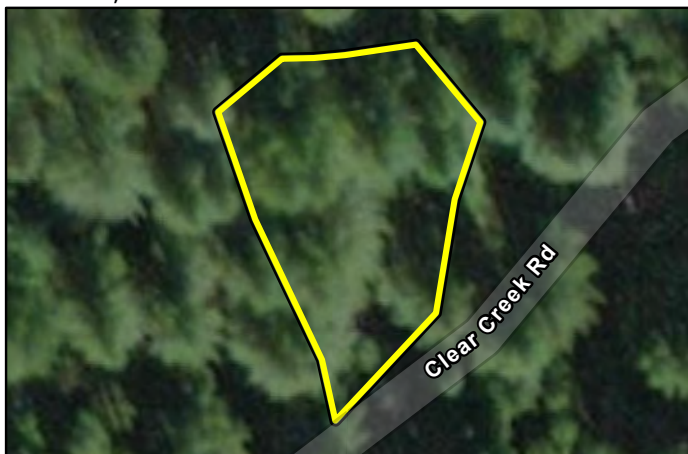
Field Observation Burned homes pads that can be used as temp housing. Additional
or Potential Hazard: determination and observations should be made by a PG or PE.

Potential Hazard to Life: **high**

Potential Hazard to Property: **moderate**

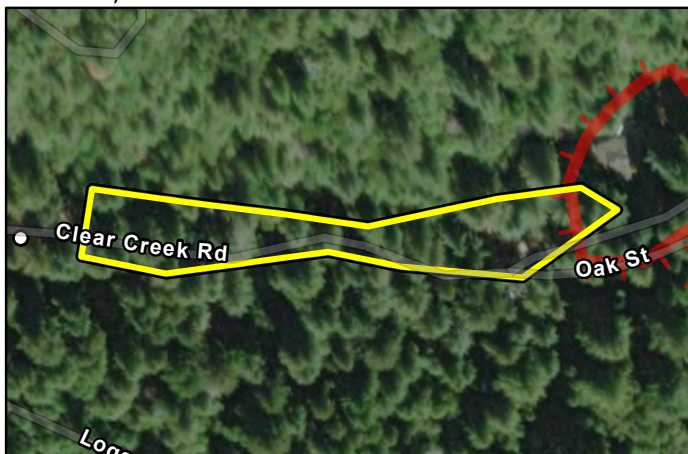
Field Observation Existing house
or Potential Hazard:

Potential Hazard to Life: **high**

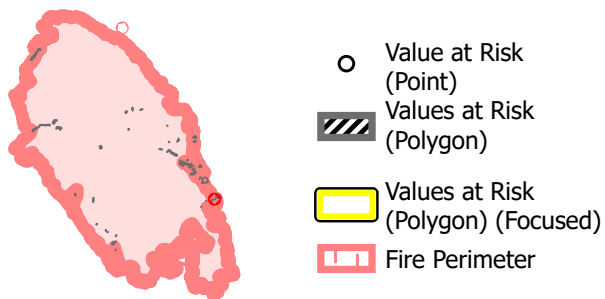
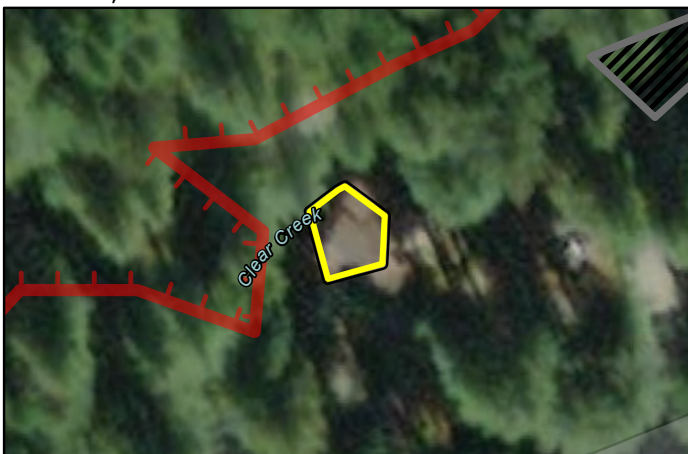
Field Observation Existing house
or Potential Hazard:

Potential Hazard to Life: **high**

Potential Hazard to Property: **high**

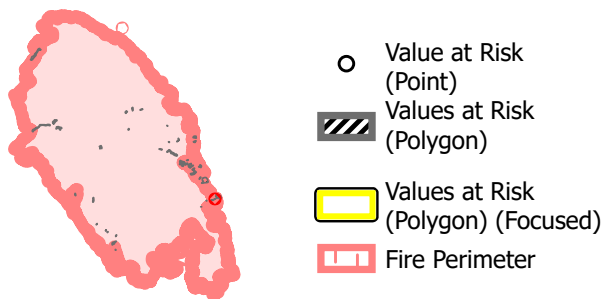
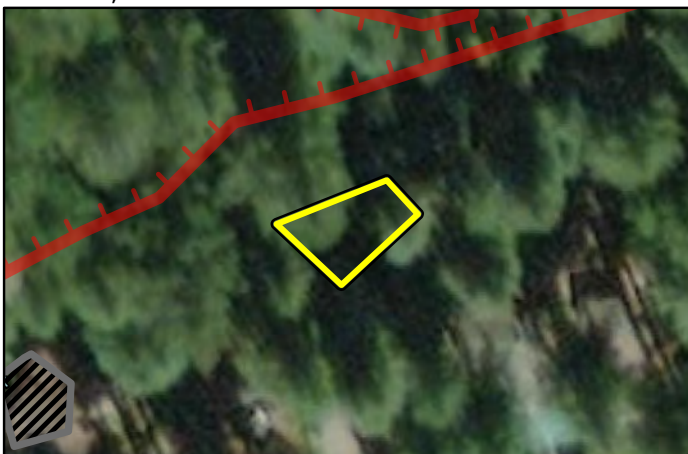
Field Observation Existing house
or Potential Hazard:

Potential Hazard to Life: **high**

Potential Hazard to Property: **high**

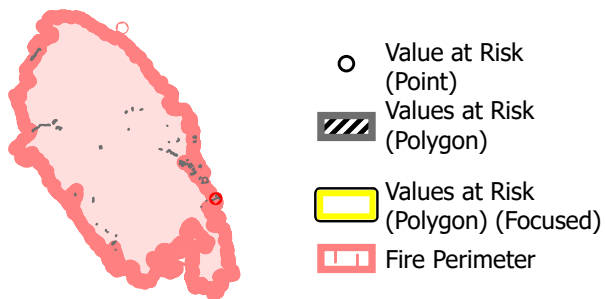
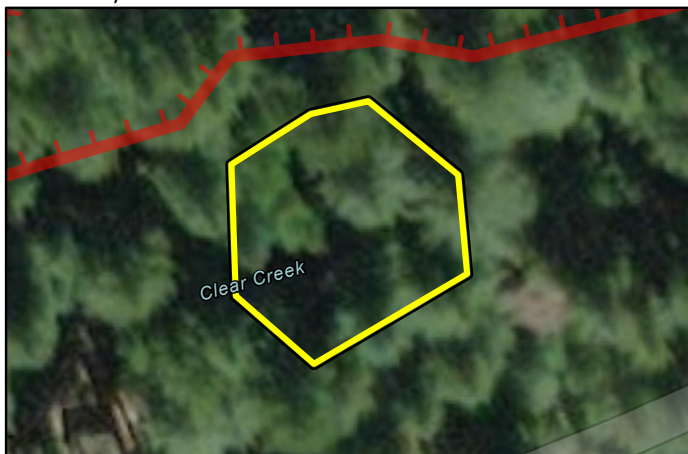
Field Observation Existing structure old building part of Brookdale lodge, the creek runs under the
or Potential Hazard: structure. Additional determination and observations should be made by a PG and PE.

Potential Hazard to Life: **high**

Potential Hazard to Property: **high**

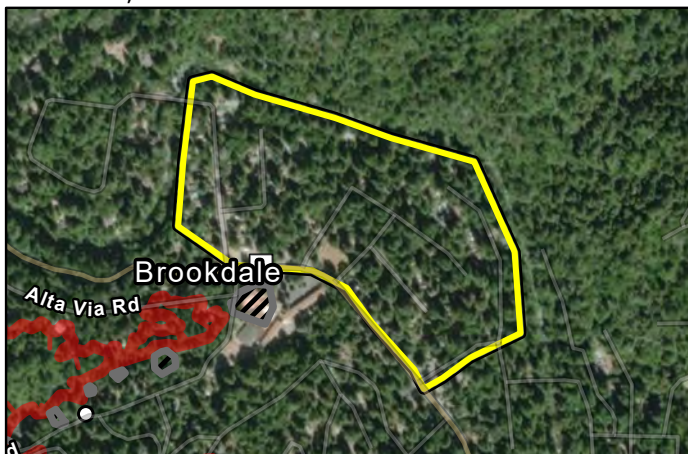
Field Observation YMCA camp located along San Lorenzo River. Low debris flow potential on or Potential Hazard: tributaries to San Lorenzo. Possible flooding on structures adjacent to San Lorenzo.

Potential Hazard to Life: **low**

Potential Hazard to Property: **moderate**

Description: Close camp during winter

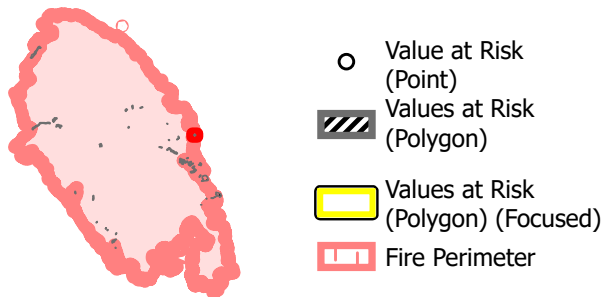
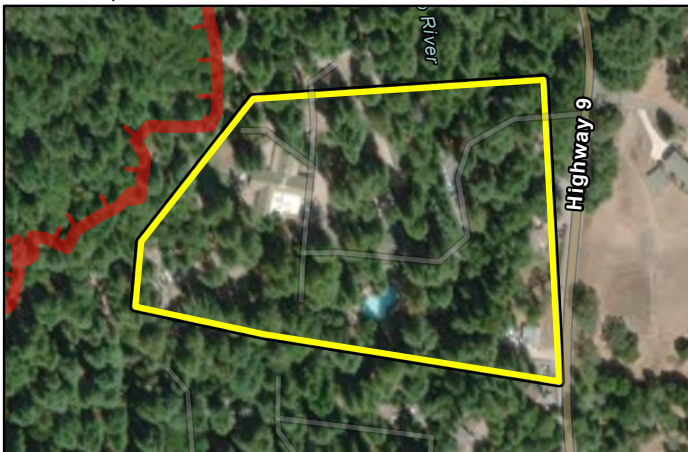
Field Observation Low debris flow potential on tributary to San Lorenzo. Possible debris flow or *Potential Hazard:* impacts to residential structures adjacent to San Lorenzo. Channel is deeply incised, near vertical side channels. Potential choke point at culvert crossing on Wildwood Road

Potential Hazard to Life: **moderate**

Potential Hazard to Property: **moderate**

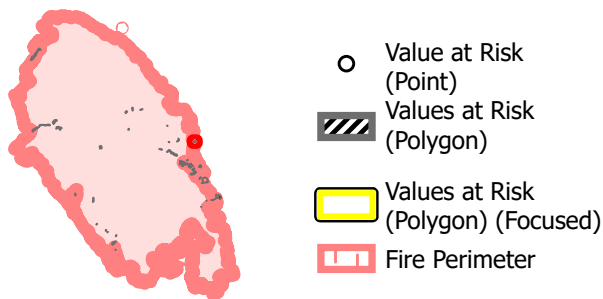
Field Observation Debris flow/slide. Campgrounds located on alluvial fan deposits visible of
or Potential Hazard: hillshade imagery. Moderate to steep slopes above.

Potential Hazard to Life: moderate

Potential Hazard to Property: low

Description: Temporary Closure

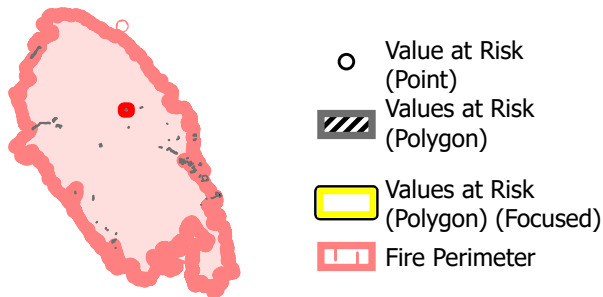
Field Observation Impact to CAL FIRE station including fuel tank. Plugging at culvert just
or Potential Hazard: upstream (east) of station, may direct flows towards structure and/gas vault.

Potential Hazard to Life: **moderate**

Potential Hazard to Property: **moderate**

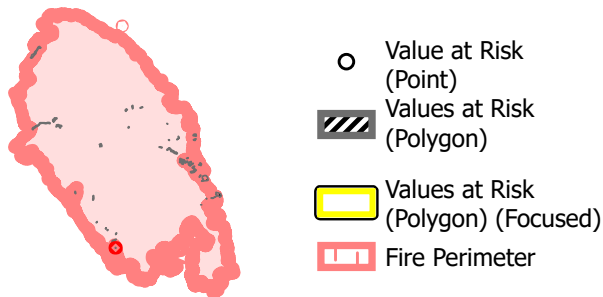
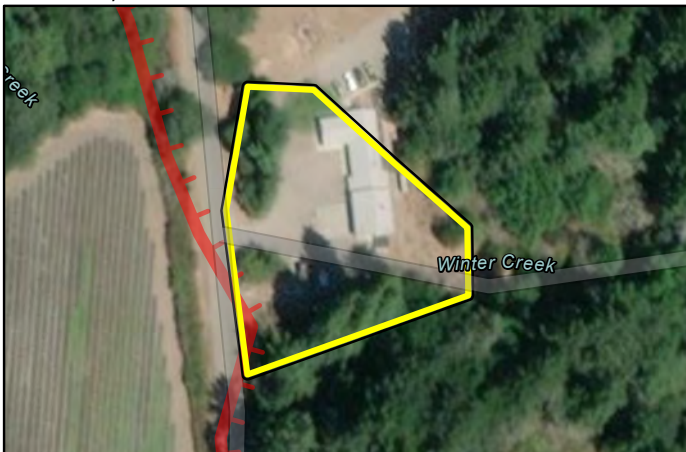
Field Observation Potential for flooding to impact temporary housing site. Existing structures or Potential Hazard: destroyed.

Potential Hazard to Life: **moderate**

Potential Hazard to Property: **moderate**

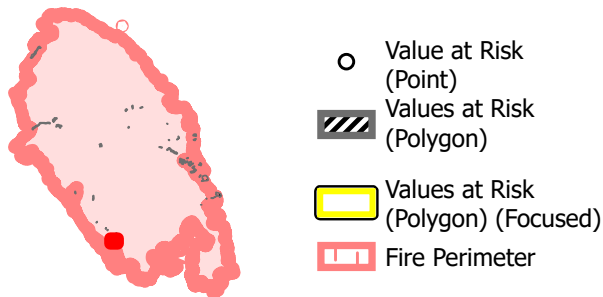
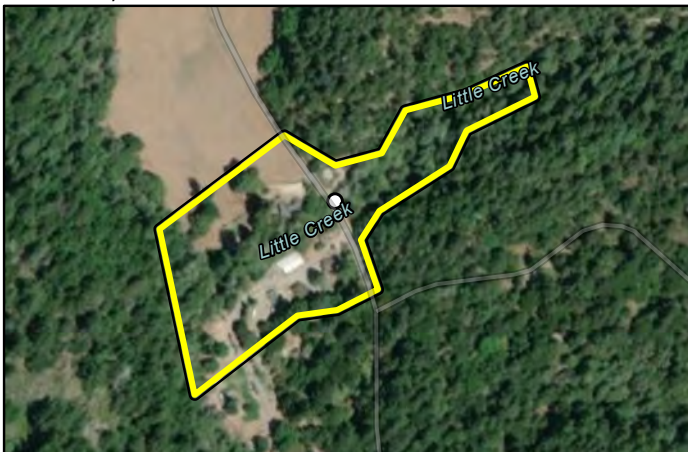
Field Observation Potential for flooding to impact temporary housing site. Existing structures or Potential Hazard: destroyed.

Potential Hazard to Life: **moderate**

Potential Hazard to Property: **moderate**

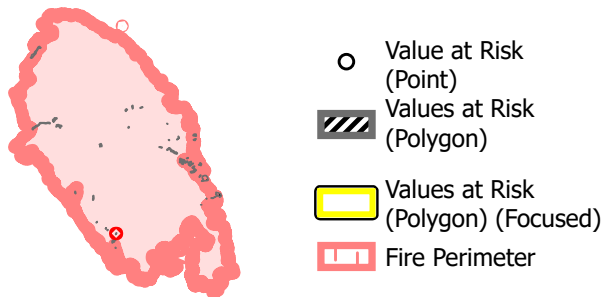
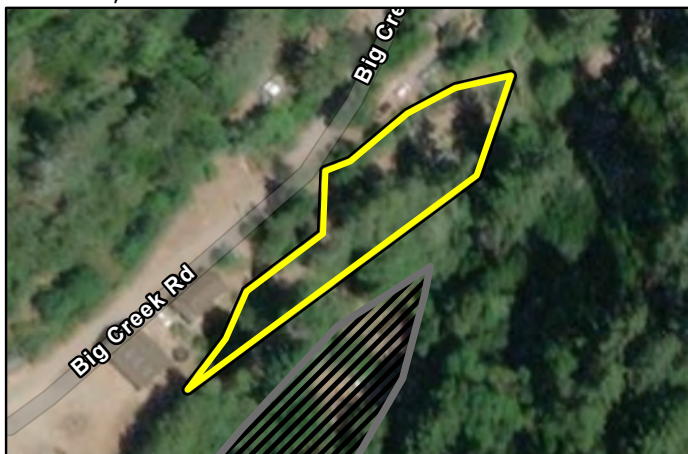
Field Observation Potential for flooding to impact temporary housing site. Existing structures or Potential Hazard: destroyed.

Potential Hazard to Life: **moderate**

Potential Hazard to Property: **moderate**

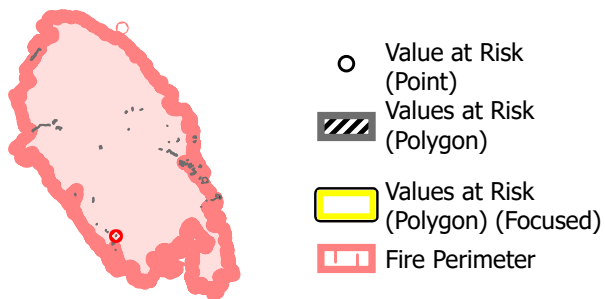
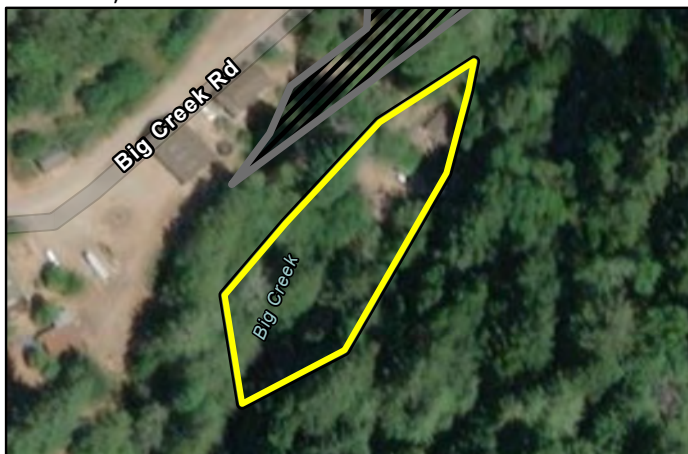
Field Observation Potential for flooding to impact temporary housing site. Existing structures or Potential Hazard: destroyed.

Potential Hazard to Life: **low**

Potential Hazard to Property: **low**

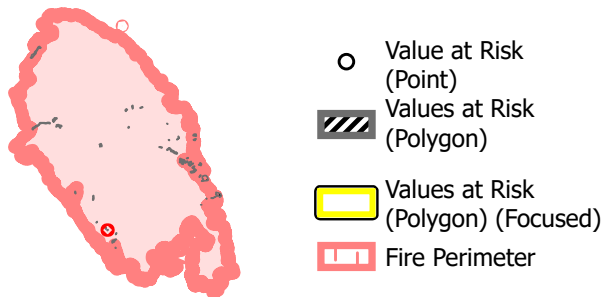
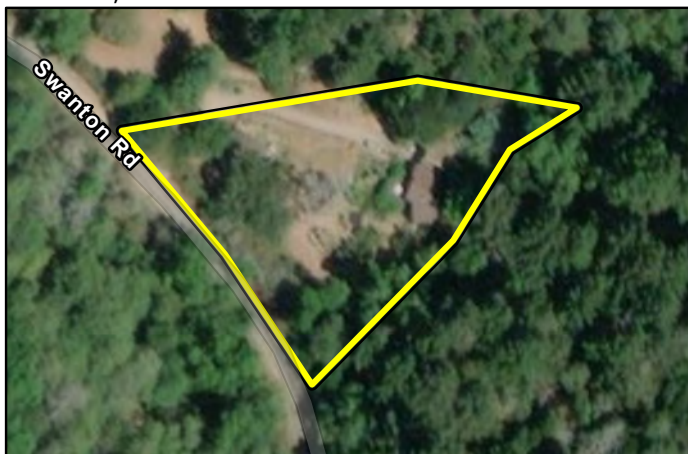
Field Observation Potential for flooding to impact temporary housing site. Existing structures or Potential Hazard: destroyed.

Potential Hazard to Life: **moderate**

Potential Hazard to Property: **moderate**

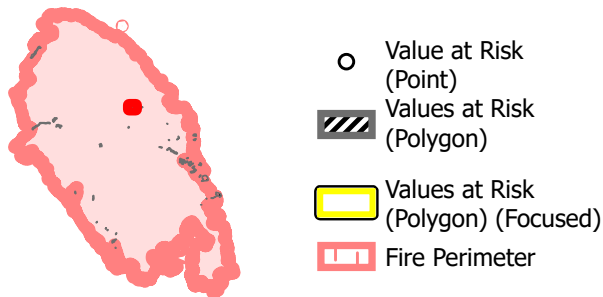
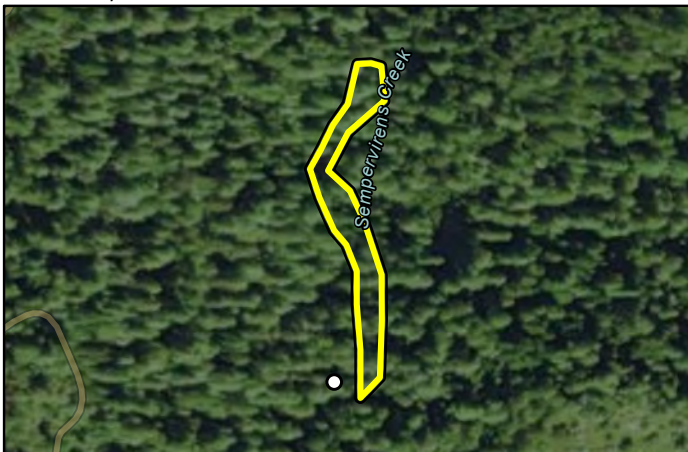
Field Observation Homes within floodplain
or Potential Hazard:

Potential Hazard to Life: **low**

Potential Hazard to Property: **moderate**

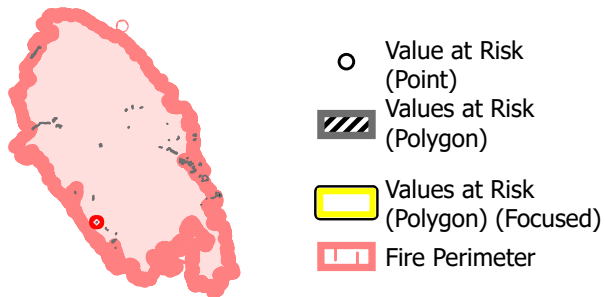
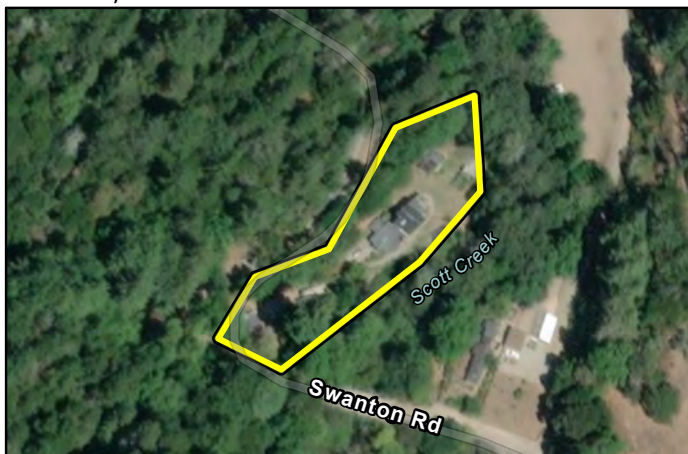
Field Observation Homes within floodplain
or Potential Hazard:

Potential Hazard to Life: **low**

Potential Hazard to Property: **moderate**

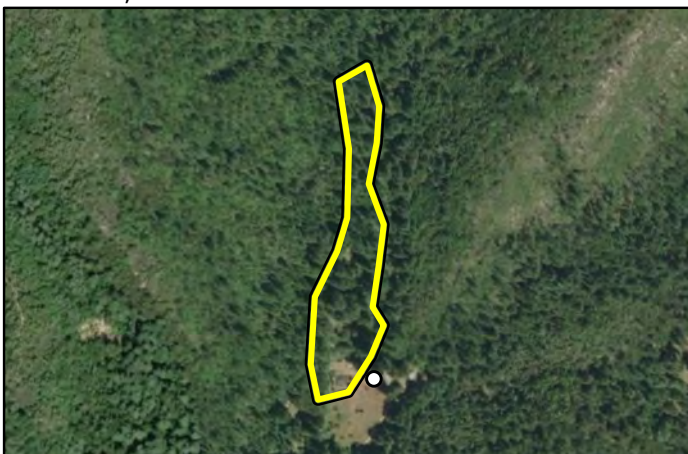
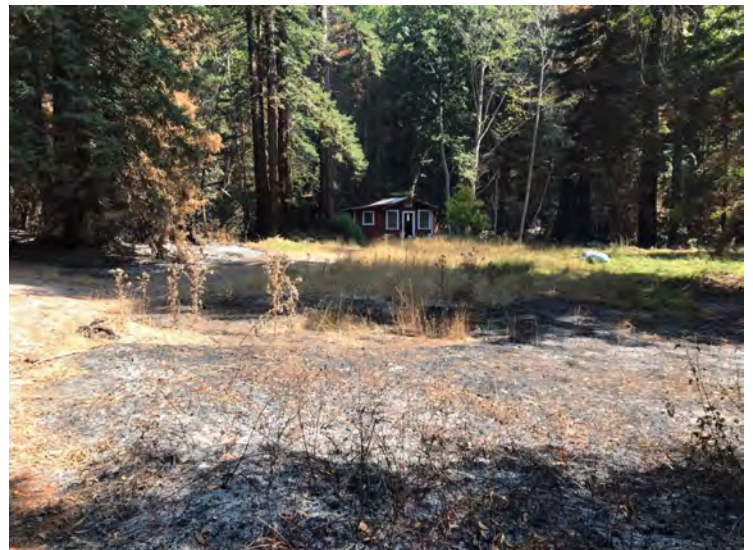
Field Observation Domestic water company located on a tributary to Jamison Creek. Large
or Potential Hazard: boulders observed in channel indicate past debris flow activity and potential for
avulsion.

Potential Hazard to Life: low

Potential Hazard to Property: moderate
