## ENGINEERING COMMITTEE MEETING Minutes November 7, 2019

Reference: Lyon Tank Access Road Landslide Repair 365 Madrone Drive Boulder Creek, California

In accordance with the request of the San Lorenzo Valley Water District (SLVWD), Haro, Kasunich and Associates, Inc. (HKA) have performed a Geotechnical Investigation for the repair of the access road that services the Lyon Tank in Boulder Creek, California.

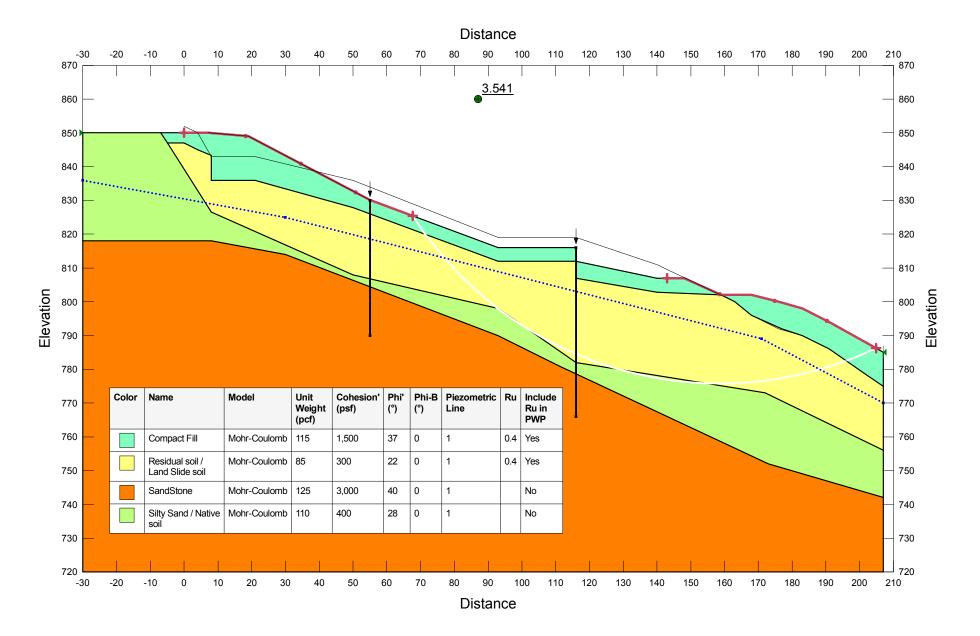
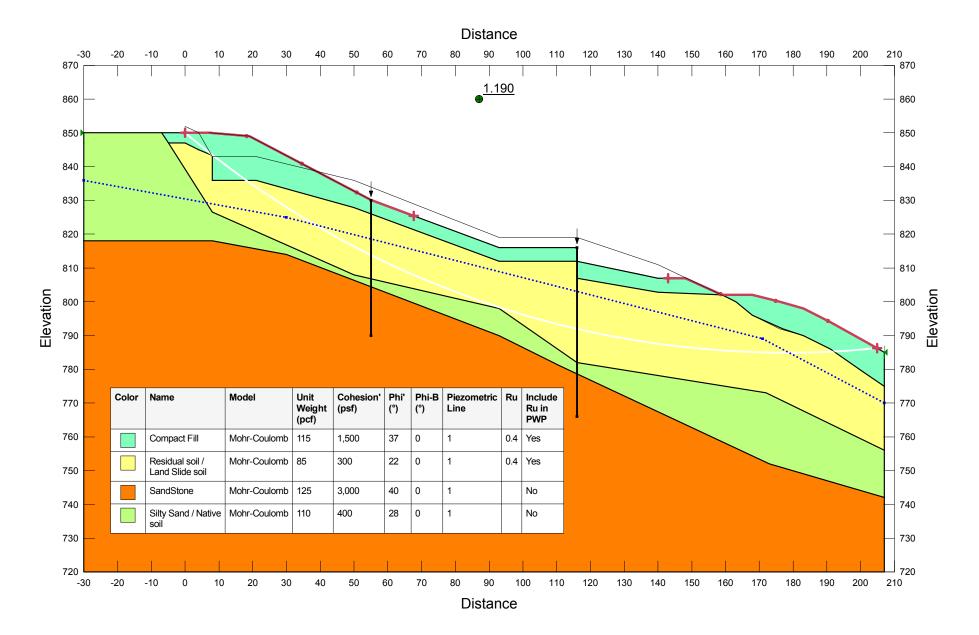
### Lyon Tank Slope Stability Safety Factor- Cross Section C3- Current Condition - Seismic

Figures 63 & 64 in Appendix C show the safety factor of the current condition slope stability. The result shows that in a probable predicted future earthquake event, the existing slope can not be stable and will likely fail. The existing landslide mass will continue to be unstable under static condition as well. Under a seismic condition, all of the soil layers above the bedrock will likely be involved in the slope failure. In order to highlight the present failure condition, shading contours have been provided. As discussed previously, the slope is considered relatively stable if the safety factor under a seismic condition is more than 1.1. As can be seen in Figure 64 in Appendix C, the dark blue shading contours show a safety factor equal to or greater than 1.1 and the border of the light and dark blue zones shows the depth of future probable landslide planes and the thickness of the resulting probable future landslide mass. This border mostly touches the bedrock which indicates the predicted potential future landslide includes the native soil layers below the 2017 landslide mass and thus are susceptible to future landsliding. Therefore, slope stabilization should be considered at least as deep as the top surface of the bedrock.

Note : The border of light blue and dark blue zones shows the thickness of the future probable landslide. (SF less than 1.1 in Figure No. 63 seismic condition are considered as instable slope.

Figures 62 and 63 in Appendix C show the slope stability safety factors for the current condition. The results show the existing landslide mass is unstable under the static condition (i.e. near a factor of safety of 1.0), as can be seen in Figure 62 in Appendix C. The results also show that in a probable future earthquake event, the existing slope will likely fail, as can be seen in Figure 63 in Appendix C. Our figure depicts the worst case (i.e. lowest factor of safety) landslide. Note that the analysis indicated multiple failure surface extending as deep as the top of bedrock. Therefore, slope stabilization should be considered at least as deep as the top surface of the bedrock.

HKA recommends unloading the soil mass by removing the upper 5 (+/-) feet of soil starting below Madrone Road up to the head scarp. The soil mass starting from Hessey Creek up to the head scarp should be stabilized using three rows of buried secant piles or two rows of buried secant walls with a culvert fill slope buttressing the toe. The upper row of secant piles is recommended to be constructed on the hillside approximately halfway up to the head scarp from Madrone Road. The upper row is estimated to be 150 feet long by as much as 40 feet deep. The middle row of secant piles would be constructed along the outboard side of Madrone Road and is estimated to be 200 feet long by as much as 55 feet deep. The lower row of secant piles is recommended to be constructed approximately 20 feet from Hessey Creek and along portions of the existing dirt path. The lower secant row is estimated to be 225 feet long and 50 feet deep. To rebuild and secure the severely damaged portion of the upper access road where the soil mass dislodged from the head scarp, an engineered fill slope is recommended to be constructed from the upper row of secant piles up to the inboard side of the damaged upper road.
