**SAN LORENZO VALLEY WATER DISTRICT
CROSS COUNTRY PIPELINE CONSTRUCTABILITY
PEER REVIEW OF FREYER & LAURETA STUDY AND MEMO**

**Peer Review of March 2022 Study and
Draft Supplemental Evaluation Dated April 6, 2022**

24 NOVEMBER 2022
PROJECT NO. 12196

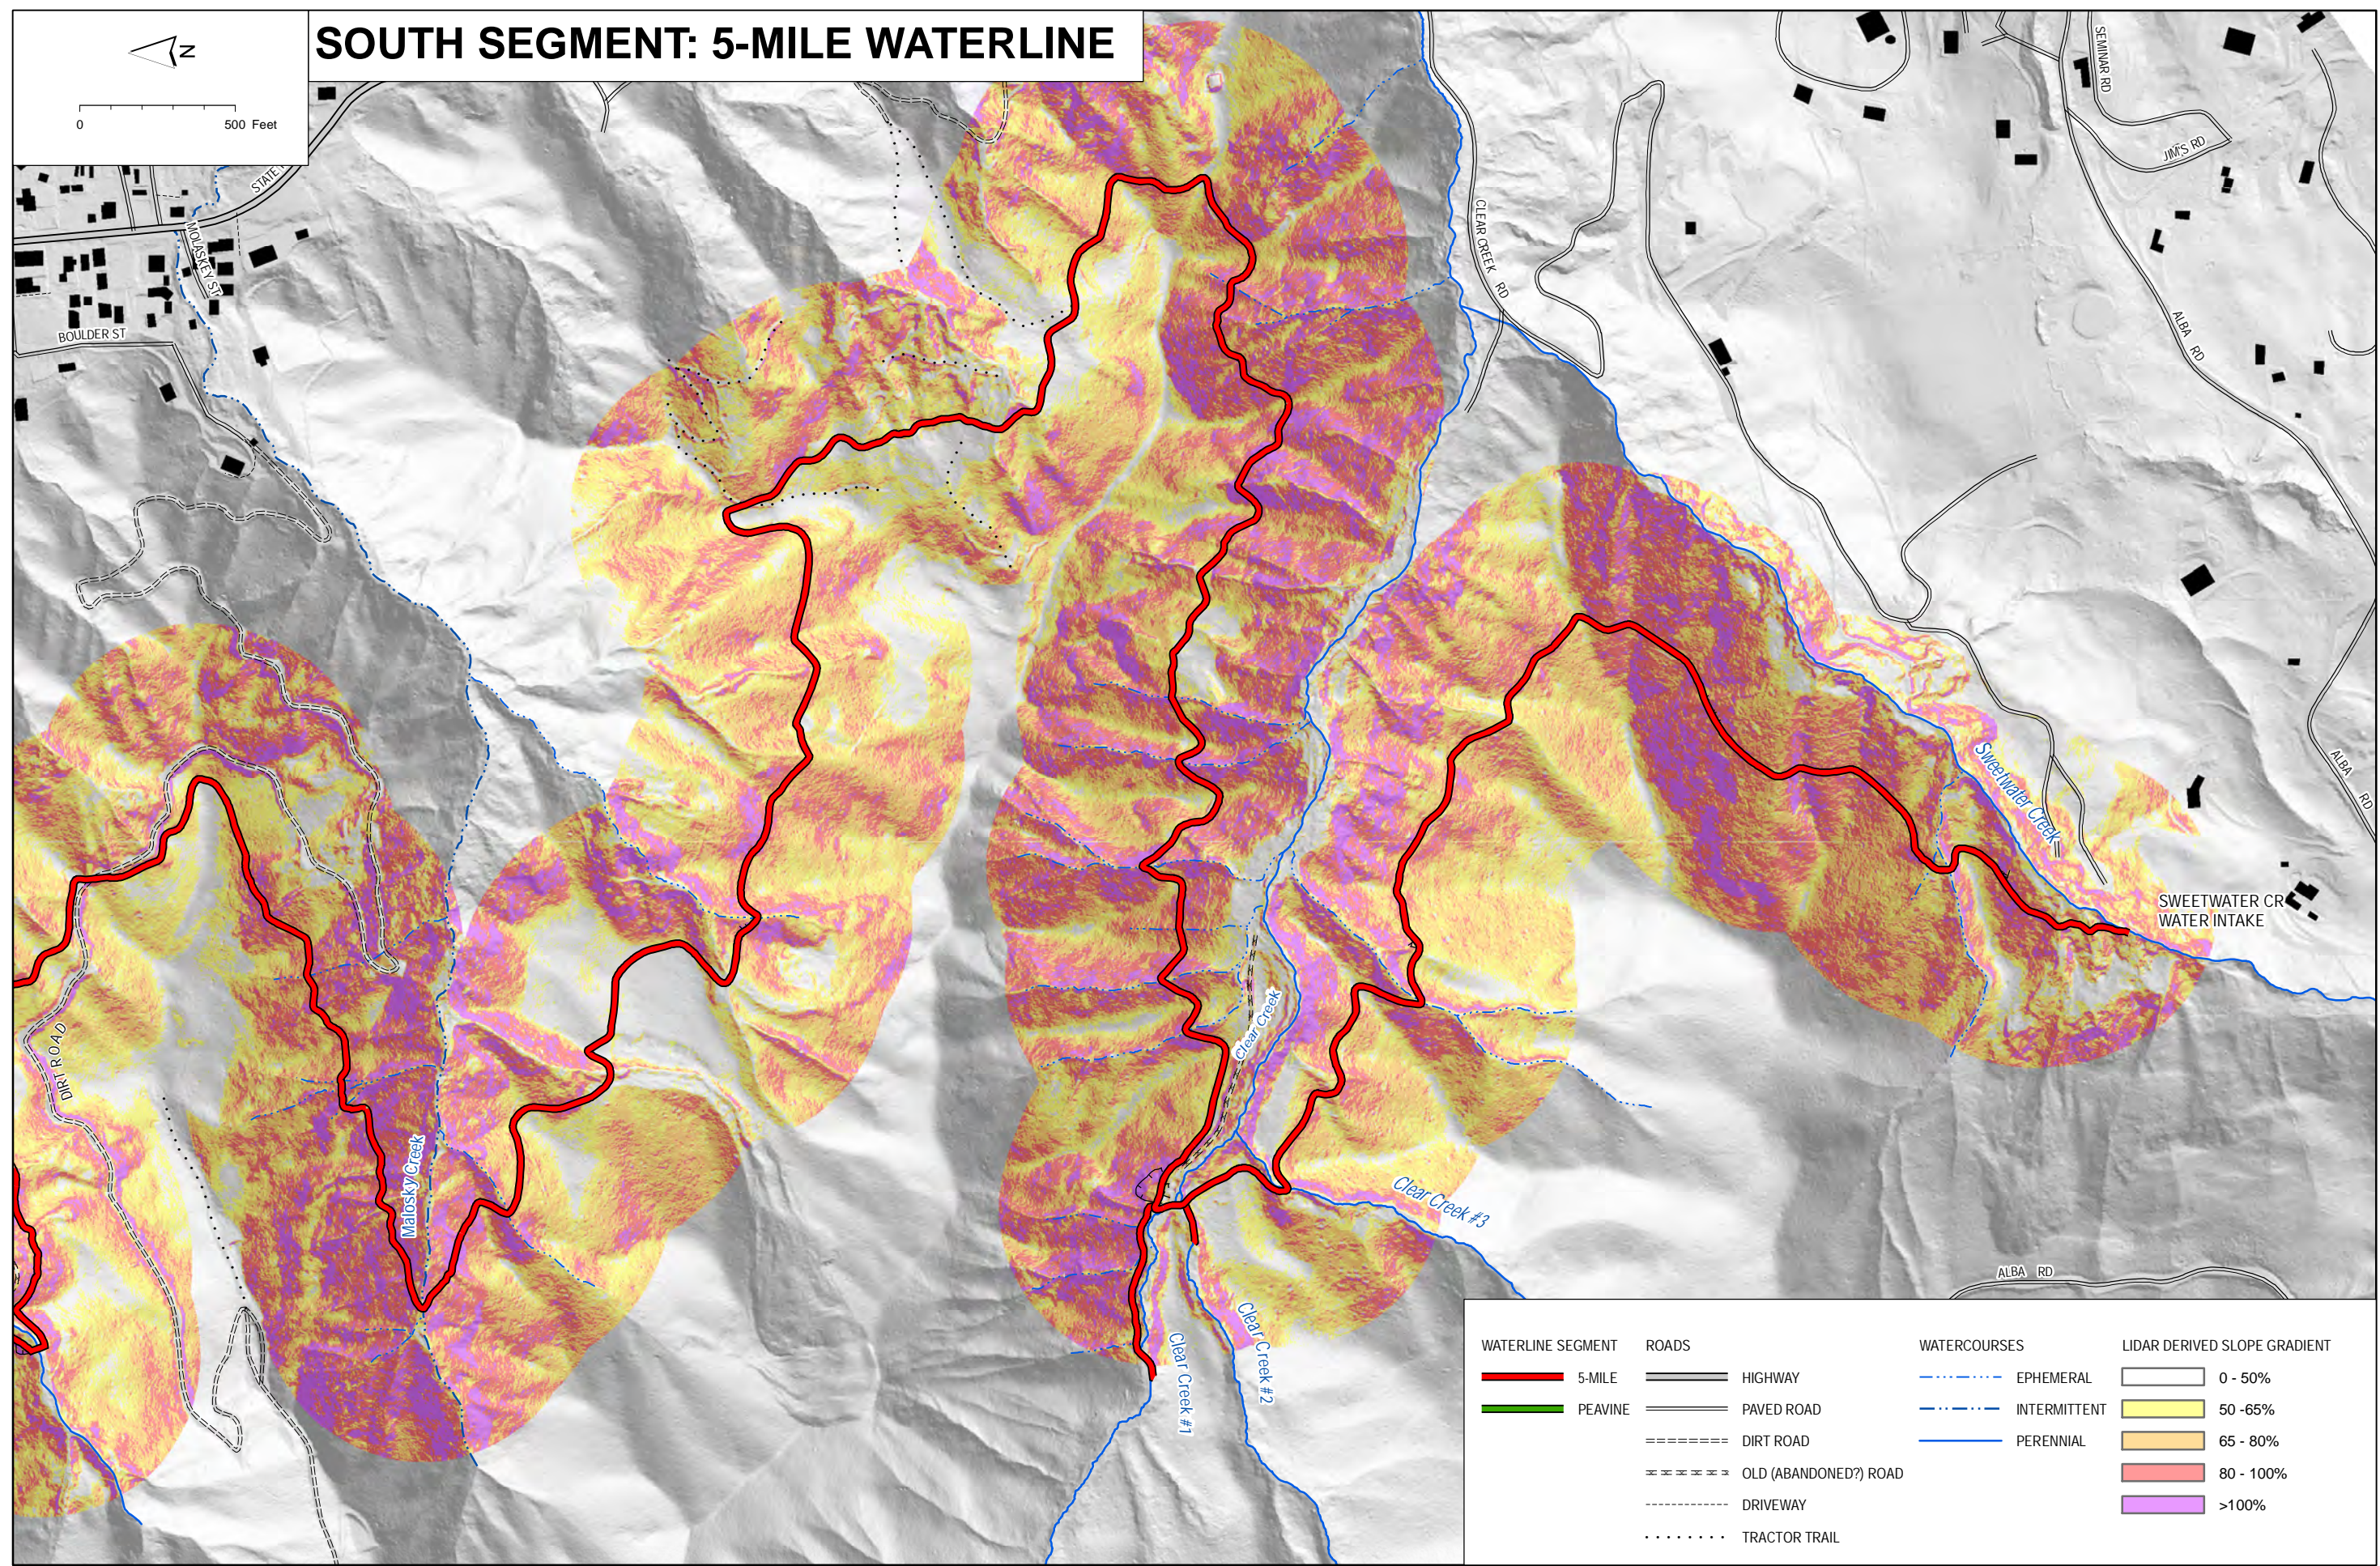
FIGURE 1A
 PROJECT: 12196
 Date: 10/24/2022

Our LiDAR analysis (See Figure 1A, B and C in Appendix A and Table 1 on Page 20) and the field reconnaissance suggests that about 87% of the alignment is adjacent to slopes steeper than 50% = 2:1(H:V). This difference corresponds to approximately 13,000 feet (lf) of additional alignment that may require retaining structures. Using the F&L unit price cost estimate of \$700/lf, an additional 37%

HKA finds about 87% of the alignment (5.7 miles) appears to traverse slopes steeper than 2:1 (50%) with nearly 13% (4,650 feet) steeper than 100% (See Figures 1A, B and C in Appendix A, and Table 1 on Page 20). The steep slopes that dominate the waterline alignment present a significant constraint and were one of the reasons why the original waterline was installed by hand.

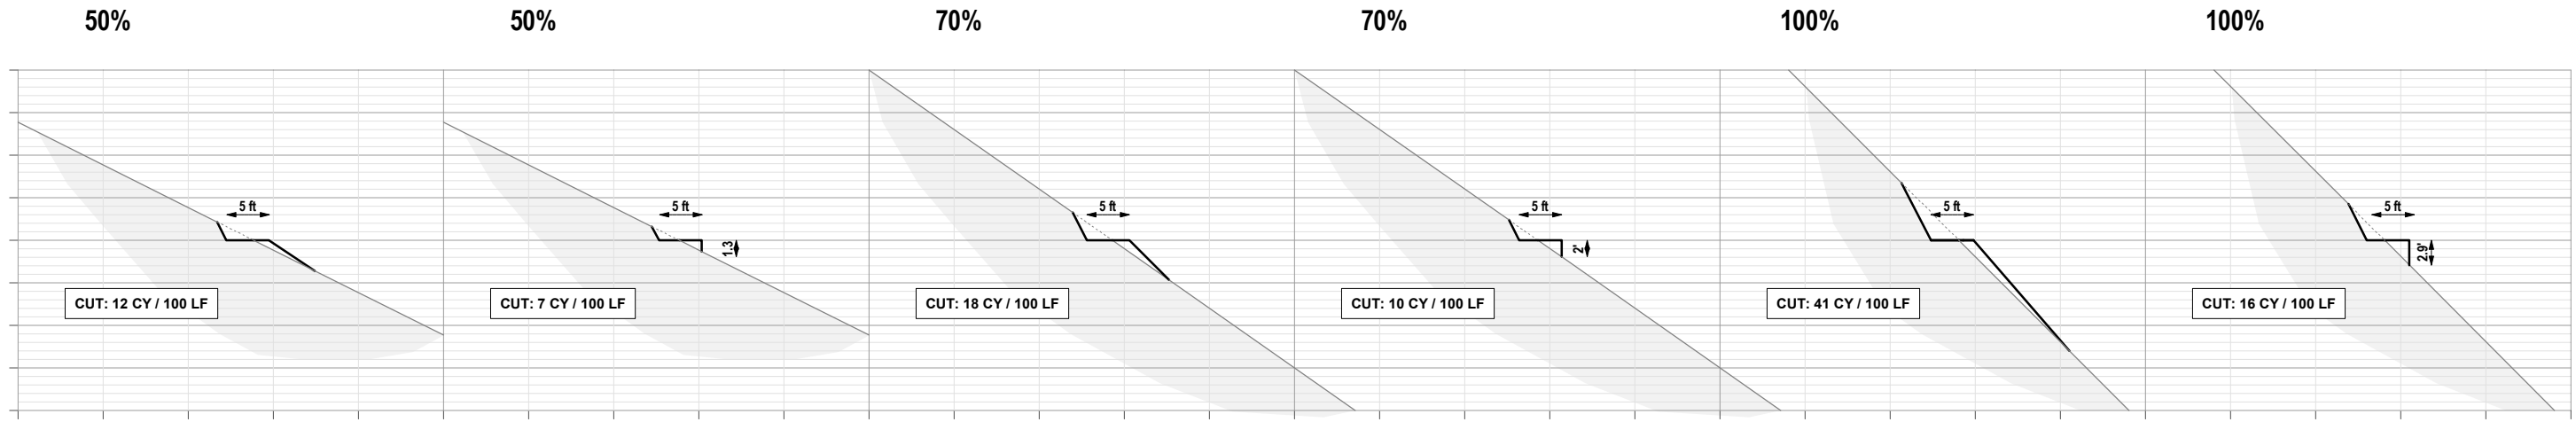
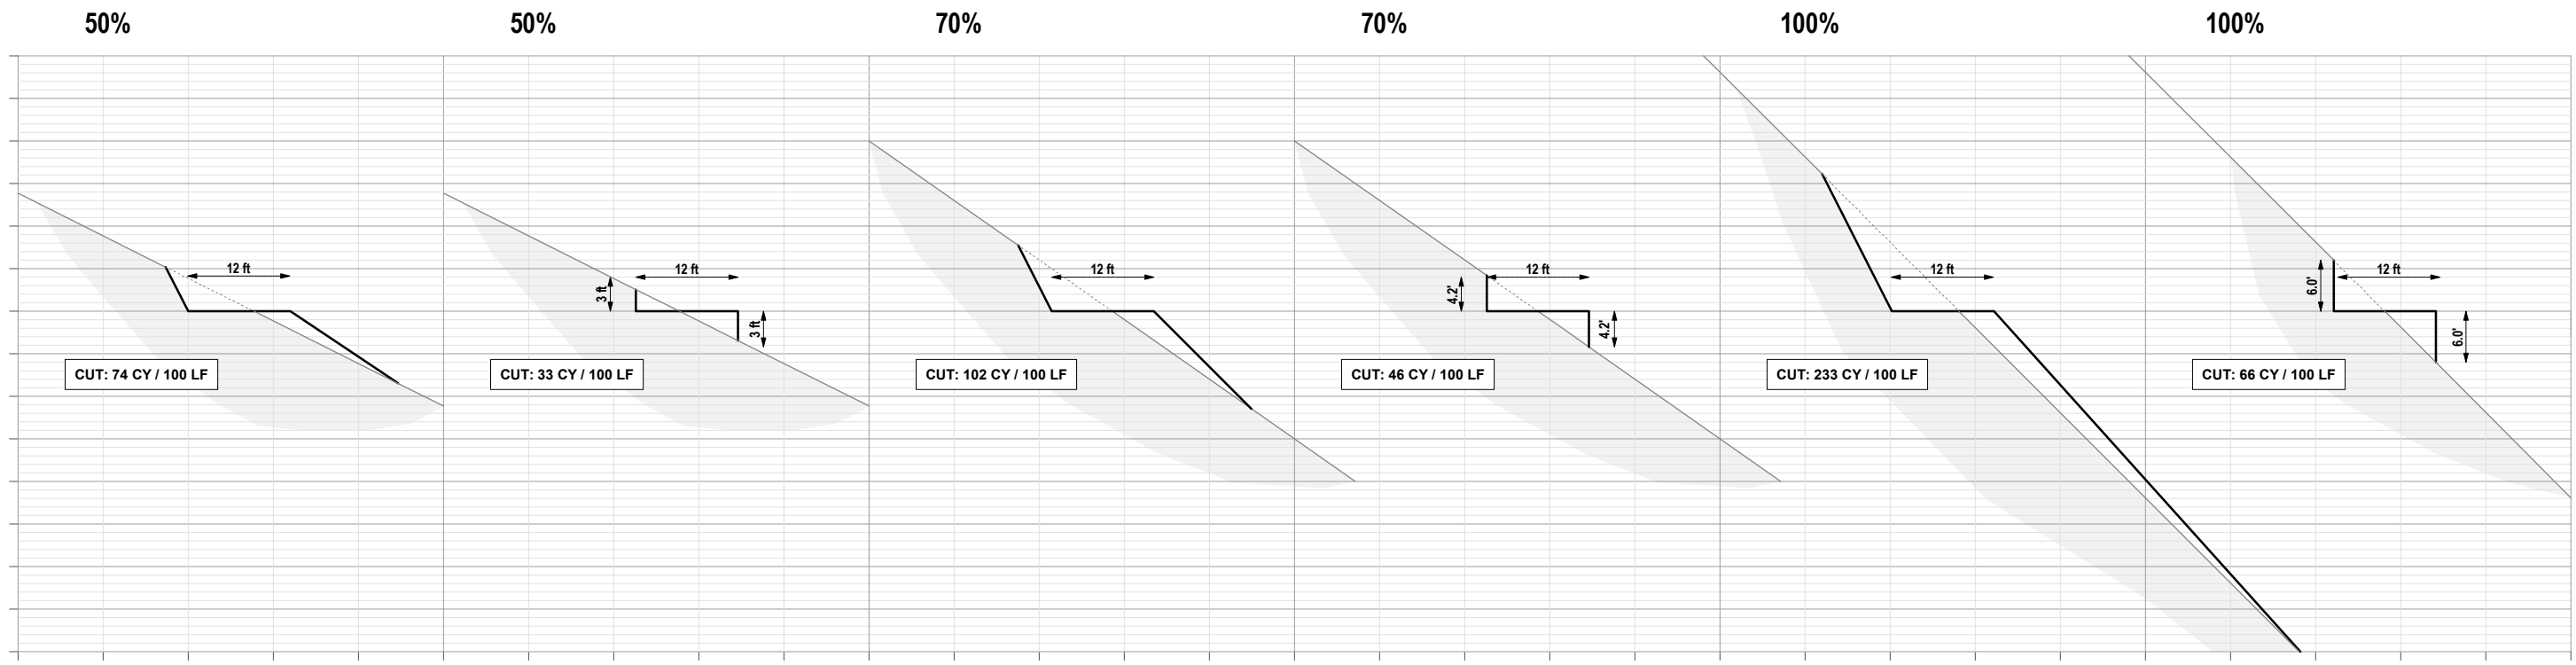
FIGURE 5
PROJECT: 12196
Date: 10/24/2022

The problem with a larger excavator is a significantly greater volume of material needs to be graded and associated larger retaining walls will be required. This is illustrated in Figure 5 that show grading volumes are much greater for the 12 foot wide (road width) bench compared to a 5 foot (trail width) bench. The problem with a smaller excavator in this environment is they tend to be more tippy and do not have the weight or power to excavate through harder soils or large tree roots in an effective manner.

HKA examined Figure 3 in the F&L March 2022 STUDY. The cross sections presented are not to scale and thus could be misleading. We have redrawn Sections 1, 3, 4, 6, 7 and 9 to scale on 50%, 70% and 100% slopes and those are presented in Figure 5. As Table 1 shows, it is likely that 87% of the pipeline alignment crosses slopes over 50%, and 48% of the pipeline alignment crosses slopes that exceed 80%.

The cross sections in the HKA Figure 5 above illustrate the comparative difficulty of construction of 5 foot and 12 foot wide temporary construction benches to support a replacement pipeline. The utilize balanced cut and fill volumes, 0.5:1 (H:V) unretained cutslope concepts, either full retaining structures or thin sliver fills.

What Figure 5 indicates is that 4 to 6 times as much cut is required for a 12 foot wide bench

compared to a 5 foot wide bench. Taking into account both the linear footage of alignment across each slope class as presented in Table 1 and the associated retaining wall heights shown in Figure 5 indicates approximately 6 times as much retaining wall face footage is required for a 12 foot wide bench compared to a 5 foot wide bench. On average, average retaining wall heights on a 12 foot wide bench is over twice that required for a narrower 5 foot wide bench. What this means is very significant grading and engineered retaining walls will be required if a 12 foot wide bench is pursued. We note that retaining wall cost estimates are often not linear with retaining wall height ratios; taller walls have greater costs per square foot of wall face.

For a narrow 5-foot bench, we find that approximately one sixth retaining wall face footage will be required compared to a wider 12 foot bench, and the retaining walls that are needed will need to be less than half the height (See Figure 5 in Appendix A). In some areas, depending on geology, topography, and distance from a watercourse, it may be possible to limit the amount of retaining walls by building the bench out on temporary fill (possibly retained behind logs), then pulling back the oversteepened fill to cover the trench and pipe. This, of course, could only be done if equipment can get to these portions of the alignment, which as we have discussed earlier is questionable in many areas. Moreover, it has been our experience on small trail projects that the precise requirements for retaining walls cannot be predicted with certainty in advance and such walls are often “field fitted” based on actual conditions encountered and are dependent on the skill of the equipment operators.
