**NOTICE OF SPECIAL
ENGINEERING/ENVIRONMENTAL
COMMITTEE
MEETING
September 14, 2023**

WATER LEAK DETECTION PROJECT

Re: June 2023 Water Leak Detection Survey and Pinpointing Project

PLAN & PROFILE VI
QUAIL HOLLOW ROAD
PIPELINE REPLACEMENT

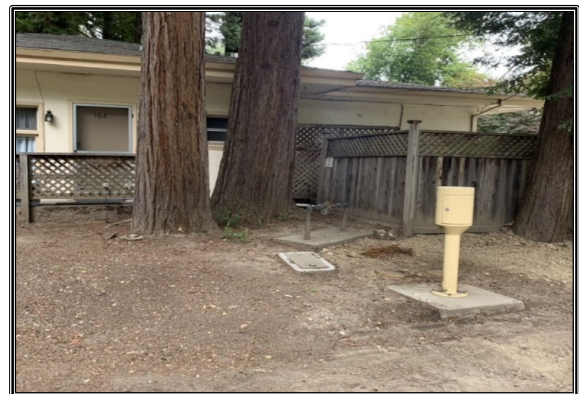
REMARKS
VALVE PACKING LEAK. WATER IN VALVE CAN.

LEAK INFORMATION	
Leak Consultant:	EK
Leak Class:	III
Leak Rate (GPM):	1.00
Cover Type:	ASPHALT
Site Marked:	NO
Mins. Pinpointing:	20

Water Loss (gallons)	
Daily:	1,440
Weekly:	10,080
Monthly:	43,800
Annual:	525,600

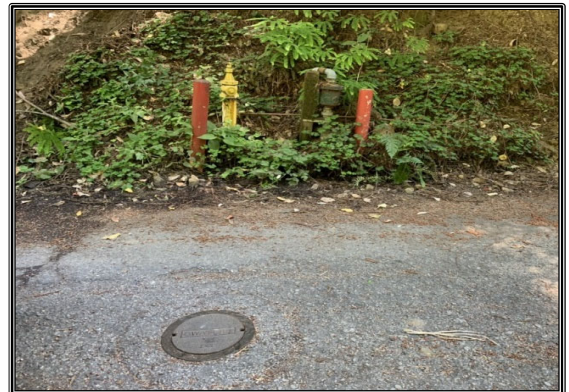
REMARKS
LEAK NEAR AIR RELEASE TIE IN ON WHARF HYDRANT LEATERAL. VERY STRONG LEAK NOISE DETECTED AND WATER FLOWING FROM AFFECTED AREA.

LEAK INFORMATION	
Leak Consultant:	EK
Leak Class:	II
Leak Rate (GPM):	5.00
Cover Type:	GRAVEL
Site Marked:	NO
Mins. Pinpointing:	30

Water Loss (gallons)	
Daily:	7,200
Weekly:	50,400
Monthly:	219,000
Annual:	2,628,000

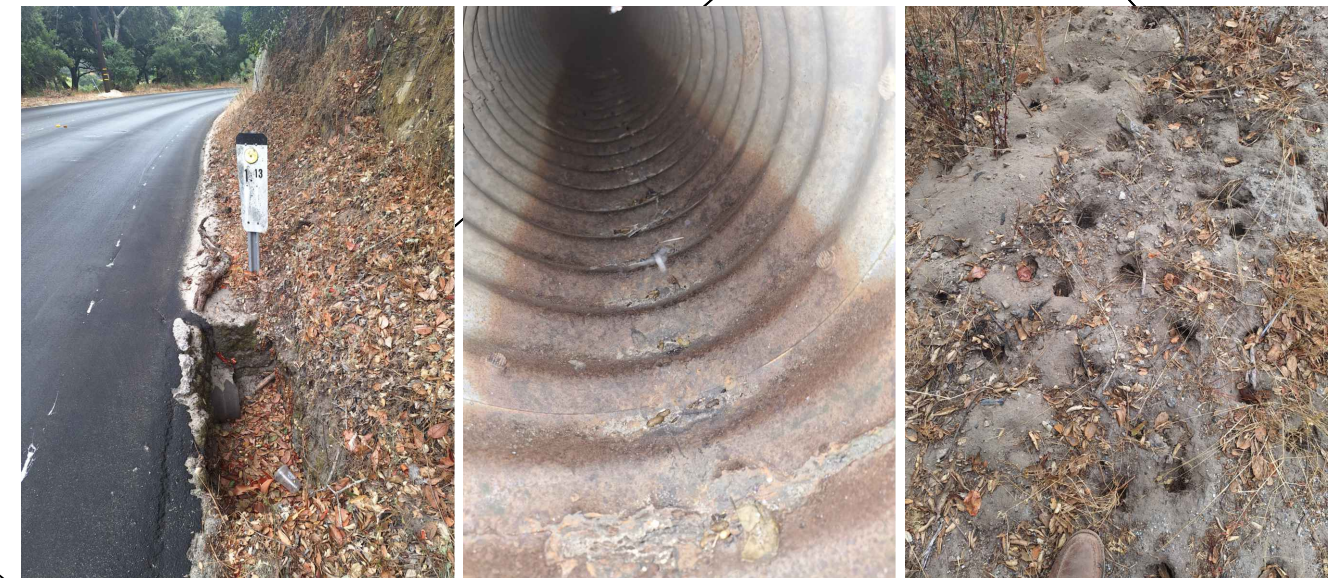
EXISTING CULVERT CONDITION PHOTOS 09/06/2023

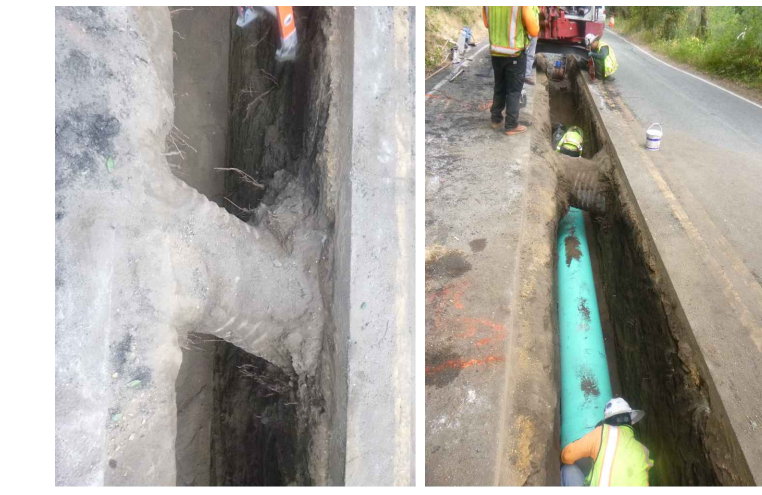
EXISTING CULVERT CONSTRUCTION PHOTOS 08/05/2022

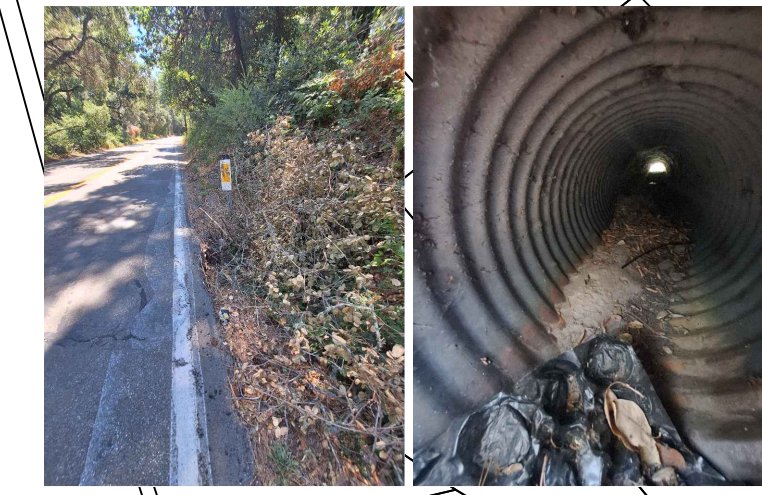
EXISTING CULVERT CONDITION PHOTOS 08/23/2023

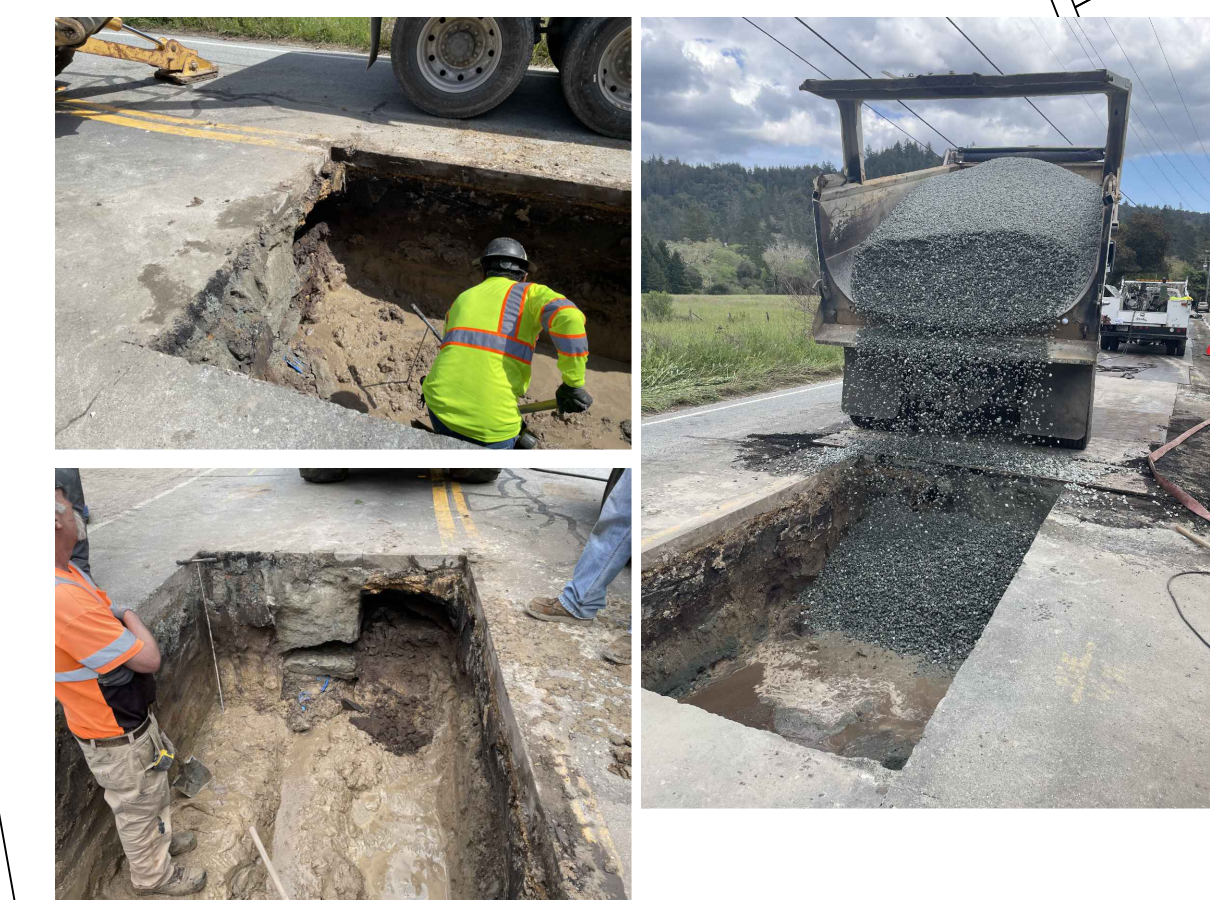
MARCH STORM DAMAGE REPAIRED BY SLVWD & ANDERSON PACIFIC PHOTOS 04/18/2023

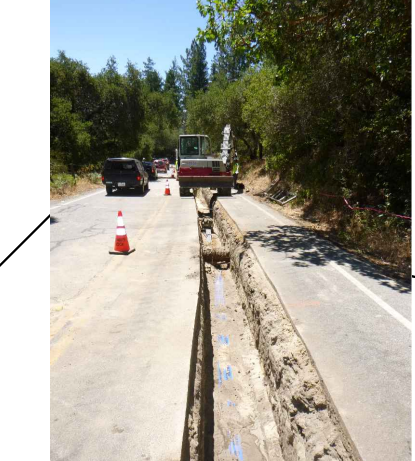
EXISTING CULVERT CONSTRUCTION PHOTOS 07/20/2022

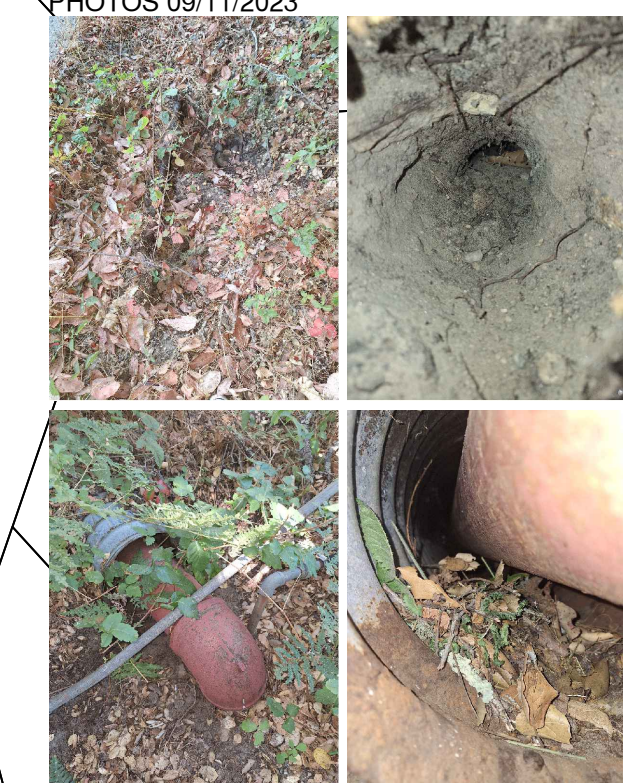
EXISTING CULVERT CONDITION PHOTOS 09/11/2023

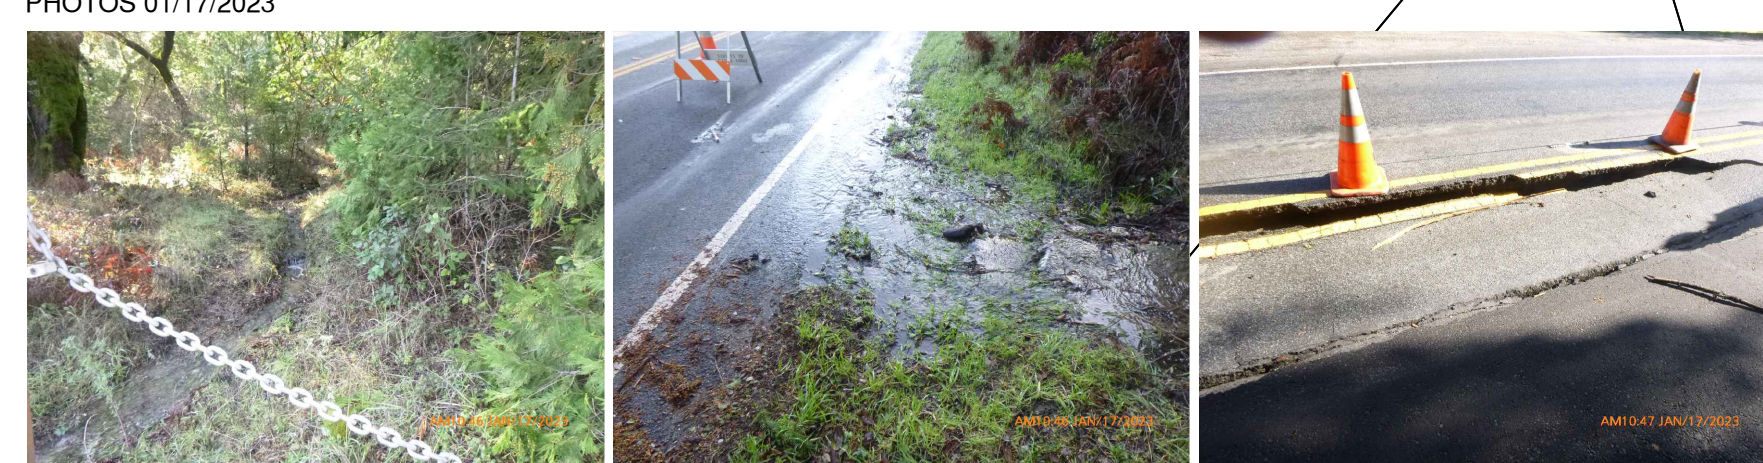
JANUARY STORM DAMAGE REPAIRED BY SANTA CRUZ COUNTY PUBLIC WORKS DEPARTMENT & GRANITEROCK PHOTOS 01/17/2023

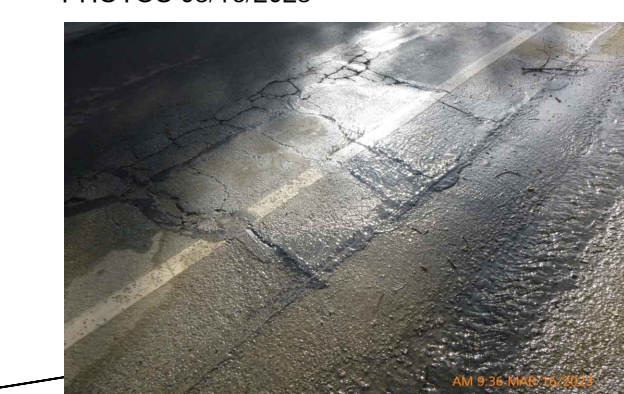
PARALLEL PG&E GAS TRENCH HIGH WATER TABLE PHOTOS 03/16/2023

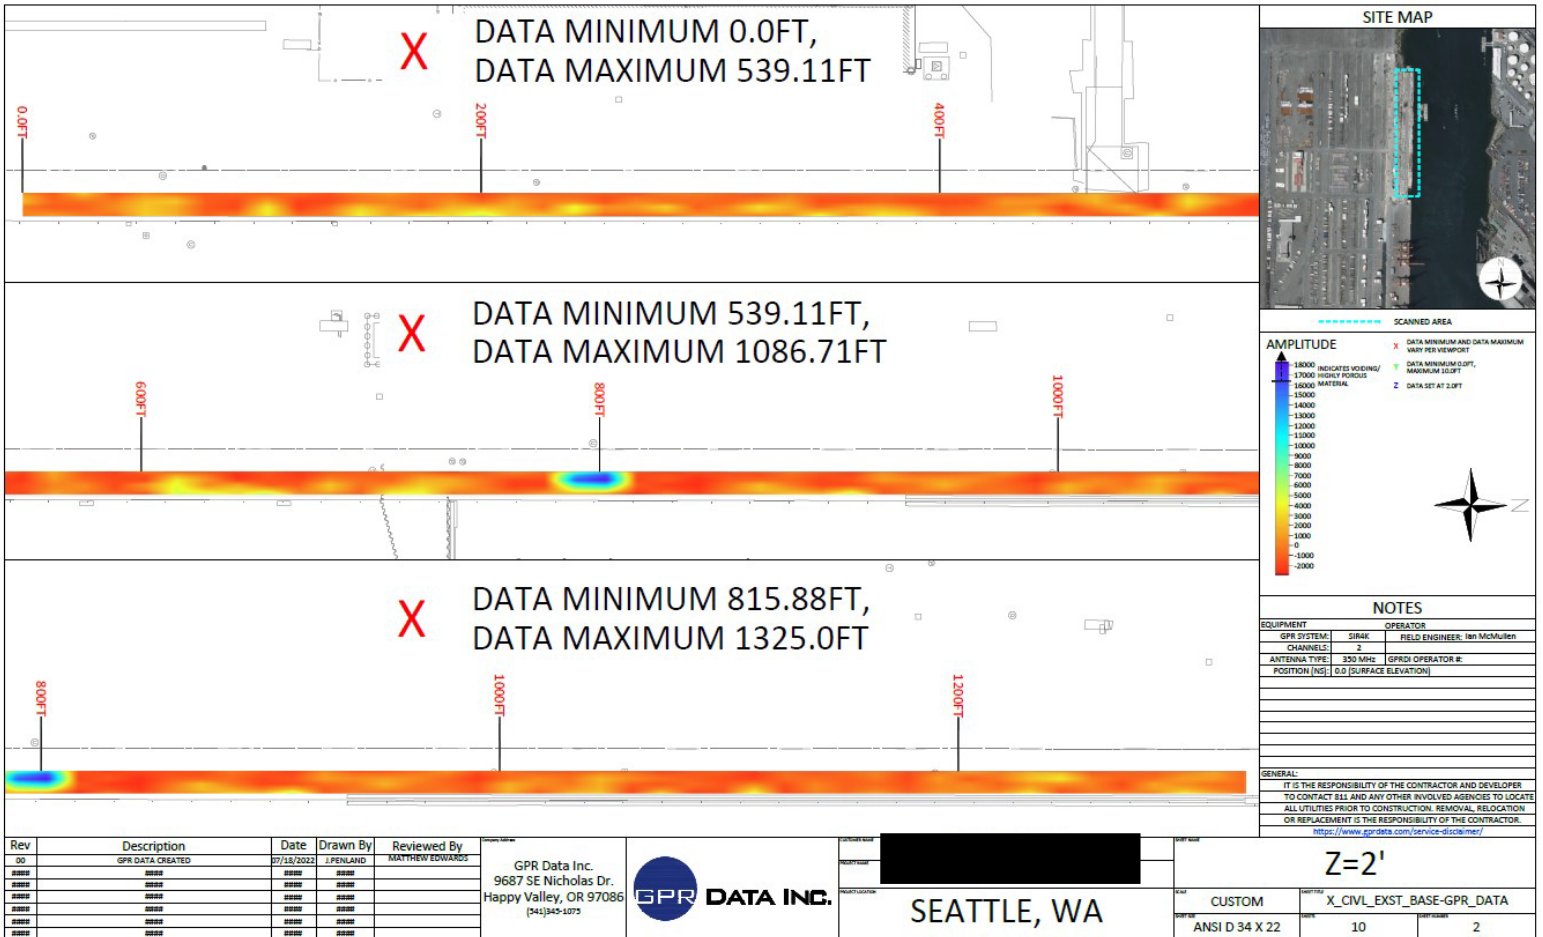
Void mapping at the Port of Seattle:

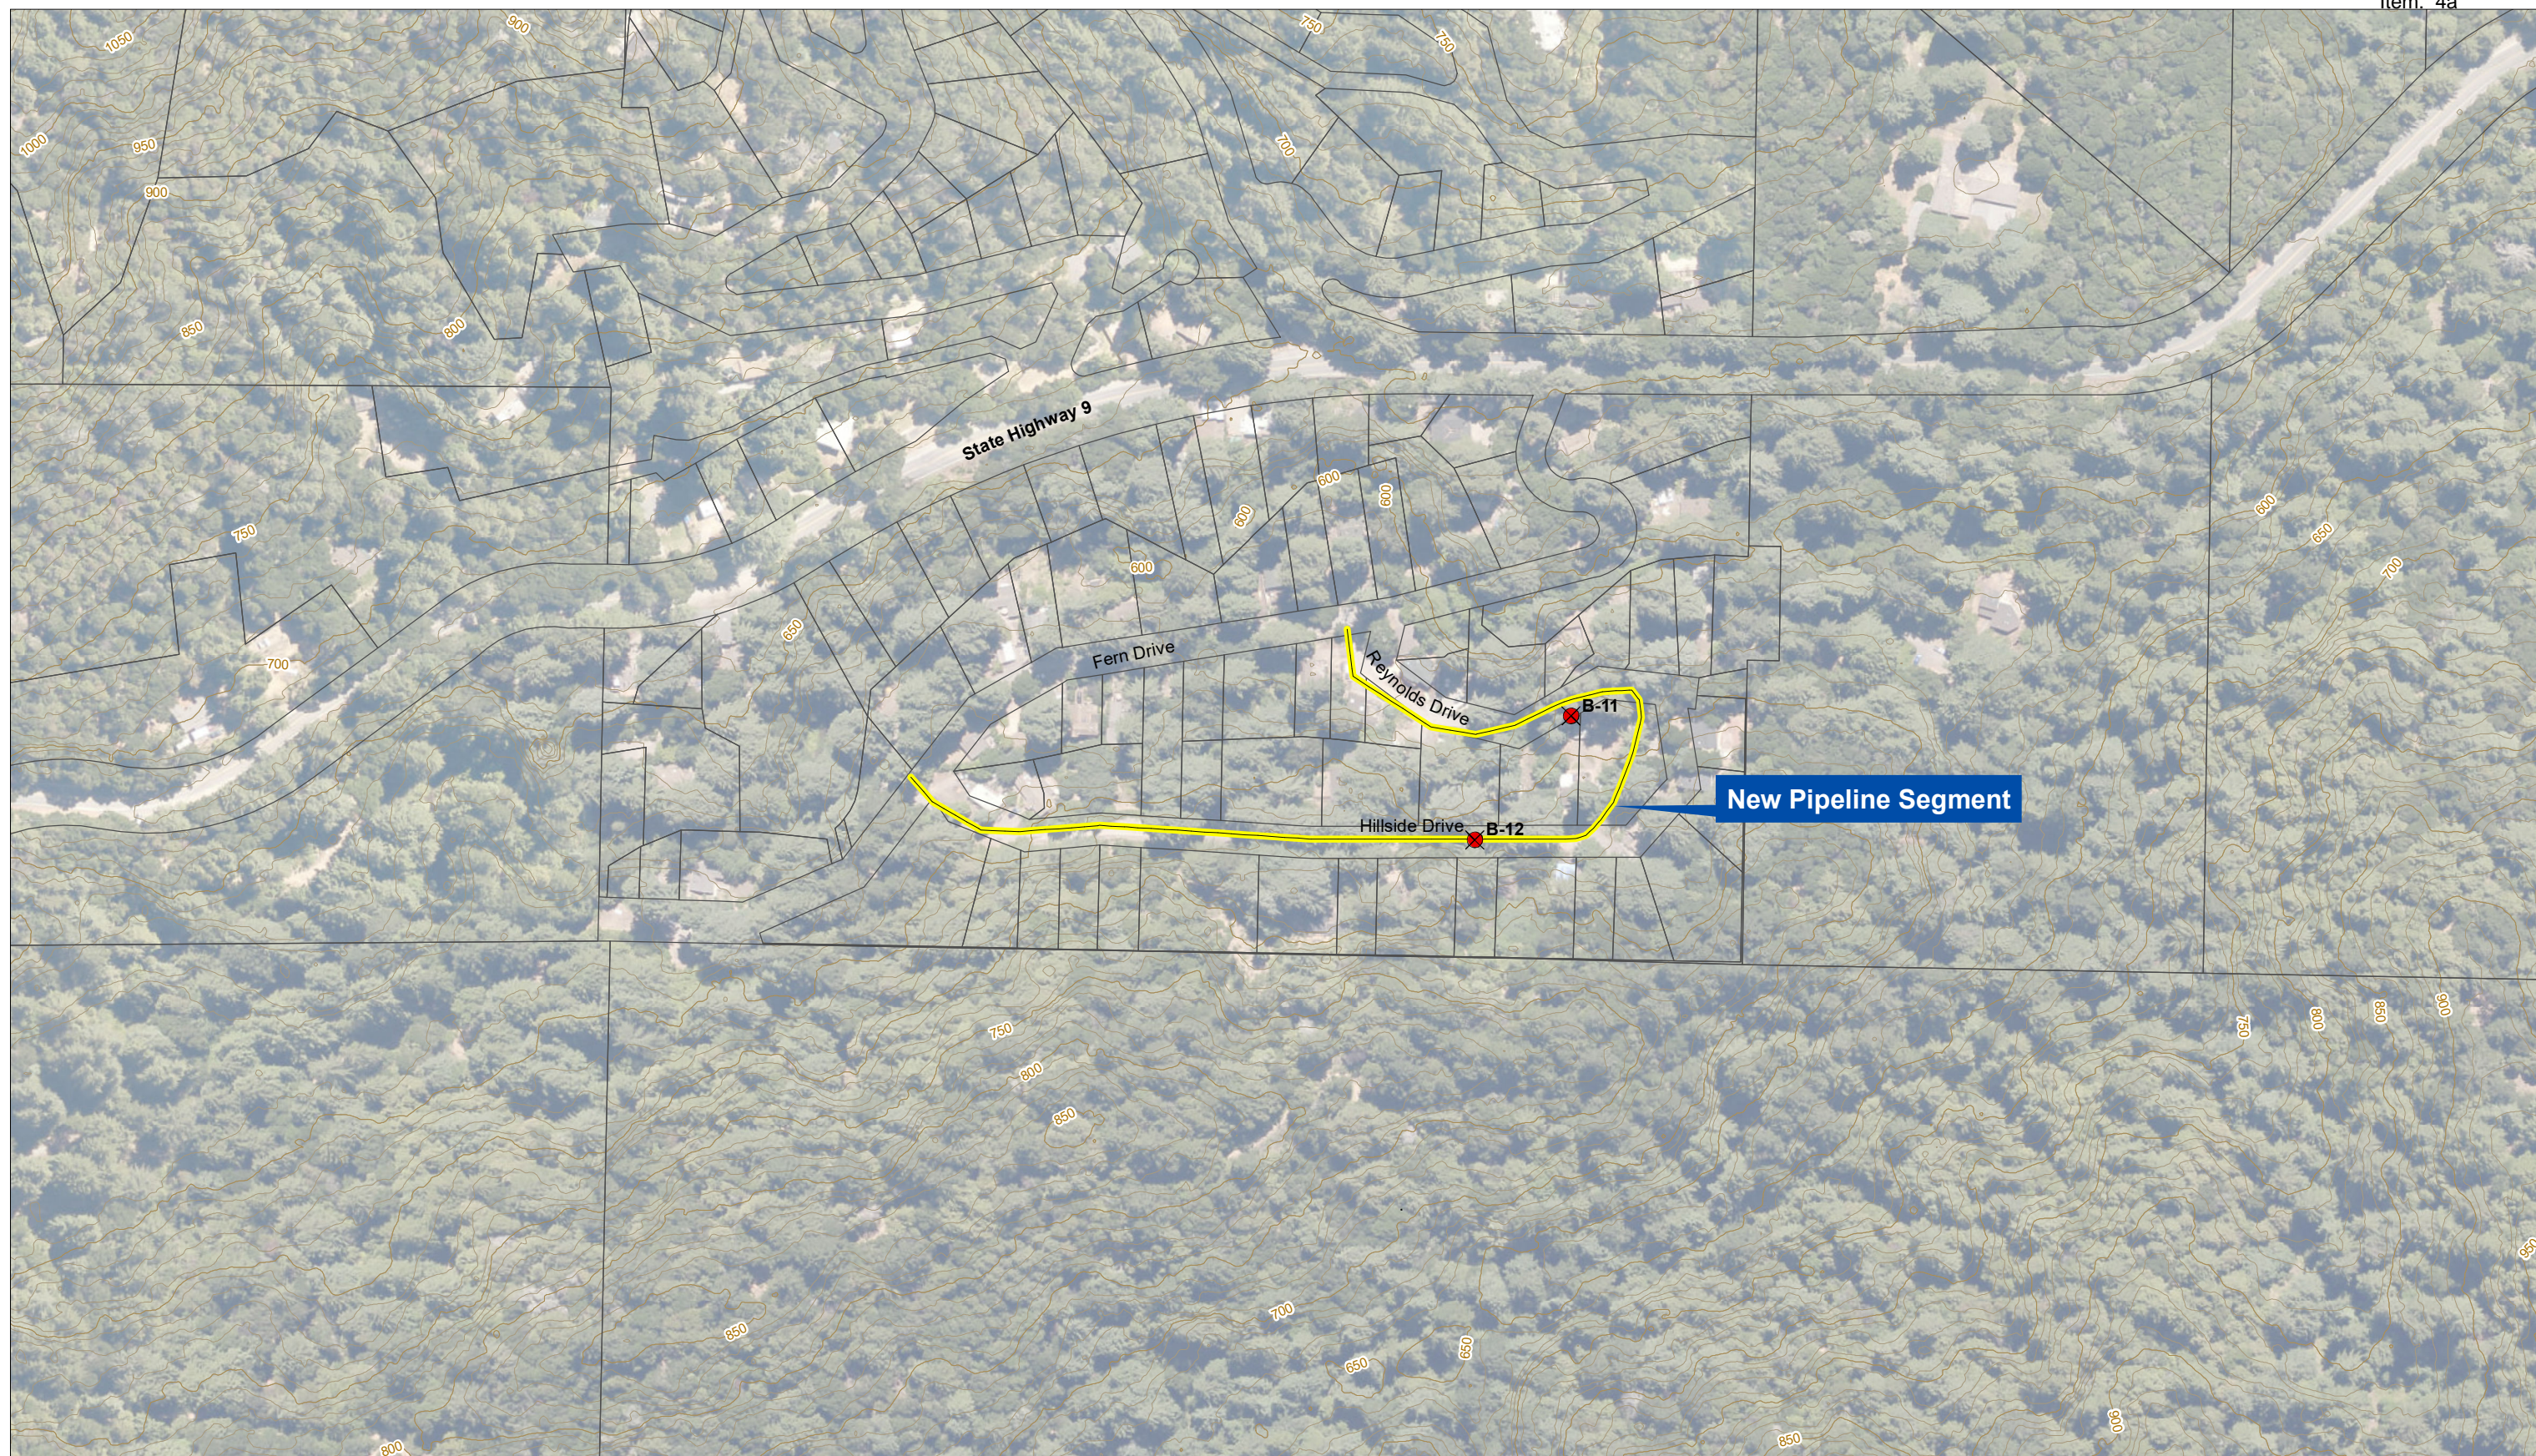
FIGURE 2A

New Pipeline Segment

- Figure 1. Site Location Map
- Figure 2A-2E. Site Plans
- Figure 3. Regional Geology Map
- Figure 4. Fault Activity Map
- Figure 5. Landslide Activity Map

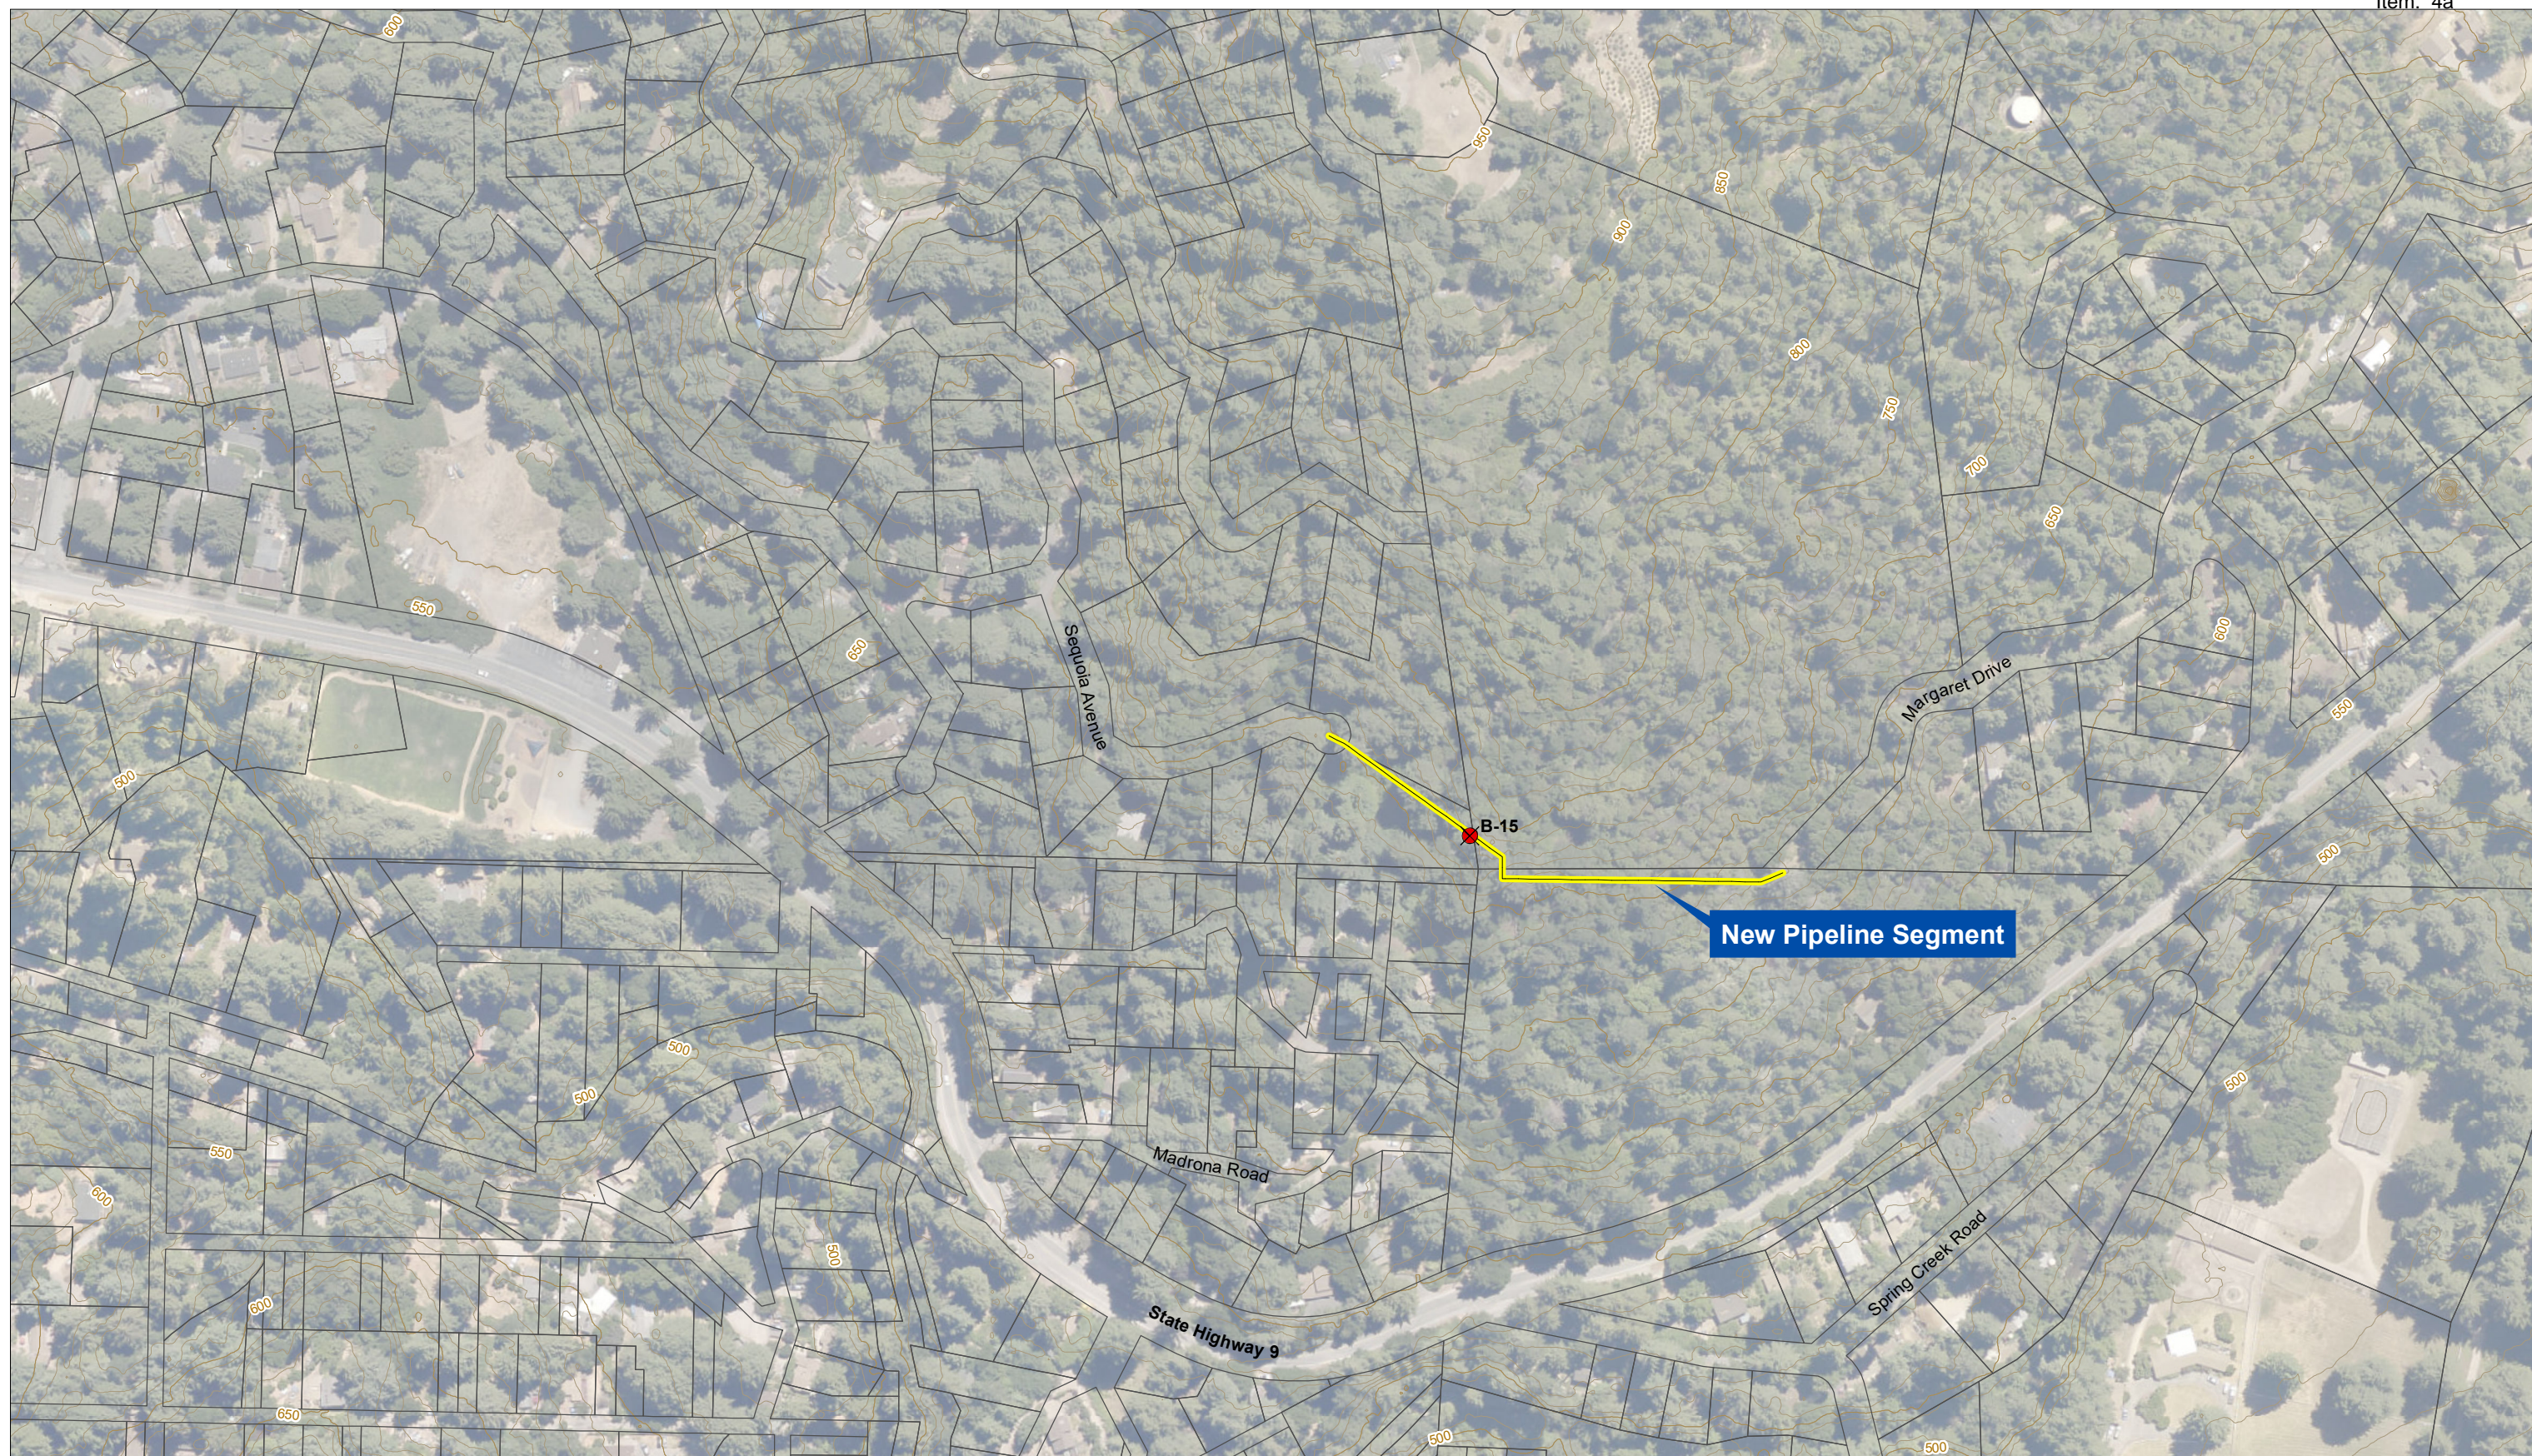
FIGURE 2B

New Pipeline Segment

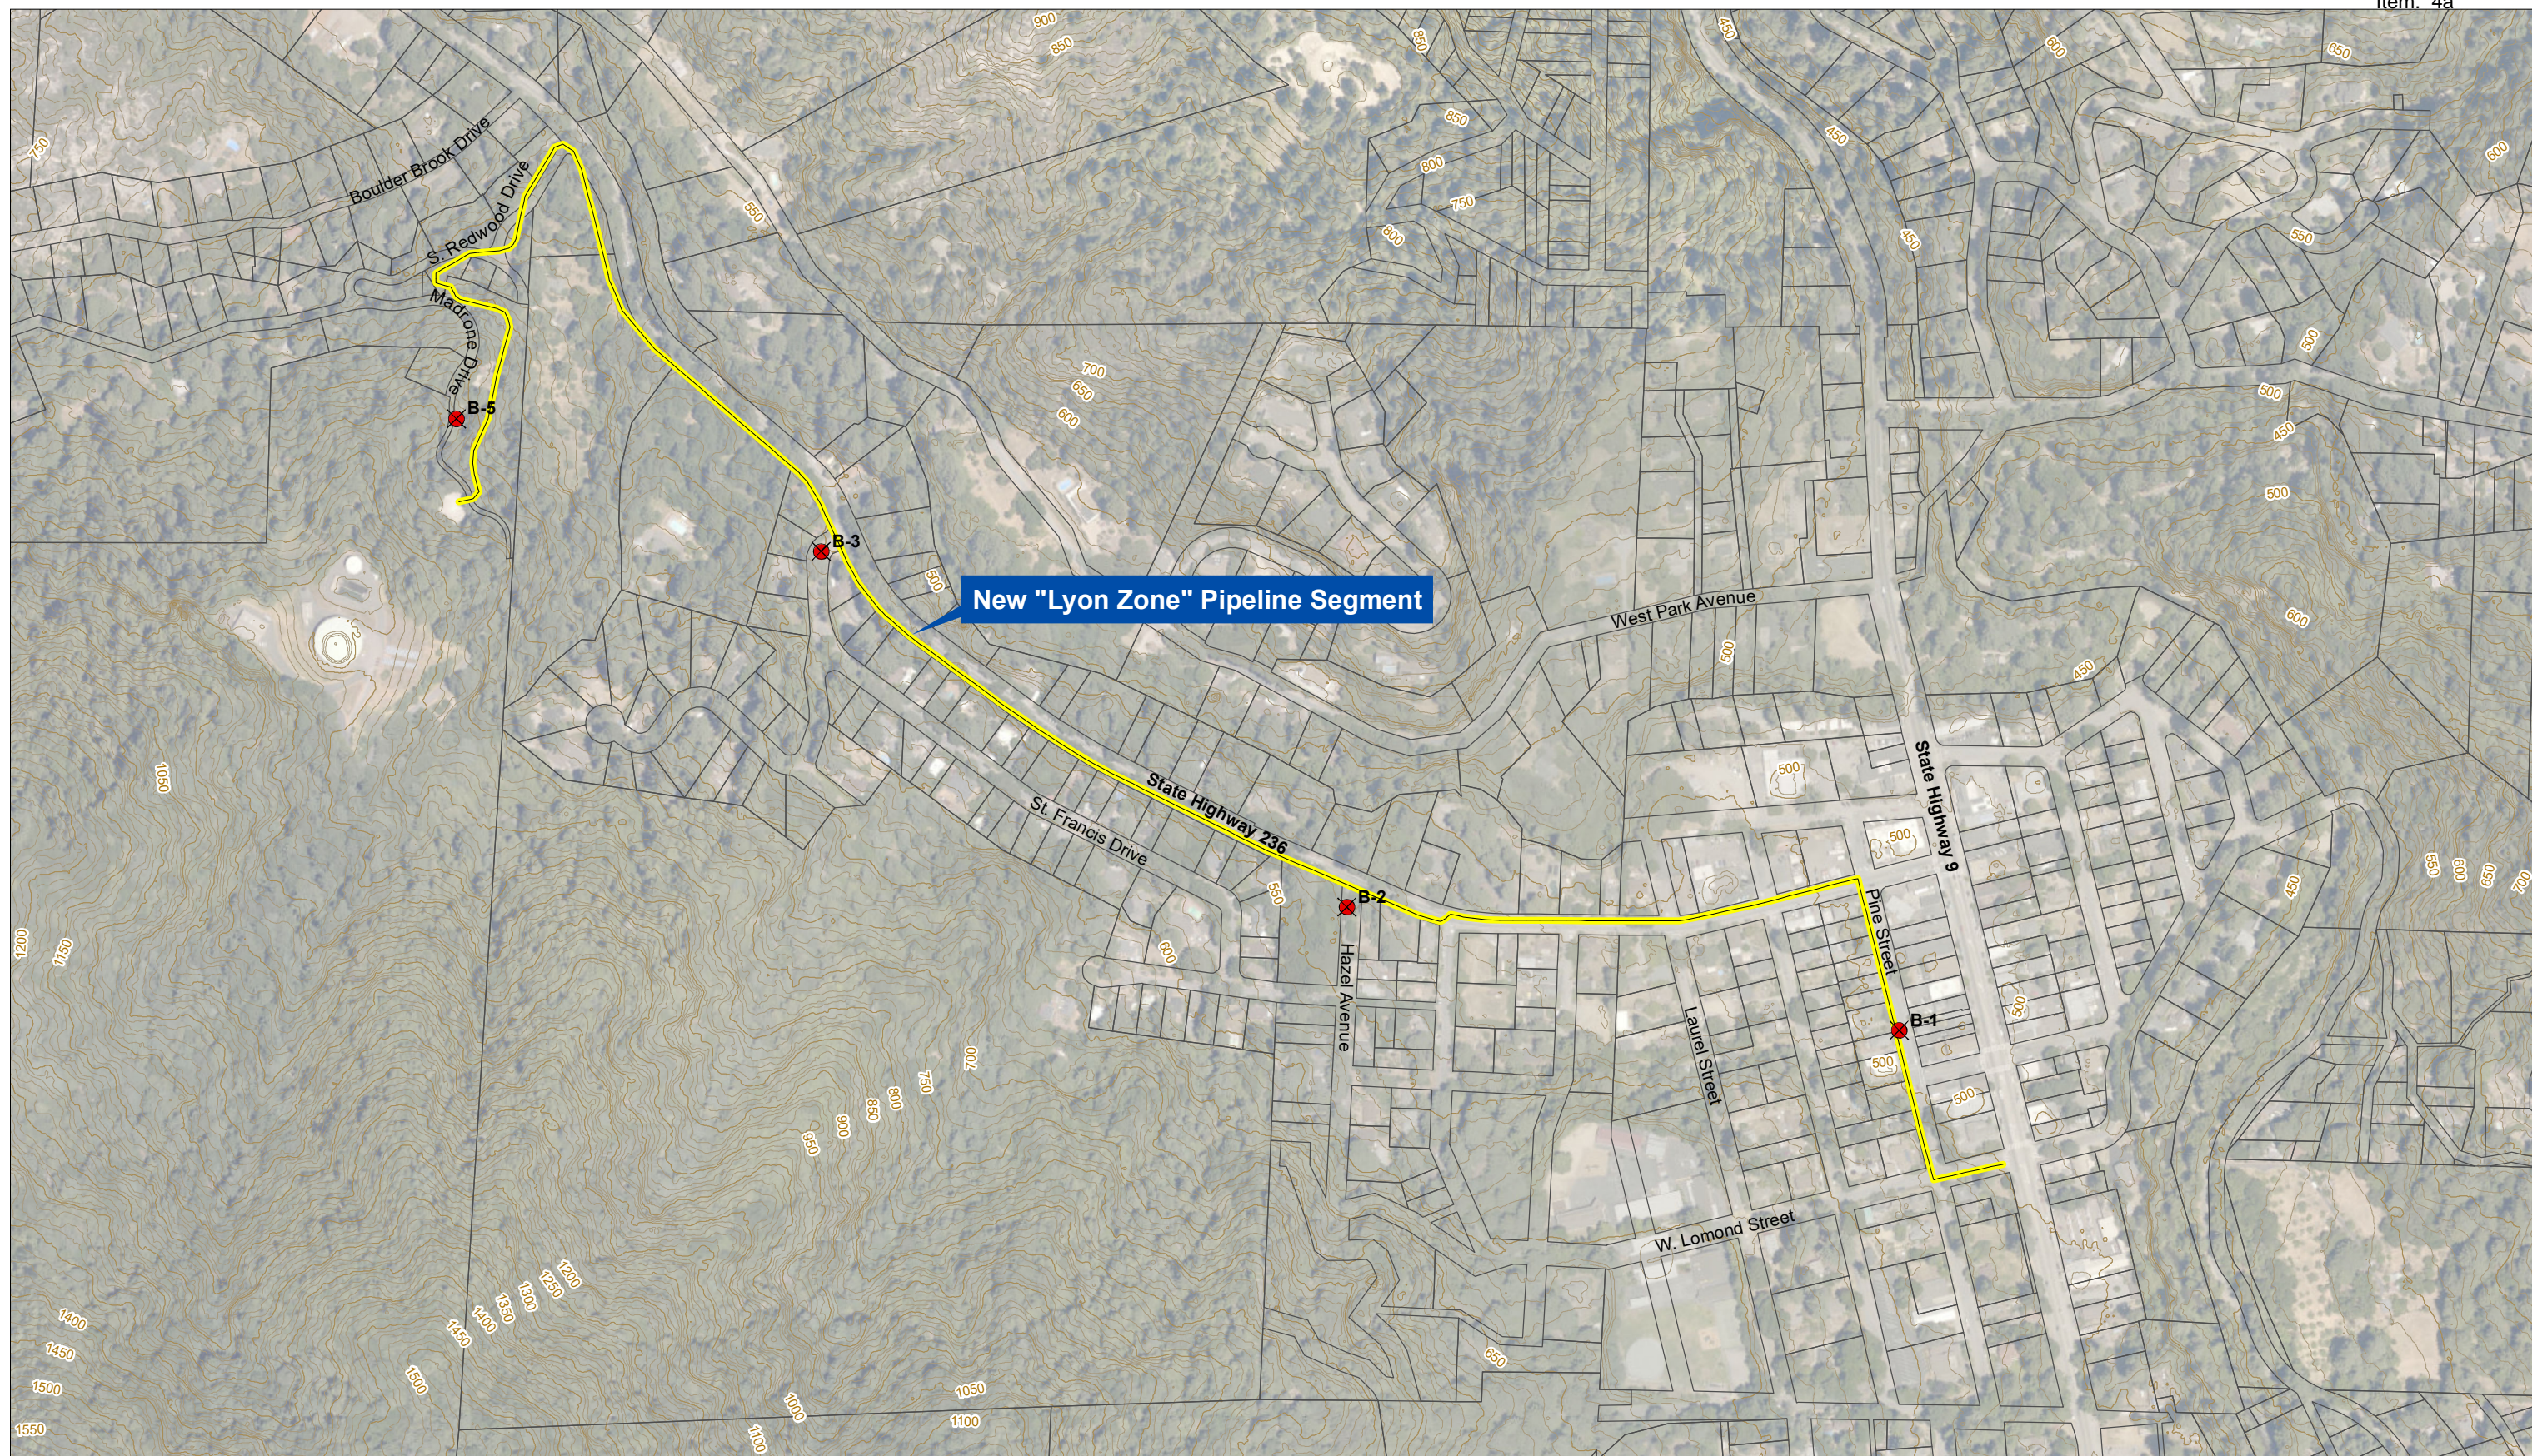
FIGURE 2C

1. 5-FEET CONTOURS DERIVED FROM 2010 LIDAR DATA.
2. ORTHOIMAGERY FROM SANTA CRUZ COUNTY, 2016
3. PIPE ALIGNMENT LOCATIONS ARE APPROXIMATE.
4. PARCEL DATA FROM SANTA CRUZ GIS DATABASE, ACCESSED ONLINE ON 08/03/2018.

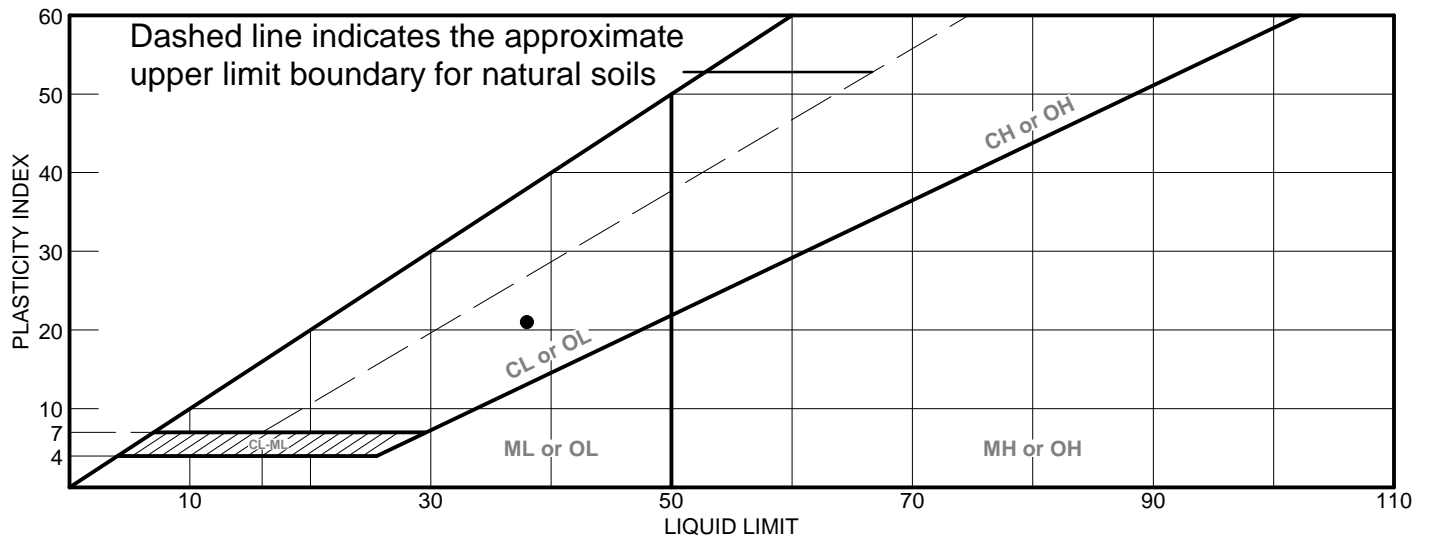
LIQUID AND PLASTIC LIMITS TEST REPORT

MATERIAL DESCRIPTION	LL	PL	PI	%<#40	%<#200	USCS
●	Dark Gray Lean Clayey SAND	38	17	21

Project No. 471-290 Client: Cal Engineering & Geology Project: SLVWD Pipeline - 191110 Source: B-1 Sample No.: 1-3 Elev./Depth: 3.5-5'	Remarks: ●
--	----------------------
