# San Lorenzo River and North Coast Watersheds Sanitary Survey Update

## San Lorenzo River and North Coast Watersheds Sanitary Survey Update

March 6, 2023

City of Santa Cruz  
715 Graham Hill Road  
Santa Cruz, California 95060  
In association with  
San Lorenzo Valley Water District

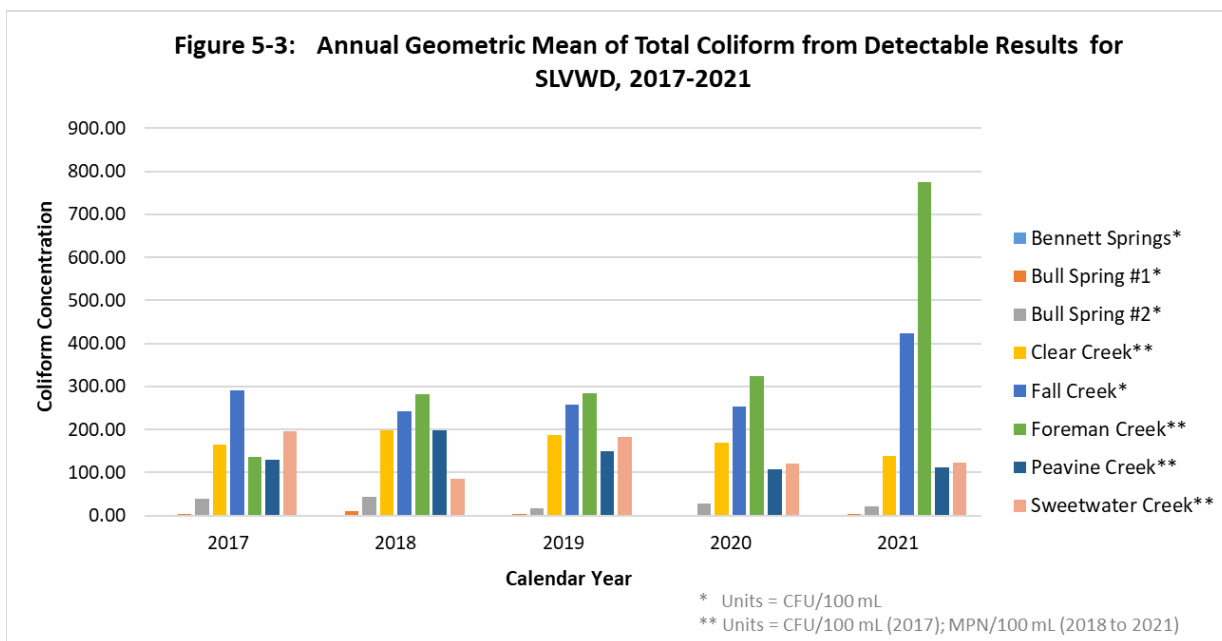
**Figure 5-3: Annual Geometric Mean of Total Coliform from Detectable Results for SLVWD, 2017-2021**
