**BOARD OF DIRECTORS
SAN LORENZO VALLEY WATER
DISTRICT
REGULAR MEETING
AGENDA
March 16, 2023**

SUBJECT: Award of Peavine Pipeline Hazard Tree Survey/Inventory and Trail Clearing

It is recommended that the Board review and accept the 2023 update for the San Lorenzo River and North Coast Watersheds Sanitary Survey the San Lorenzo Valley Water District and for the City of Santa Cruz Water Department. The Sanitary Survey update was submitted to the State Water Resources Control Board (SWRCB) Division of Drinking Water in March 2023.

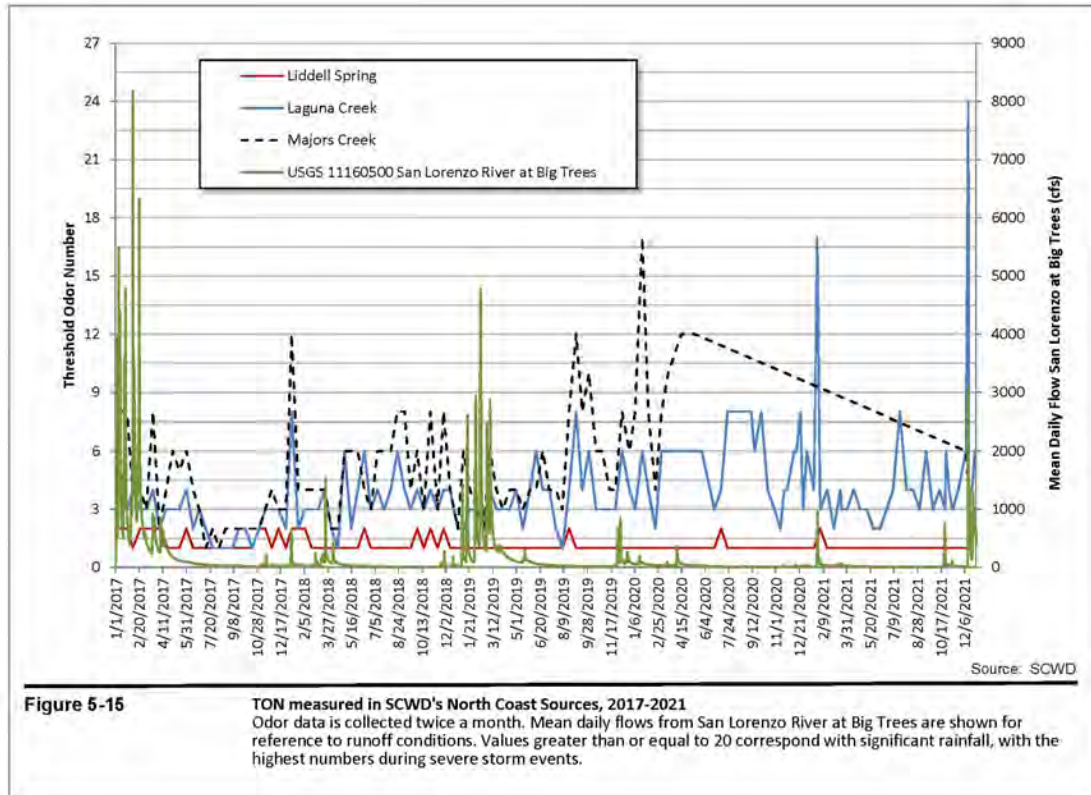
Figure 5-15: TON Measured in City's North Coast Sources, 2017-2021

Figure 5-15 shows TON values for City's North Coast sources over the same 5-year period. TON at Liddell Spring is much lower than at Laguna and Majors Creeks. Generally, values for the San Lorenzo River and North Coast sources are about the same, but the spikes for the San Lorenzo River during significant rain events are more dramatic.
